Yamhill Watershed Culvert Prioritization and Action Plan for Fish Passage

**GREATER YAMHILL
WATERSHED COUNCIL**

**Luke Westphal
Executive Director
Greater Yamhill Watershed Council**

December 2012

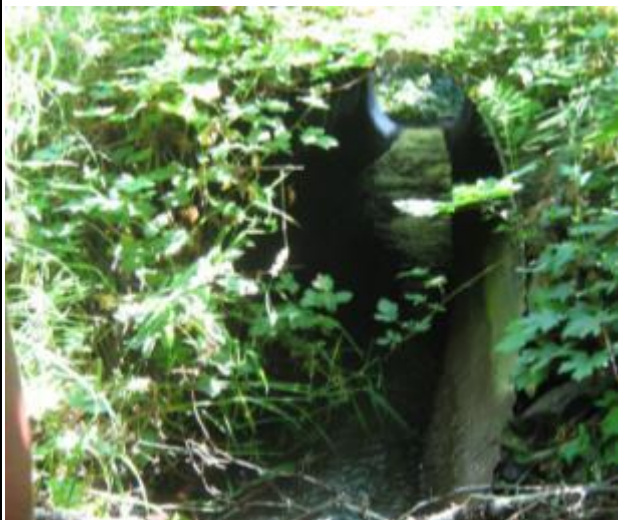
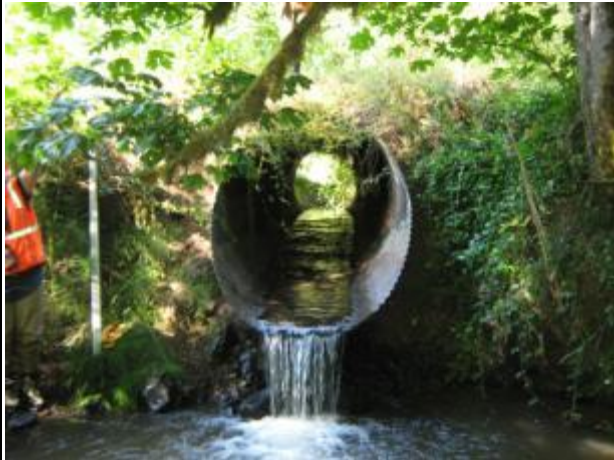
Culvert ID #	4166	Priority Ranking	High
Location Information			
Watershed	Mill Creek	Township-Range-Section-1/4	6S 6W 31 NE of SW
Stream Name	Gooseneck Creek	UTM Easting/Northing	NA
Road Name	Gooseneck Creek Rd	Owner Type	Private
Culvert Information			
Barrel Shape	Circular	Length (ft)	55.50
Culvert Material	Annular CMP	Horizontal Width (in)	72.00
Slope (%)	1.00	Vertical Height (in)	68.00
Overall Culvert Condition	Good	Outlet Drop(ft)	1.70
Channel Information			
Inlet Gradient (%)	5.00	Upstream Bankfull Width (ft)	10.30
Upstream Channel Gradient (%)	2.00	Downstream Bankfull Width (ft)	18.40
Bankfull Ratio	0.42		
Prioritization Analysis			
Habitat Length (miles)	2.22	(1) Habitat Length Points	3
Habitat Quality	0.90	(2) Habitat Quality Points	2
Fish Presence	Yes	(3) Fish Presence Points	2
Barrier Severity	Red	Total Prioritization Points	7
Comments			
<p>Survey Date: 7/21/2010; Survey Comments: Culvert perched; November 29 2012 TAC Meeting: (ODFW): Actually a County-owned pipe; Very High Priority; High quality habitat upstream. (BLM): BLM replaced a pipe upstream six years ago; GIS stream layer is wrong - tributary is actually upstream, thus more habitat upstream.</p>

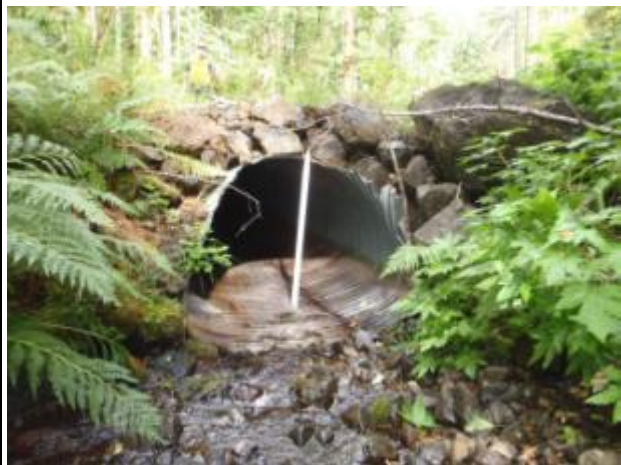
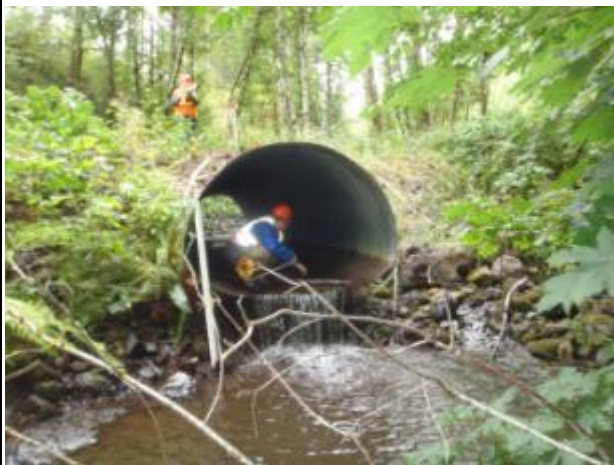
Culvert ID #	4238	Priority Ranking	Med
Location Information			
Watershed	Mill Creek	Township-Range-Section-1/4	7S 7W 14 SE of NW
Stream Name	Wind Creek	UTM Easting/Northing	NA
Road Name	Wind Creek Road	Owner Type	Private Industrial
Culvert Information			
Barrel Shape	Pipe-Arch	Length (ft)	48.42
Culvert Material	Annular CMP	Horizontal Width (in)	86.00
Slope (%)	0.20	Vertical Height (in)	66.00
Overall Culvert Condition	Good	Outlet Drop(ft)	1.75
Channel Information			
Inlet Gradient (%)	11.00	Upstream Bankfull Width (ft)	12.28
Upstream Channel Gradient (%)	12.00	Downstream Bankfull Width (ft)	19.80
Bankfull Ratio	0.48		
Prioritization Analysis			
Habitat Length (miles)	3.94	(1) Habitat Length Points	4
Habitat Quality	1.55	(2) Habitat Quality Points	2
Fish Presence	Yes	(3) Fish Presence Points	2
Barrier Severity	Red	Total Prioritization Points	8
Comments			
<p>Survey Date: 9/1/2010; Survey Comments: Bent inlet and sections folded apart; November 29 2012 TAC Meeting: (BLM): Culvert almost washed out this year - debris jams; WYCO mainline. (ODFW): Downstream barriers (slots) to steelhead access; Need more information on fish distributions and habitat.</p>

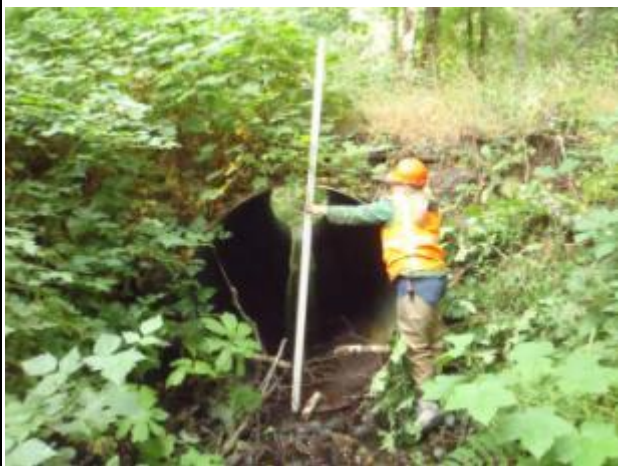
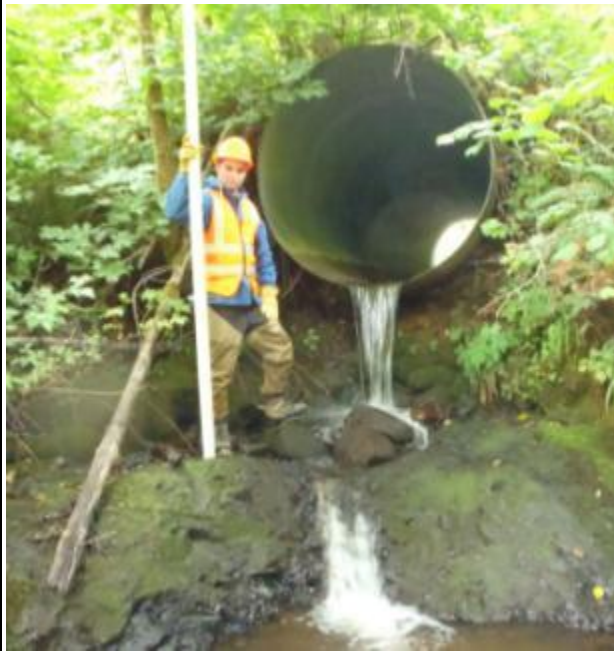
Culvert ID #	4226	Priority Ranking	Med
Location Information			
Watershed	Mill Creek	Township-Range-Section-1/4	7S 6W 18 SE of NW
Stream Name	Bear Creek	UTM Easting/Northing	NA
Road Name	Bear Creek Road	Owner Type	Private Industrial
Culvert Information			
Barrel Shape	Circular	Length (ft)	40.6
Culvert Material	Annular CMP	Horizontal Width (in)	72.00
Slope (%)	3.00	Vertical Height (in)	72.00
Overall Culvert Condition	Good	Outlet Drop(ft)	5.30
Channel Information			
Inlet Gradient (%)	13.00	Upstream Bankfull Width (ft)	11.93
Upstream Channel Gradient (%)	6.00	Downstream Bankfull Width (ft)	11.13
Bankfull Ratio	0.52		
Prioritization Analysis			
Habitat Length (miles)	2.20	(1) Habitat Length Points	3
Habitat Quality	1.13 - Med	(2) Habitat Quality Points	2
Fish Presence	Yes	(3) Fish Presence Points	2
Barrier Severity	Red	Total Prioritization Points	7
Comments			
Survey Date: 8/31/2010; Survey Comments: NA; November 29 2012 TAC Meeting: (ODFW): Does not have anadromy; Cutthroat trout present in streams.

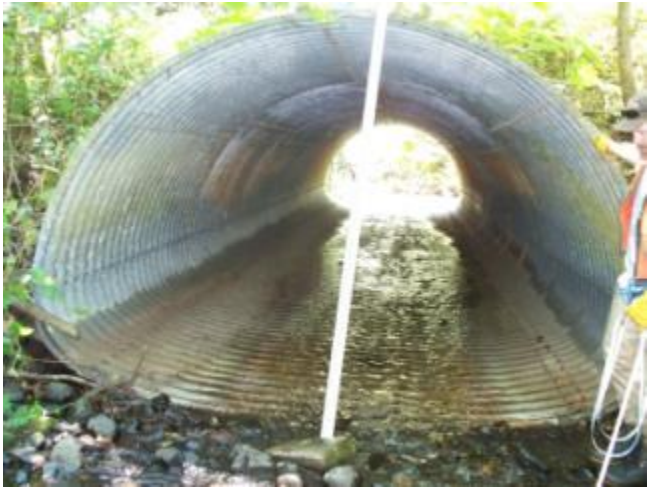
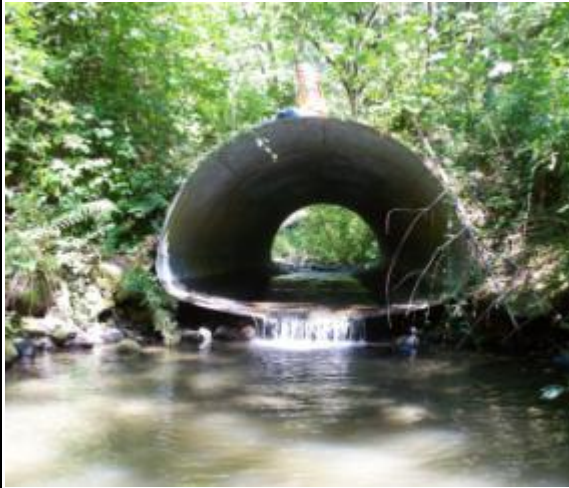
Culvert ID #	47	Priority Ranking	High
Location Information			
Watershed	North Yamhill	Township-Range-Section-1/4	2S 5W 10 SW of NW
Stream Name	Turner Creek	UTM Easting/Northing	NA
Road Name	Turner Creek Road	Owner Type	Private
Culvert Information			
Barrel Shape	Pipe Arch	Length (ft)	50.00
Culvert Material	SSP	Horizontal Width (in)	144.00
Slope (%)	2.00	Vertical Height (in)	96.00
Overall Culvert Condition	Good	Outlet Drop(ft)	1.02
Channel Information			
Inlet Gradient (%)	7.00	Upstream Bankfull Width (ft)	22.00
Upstream Channel Gradient (%)	5.00	Downstream Bankfull Width (ft)	27.00
Bankfull Ratio	0.48		
Prioritization Analysis			
Habitat Length (miles)	5.68	(1) Habitat Length Points	5
Habitat Quality	2.03 - High	(2) Habitat Quality Points	3
Fish Presence	Yes	(3) Fish Presence Points	2
Barrier Severity	Red	Total Prioritization Points	10
Comments			
<p>Survey Date: 8/23/2007; Survey Comments: A little water flows under left side (looking downstream); Fish Sighted; November 29 2012 Meeting: Steep. Undersized. Probably velocity barrier. Access to some good habitat quality. Steelhead. Confirmed Coho. Probable bridge given the bankfull width.</p>

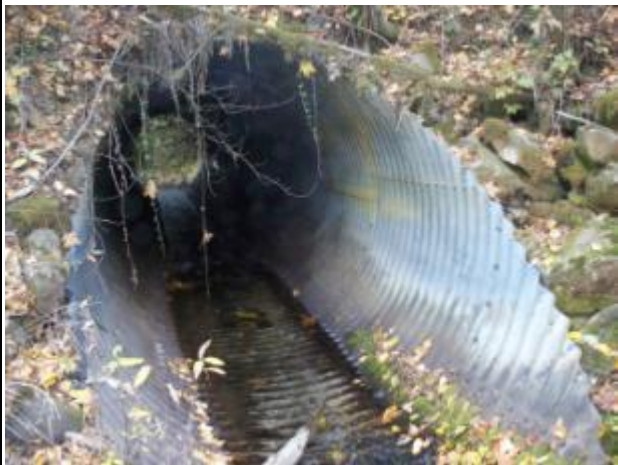
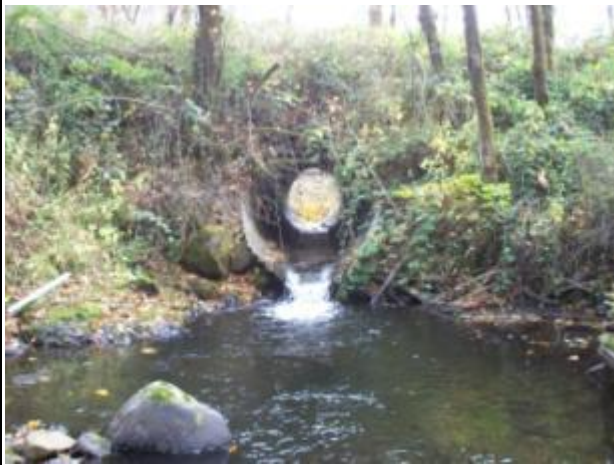
Culvert ID #	262	Priority Ranking	High
Location Information			
Watershed	North Yamhill	Township-Range-Section-1/4	2S 5W 28 SW of SW
Stream Name	Cedar Creek	UTM Easting/Northing	NA
Road Name	Old RailRd Grade Rd	Owner Type	County
Culvert Information			
Barrel Shape	Circular	Length (ft)	75.00
Culvert Material	Annular CMP	Horizontal Width (in)	102.00
Slope (%)	1.00	Vertical Height (in)	120.00
Overall Culvert Condition	Good	Outlet Drop(ft)	1.00
Channel Information			
Inlet Gradient (%)	13.00	Upstream Bankfull Width (ft)	24.00
Upstream Channel Gradient (%)	3.00	Downstream Bankfull Width (ft)	16.00
Bankfull Ratio	0.50		
Prioritization Analysis			
Habitat Length (miles)	6.74	(1) Habitat Length Points	5
Habitat Quality	3.48 - High	(2) Habitat Quality Points	3
Fish Presence	Yes	(3) Fish Presence Points	2
Barrier Severity	Red	Total Prioritization Points	10
Comments			
<p>Survey Date: 10/29/2007; Survey Comments: Will be good habitat. Restoration zone. Outlet drop but nice deep pool; November 29 2012 TAC Meeting: (BLM): Velocity barrier; probable bridge; BLM has done evaluation of the channel downstream - found Clams; Steelhead verified; Good habitat but needs wood. One culvert way upstream.</p>

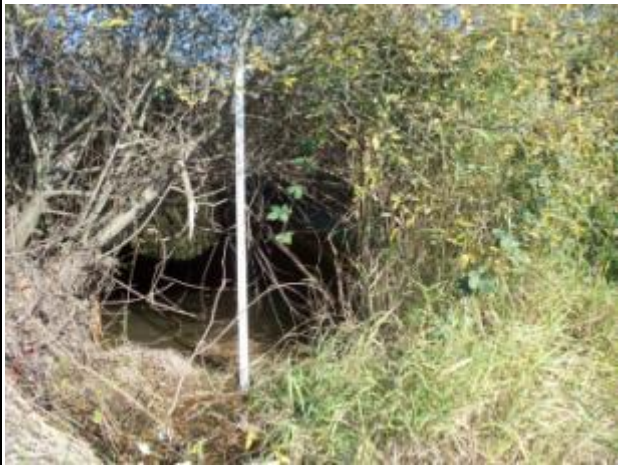
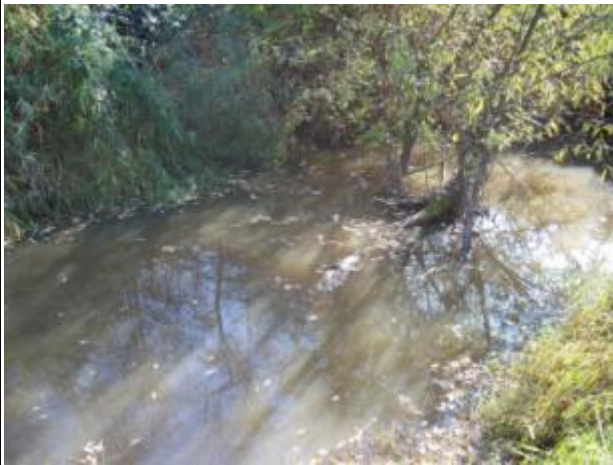
Culvert ID #	3327	Priority Ranking	High
Location Information			
Watershed	North Yamhill	Township-Range-Section-1/4	3S 4W 6 SE of SE
Stream Name	Unnamed Trib of North Yamhill River	UTM Easting/Northing	NA
Road Name	Old RailRd Grade Rd	Owner Type	County
Culvert Information			
Barrel Shape	Circular	Length (ft)	45.00
Culvert Material	Annular CMP	Horizontal Width (in)	120.00
Slope (%)	2.00	Vertical Height (in)	72.00
Overall Culvert Condition	Fair	Outlet Drop(ft)	0.00
Channel Information			
Inlet Gradient (%)	13.00	Upstream Bankfull Width (ft)	35.00
Upstream Channel Gradient (%)	1.00	Downstream Bankfull Width (ft)	10.00
Bankfull Ratio	2.85		
Prioritization Analysis			
Habitat Length (miles)	5.33	(1) Habitat Length Points	5
Habitat Quality	2.39 - High	(2) Habitat Quality Points	3
Fish Presence	Yes	(3) Fish Presence Points	2
Barrier Severity	Red	Total Prioritization Points	10
Comments			
<p>Survey Date: 10/30/2007; Survey Comments: Not good habitat, no real channel; Backwater; Channelized upstream; Oily film/murky; November 29 2012 TAC Meeting: (ODFW) Surrounded by fields; need more information on fish distributions. Upstream 35' BFW; downstream 10' (incised?).</p>

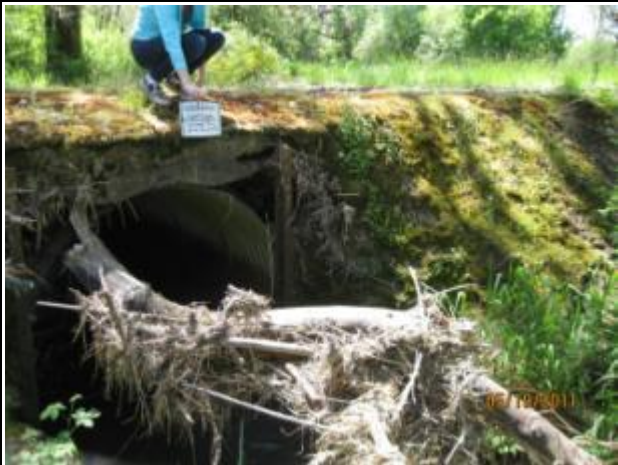
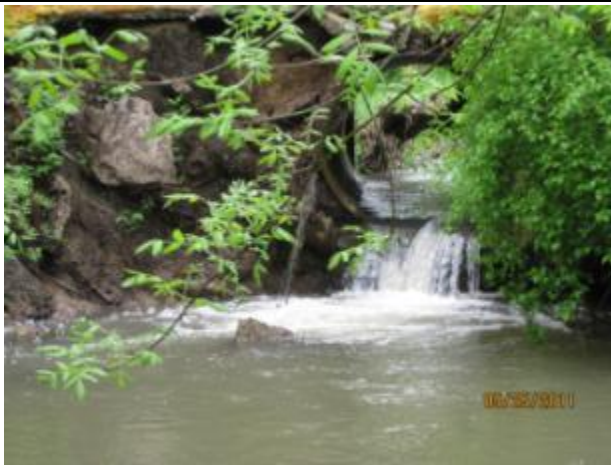
Culvert ID #	3093	Priority Ranking	High
Location Information			
Watershed	North Yamhill	Township-Range-Section-1/4	2S 5W 24
Stream Name	Unnamed Trib of North Yamhill River	UTM Easting/Northing	481222 / 5025030
Road Name	Tanager Lane	Owner Type	Private
Culvert Information			
Barrel Shape	Circular	Length (ft)	16.00
Culvert Material	Spiral CMP	Horizontal Width (in)	72.00
Slope (%)	- 1.00	Vertical Height (in)	72.00
Overall Culvert Condition	Poor	Outlet Drop(ft)	1.48
Channel Information			
Inlet Gradient (%)	4.00	Upstream Bankfull Width (ft)	50.00
Upstream Channel Gradient (%)	3.00	Downstream Bankfull Width (ft)	80.00
Bankfull Ratio	NA		
Prioritization Analysis			
Habitat Length (miles)	3.20	(1) Habitat Length Points	4
Habitat Quality	1.46 - Med	(2) Habitat Quality Points	2
Fish Presence	Yes	(3) Fish Presence Points	2
Barrier Severity	Red	Total Prioritization Points	8
Comments			
<p>Survey Date: 5/16/2011; Survey Comments: Located on Lazy River Vineyard. Owners willing to participate in any restoration needed. Heavy Bank Erosion, perched, water flows over and around culvert in high flows, Debris Plugging Inlet; Bottom Worn Thru; November 29 2012 TAC Meeting: (ODFW) Downstream Culvert #10037 being replaced soon; Habitat to 3093 should be next on the list.</p>

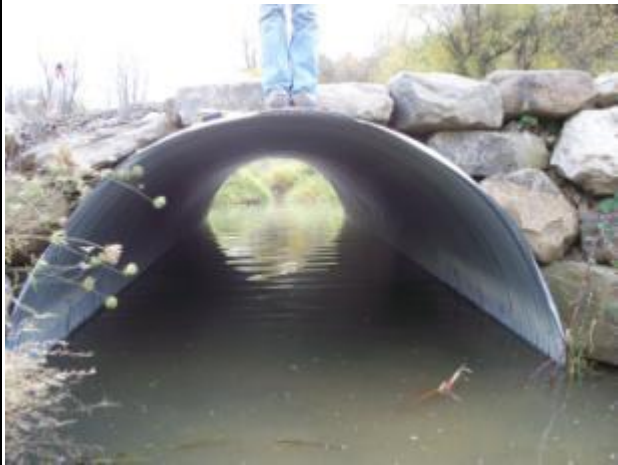
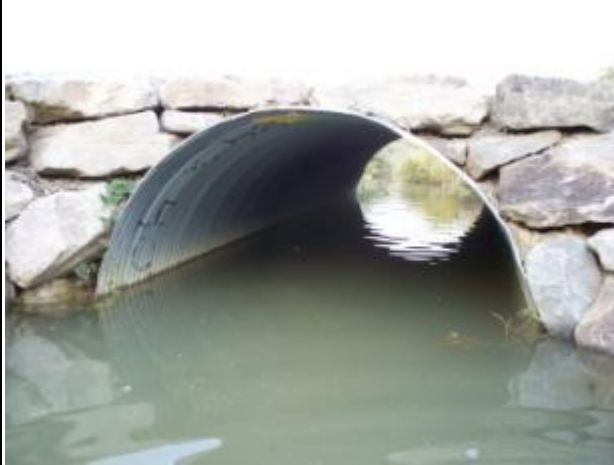
Culvert ID #	3048	Priority Ranking	High
Location Information			
Watershed	North Yamhill	Township-Range-Section-1/4	2S 4W 19 NE of NE
Stream Name	Unnamed Trib of North Yamhill River	UTM Easting/Northing	NA
Road Name	Garrish Valley Rd	Owner Type	County
Culvert Information			
Barrel Shape	Circular	Length (ft)	30.00
Culvert Material	Annular CMP	Horizontal Width (in)	96.00
Slope (%)	1.00	Vertical Height (in)	65.00
Overall Culvert Condition	Good	Outlet Drop(ft)	
Channel Information			
Inlet Gradient (%)	4.00	Upstream Bankfull Width (ft)	12.00
Upstream Channel Gradient (%)	1.00	Downstream Bankfull Width (ft)	12.00
Bankfull Ratio	0.67		
Prioritization Analysis			
Habitat Length (miles)	5.44	(1) Habitat Length Points	5
Habitat Quality	2.38 - High	(2) Habitat Quality Points	3
Fish Presence	Yes	(3) Fish Presence Points	2
Barrier Severity	Red	Total Prioritization Points	10
Comments			
<p>Survey Date: 10/29/2007; Survey Comments: Stagnant water, silty downstream, no habitat/riparian area, oil slick/film on water; November 29 2012 TAC Meeting: (ODFW): Not a spawning stream for steelhead; Juvenile steelhead will use the system; Poor habitat quality; Needs restoration; Fish are probably moving upstream - partial barrier; Coho probably all of the way up; Low gradient agricultural stream. (BLM): Downstream barrier being addressed.</p>

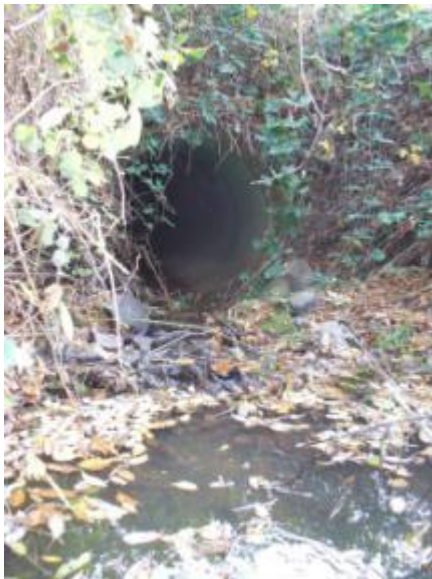
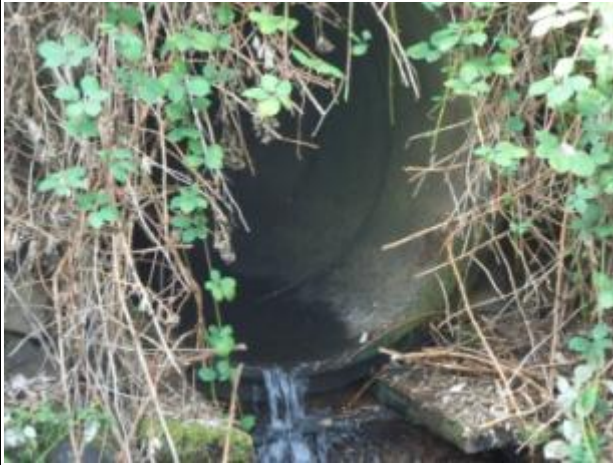
Culvert ID #	3444	Priority Ranking	Med
Location Information			
Watershed	North Yamhill	Township-Range-Section-1/4	3S 5W 23 NE of SW
Stream Name	Beaver Creek	UTM Easting/Northing	NA
Road Name	Panther Creek Road	Owner Type	County
Culvert Information			
Barrel Shape	Circular	Length (ft)	61.00
Culvert Material	Concrete	Horizontal Width (in)	70.00
Slope (%)	2.00	Vertical Height (in)	70.00
Overall Culvert Condition	Good	Outlet Drop(ft)	1.16
Channel Information			
Inlet Gradient (%)	4.00	Upstream Bankfull Width (ft)	NA
Upstream Channel Gradient (%)	NA	Downstream Bankfull Width (ft)	14.00
Bankfull Ratio	NA		
Prioritization Analysis			
Habitat Length (miles)	1.80	(1) Habitat Length Points	2
Habitat Quality	0.72 Med	(2) Habitat Quality Points	2
Fish Presence	Yes	(3) Fish Presence Points	2
Barrier Severity	Red	Total Prioritization Points	6
Comments			
<p>Survey Date: 11/01/2007; Survey Comments: Railroad ties underneath culvert; dip in culvert near outlet; downstream old car upside down in creek; beaver activity upstream; November 29 2012 TAC Meeting: N/A</p>

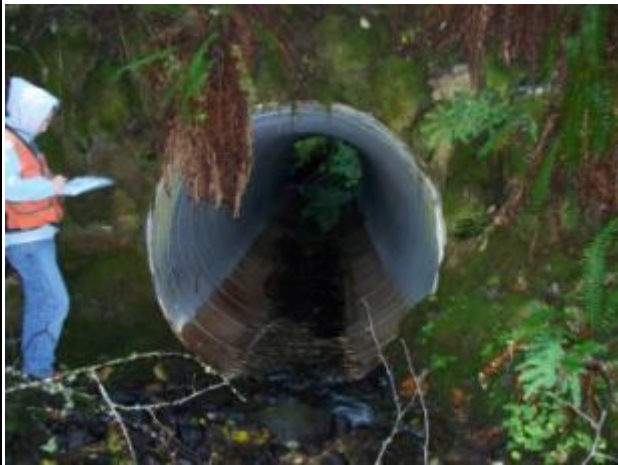
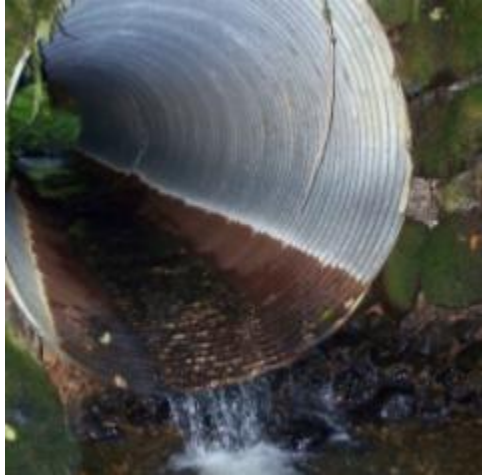
Culvert ID #	3475	Priority Ranking	Med
Location Information			
Watershed	North Yamhill	Township-Range-Section-1/4	3S 5W 28 SE of NE
Stream Name	Kane Creek	UTM Easting/Northing	NA
Road Name	Panther Creek Road	Owner Type	Private
Culvert Information			
Barrel Shape	Circular	Length (ft)	49.00
Culvert Material	Spiral CMP	Horizontal Width (in)	69.00
Slope (%)	3.00	Vertical Height (in)	71.00
Overall Culvert Condition	Poor	Outlet Drop(ft)	0.70
Channel Information			
Inlet Gradient (%)	10.00	Upstream Bankfull Width (ft)	12.00
Upstream Channel Gradient (%)	7.00	Downstream Bankfull Width (ft)	14.00
Bankfull Ratio	0.48		
Prioritization Analysis			
Habitat Length (miles)	2.43	(1) Habitat Length Points	3
Habitat Quality	0.48 - Low	(2) Habitat Quality Points	1
Fish Presence	Yes	(3) Fish Presence Points	2
Barrier Severity	Red	Total Prioritization Points	6
Comments			
Survey Date: 10/5/2007; Survey Comments: Hydro power "station" connected at outlet from holes in the bottom of the pipe. Good habitat; November 29 2012 TAC Meeting: N/A

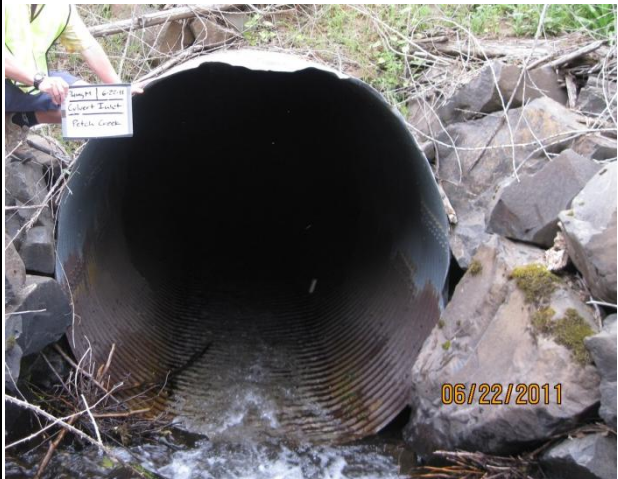
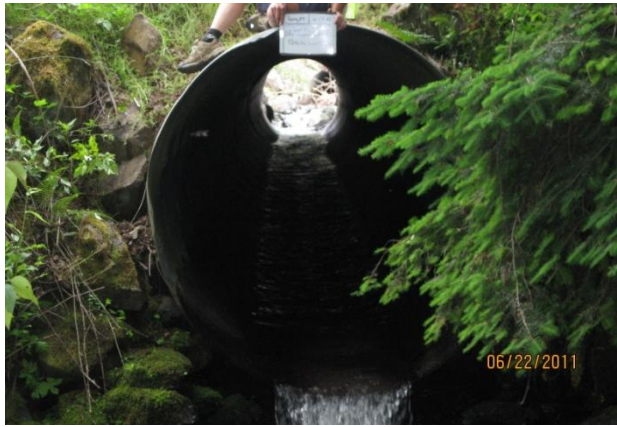
Culvert ID #	10040	Priority Ranking	Med
Location Information			
Watershed	North Yamhill	Township-Range-Section-1/4	NA
Stream Name	Petch Creek	UTM Easting/Northing	NA
Road Name	Flying M Road	Owner Type	Private
Culvert Information			
Barrel Shape	Circular	Length (ft)	24.00
Culvert Material	Concrete	Horizontal Width (in)	84.00
Slope (%)	6.00	Vertical Height (in)	84.00
Overall Culvert Condition	Good	Outlet Drop(ft)	1.13
Channel Information			
Inlet Gradient (%)	NA	Upstream Bankfull Width (ft)	60.00
Upstream Channel Gradient (%)	3.00	Downstream Bankfull Width (ft)	30.00
Bankfull Ratio	NA		
Prioritization Analysis			
Habitat Length (miles)	1.95	(1) Habitat Length Points	2
Habitat Quality	1.15 - Med	(2) Habitat Quality Points	2
Fish Presence	Yes	(3) Fish Presence Points	2
Barrier Severity	Red	Total Prioritization Points	6
Comments			
Survey Date: 6/6/2011; Survey Comments: Well known by landowners as having a salmon run ; November 29 2012 TAC Meeting: N/A

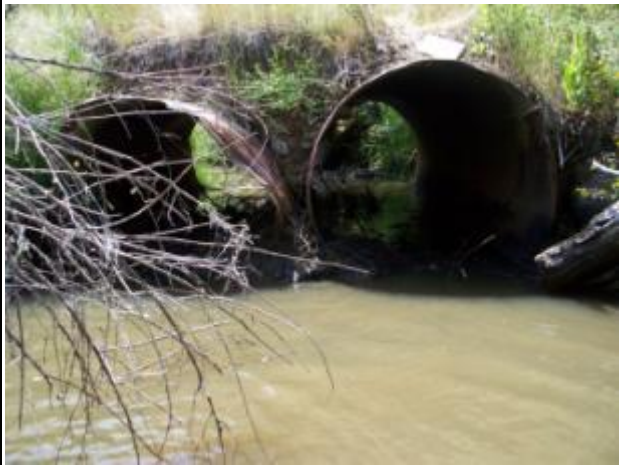
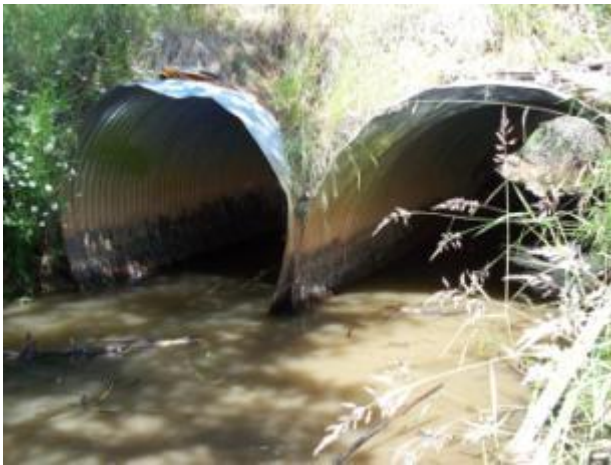
Culvert ID #	11090	Priority Ranking	High
Location Information			
Watershed	Willamina	Township-Range-Section-1/4	4S 6W 27 SW of NW
Stream Name	Baltimore Creek	UTM Easting/Northing	NA
Road Name	Baltimore Creek Rd	Owner Type	Private
Culvert Information			
Barrel Shape	Circular	Length (ft)	20.25
Culvert Material	Spiral CMP	Horizontal Width (in)	70.8
Slope (%)	3.00	Vertical Height (in)	61.2
Overall Culvert Condition	Poor	Outlet Drop(ft)	- 0.68
Channel Information			
Inlet Gradient (%)	22.00	Upstream Bankfull Width (ft)	12.00
Upstream Channel Gradient (%)	0.50	Downstream Bankfull Width (ft)	12.00
Bankfull Ratio	0.49		
Prioritization Analysis			
Habitat Length (miles)	8.52	(1) Habitat Length Points	5
Habitat Quality	3.33 - High	(2) Habitat Quality Points	3
Fish Presence	Yes	(3) Fish Presence Points	2
Barrier Severity	Red	Total Prioritization Points	10
Comments			
<p>Survey Date: 7/5/2007; Survey Comments: 2 culverts, both dammed by beaver; Debris plugging inlet; November 29 2012 TAC Meeting: (ODFW)Coho uses system; probable steelhead; Good habitat upstream; City has water rights upstream; Need more information on fish distributions.</p>

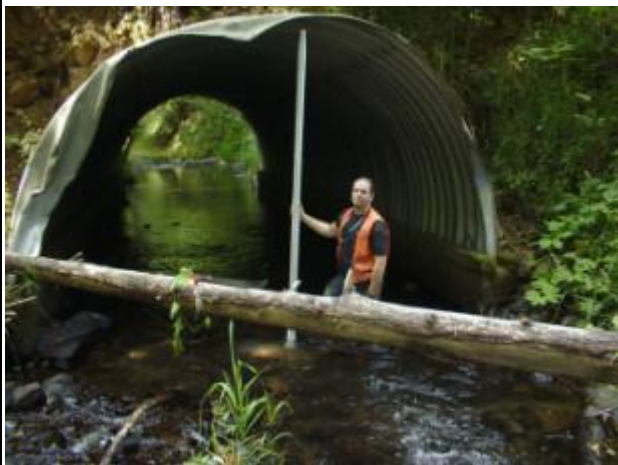
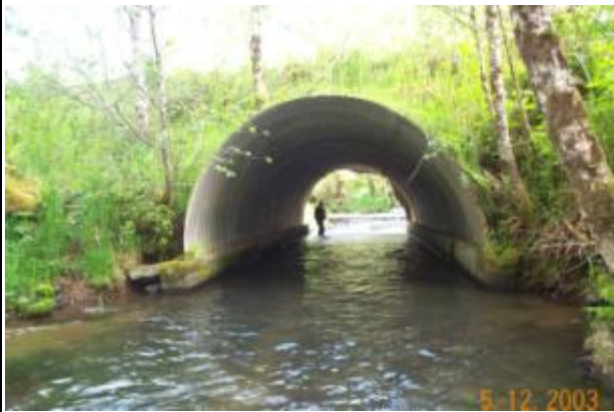
Culvert ID #	1314	Priority Ranking	Med
Location Information			
Watershed	Willamina	Township-Range-Section-1/4	5S 7W 10 NW of NW
Stream Name	Canada Creek	UTM Easting/Northing	457530 / 5000415
Road Name	Canada Creek Road	Owner Type	Private Industrial
Culvert Information			
Barrel Shape	Open Bottom Arch	Length (ft)	48.00
Culvert Material	SSP (Steel)	Horizontal Width (in)	168.00
Slope (%)	1.00	Vertical Height (in)	120.00
Overall Culvert Condition	Good	Outlet Drop(ft)	- 1.20
Channel Information			
Inlet Gradient (%)	10.00	Upstream Bankfull Width (ft)	27.00
Upstream Channel Gradient (%)	2.00	Downstream Bankfull Width (ft)	24.00
Bankfull Ratio	0.52		
Prioritization Analysis			
Habitat Length (miles)	5.70	(1) Habitat Length Points	5
Habitat Quality	4.02 - High	(2) Habitat Quality Points	3
Fish Presence	Yes	(3) Fish Presence Points	2
Barrier Severity	Red	Total Prioritization Points	10
Comments			
<p>Survey Date: 7/6/2004; Survey Comments: Backwater pool; Culvert sits on a 2ft concrete footwall; Fill eroding; November 29 2012 TAC Meeting: (BLM): Undersized culvert; May have washed out; Not scheduled to be replaced; Possibly still used as access road - low water ford.</p>

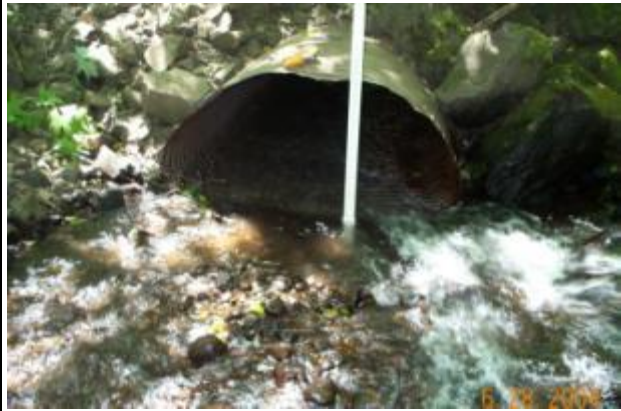
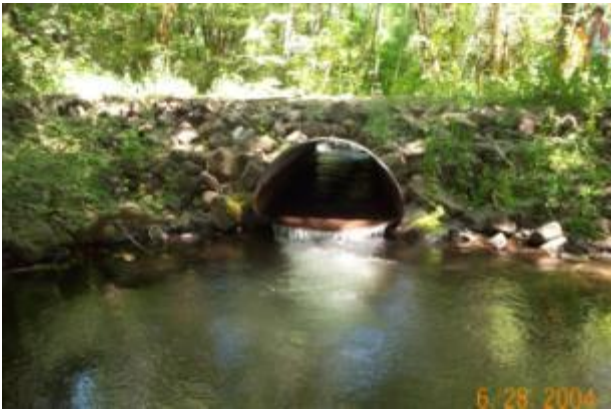
Culvert ID #	847	Priority Ranking	Med
Location Information			
Watershed	Willamina	Township-Range-Section-1/4	4S 6W 4 NW of SE
Stream Name	Cedar Creek	UTM Easting/Northing	466145 / 5010553
Road Name	Peavine Road	Owner Type	Private Industrial
Culvert Information			
Barrel Shape	Pipe-Arch	Length (ft)	41.00
Culvert Material	Annular CMP	Horizontal Width (in)	72.00
Slope (%)	1.00	Vertical Height (in)	42.00
Overall Culvert Condition	Fair	Outlet Drop(ft)	0.20
Channel Information			
Inlet Gradient (%)	2.00	Upstream Bankfull Width (ft)	16.50
Upstream Channel Gradient (%)	1.00	Downstream Bankfull Width (ft)	16.50
Bankfull Ratio	0.36		
Prioritization Analysis			
Habitat Length (miles)	4.08	(1) Habitat Length Points	5
Habitat Quality	2.38 - High	(2) Habitat Quality Points	3
Fish Presence	Yes	(3) Fish Presence Points	2
Barrier Severity	Red	Total Prioritization Points	10
Comments			
Survey Date: 6/28/2004; Survey Comments: Fish presence verified; November 29 2012 TAC Meeting: (ODFW): Above anadromous use; 50' waterfall downstream.

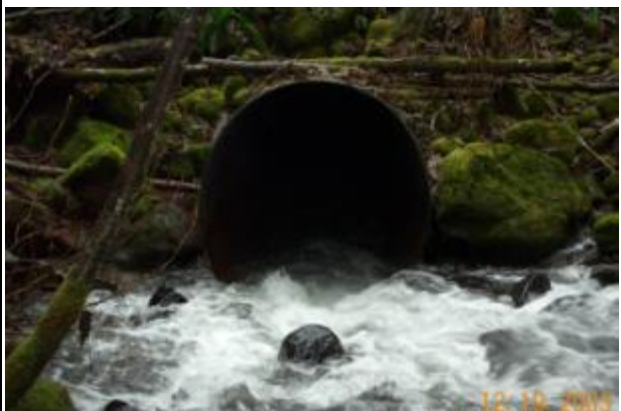
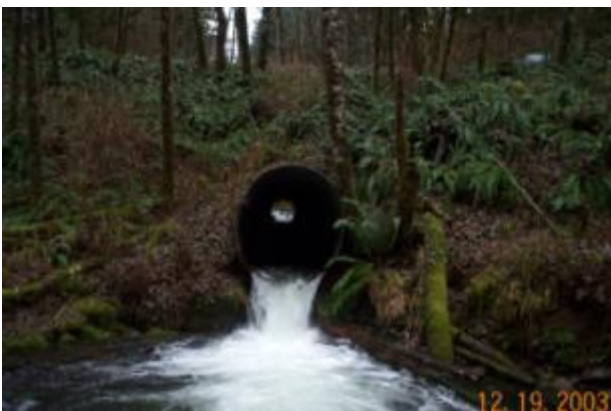
Culvert ID #	1058	Priority Ranking	Med
Location Information			
Watershed	Willamina	Township-Range-Section-1/4	4S 7W 24 SW of SW
Stream Name	Trib to Willamina Creek	UTM Easting/Northing	460697 / 5005596
Road Name	Willamina Creek Road	Owner Type	USDI-BLM
Culvert Information			
Barrel Shape	Circular	Length (ft)	114.00
Culvert Material	Annular CMP	Horizontal Width (in)	78.00
Slope (%)	5.00	Vertical Height (in)	78.00
Overall Culvert Condition	Fair	Outlet Drop(ft)	2.84
Channel Information			
Inlet Gradient (%)	25.00	Upstream Bankfull Width (ft)	27.00
Upstream Channel Gradient (%)	10.00	Downstream Bankfull Width (ft)	NA
Bankfull Ratio	0.24		
Prioritization Analysis			
Habitat Length (miles)	4.08	(1) Habitat Length Points	5
Habitat Quality	1.75 - Med	(2) Habitat Quality Points	2
Fish Presence	Yes	(3) Fish Presence Points	2
Barrier Severity	Red	Total Prioritization Points	9
Comments			
<p>Survey Date: 9/30/2003; Survey Comments: Culvert outlet influenced by another stream; no channel downstream; November 29 2012 TAC Meeting: (ODFW): Most stream crossings in this area have waterfalls upstream. (BLM): May not be fish upstream; Need more information on fish distribution; BLM recently cleaned debris from the culvert; Willamina Creek is downstream and backwaters; BLM does not rank highly – Low Priority for BLM.</p>

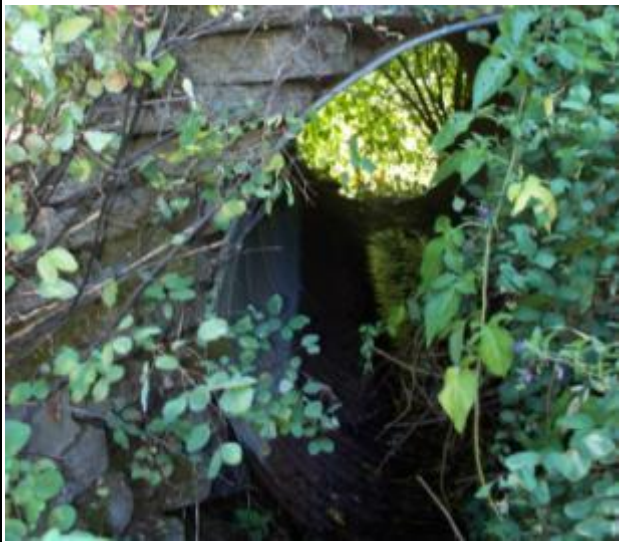
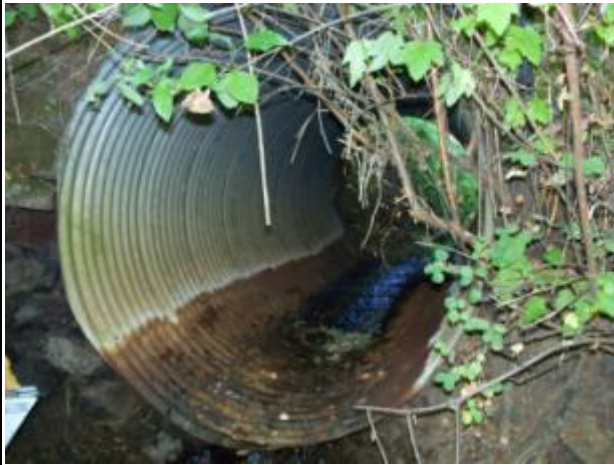
Culvert ID #	4009	Priority Ranking	Med
Location Information			
Watershed	Willamina	Township-Range-Section-1/4	5S 7W 36 NE of SW
Stream Name	Trib to Willamina Creek	UTM Easting/Northing	NA
Road Name	Fort Hill Road	Owner Type	Private
Culvert Information			
Barrel Shape	Circular	Length (ft)	16.00
Culvert Material	Spiral CMP	Horizontal Width (in)	60.00
Slope (%)	5.00	Vertical Height (in)	60.00
Overall Culvert Condition	Poor	Outlet Drop(ft)	1.48
Channel Information			
Inlet Gradient (%)	15.00	Upstream Bankfull Width (ft)	7.00
Upstream Channel Gradient (%)	3.00	Downstream Bankfull Width (ft)	6.00
Bankfull Ratio	0.76		
Prioritization Analysis			
Habitat Length (miles)	2.21	(1) Habitat Length Points	3
Habitat Quality	1.13 - Med	(2) Habitat Quality Points	2
Fish Presence	Yes	(3) Fish Presence Points	2
Barrier Severity	Red	Total Prioritization Points	7
Comments			
Survey Date: 7/24/2007; Survey Comments: Outlet 7' to Willamina Creek; Culvert bottom worn through; November 29 2012 TAC Meeting: N/A

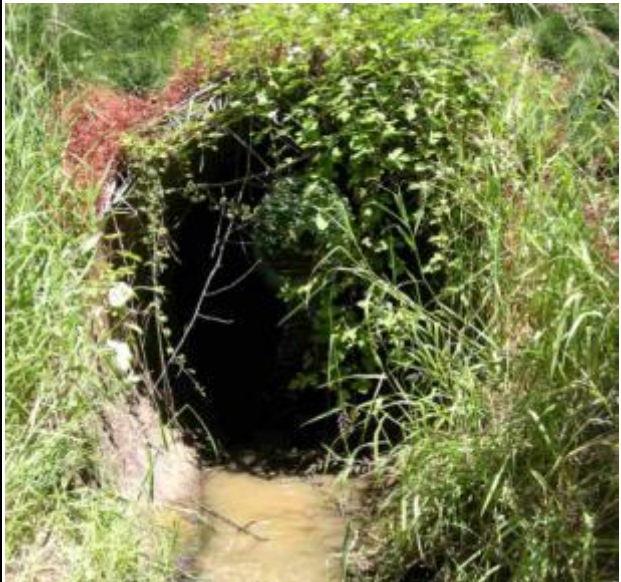
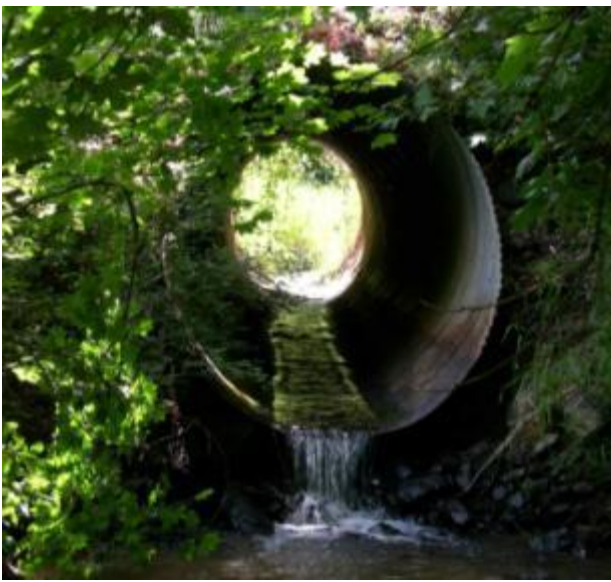
Culvert ID #	10019	Priority Ranking	Med
Location Information			
Watershed	Willamina	Township-Range-Section-1/4	5S 7W 27 NE OF SE
Stream Name	Trib to Willamina	UTM Easting/Northing	NA
Road Name	Allen Road	Owner Type	Private
Culvert Information			
Barrel Shape	Circular	Length (ft)	55.00
Culvert Material	Annular CMP	Horizontal Width (in)	76.80
Slope (%)	3.00	Vertical Height (in)	91.20
Overall Culvert Condition	Fair	Outlet Drop(ft)	1.45
Channel Information			
Inlet Gradient (%)	0.00	Upstream Bankfull Width (ft)	11.50
Upstream Channel Gradient (%)	1.00	Downstream Bankfull Width (ft)	11.00
Bankfull Ratio	0.56		
Prioritization Analysis			
Habitat Length (miles)	2.51	(1) Habitat Length Points	3
Habitat Quality	1.24 - Med	(2) Habitat Quality Points	2
Fish Presence	Yes	(3) Fish Presence Points	2
Barrier Severity	Red	Total Prioritization Points	7
Comments			
<p>Survey Date: 6/19/2007; Survey Comments: Beaver pools upstream; Culvert bottom rusting through; November 29 2012 TAC Meeting: (ODFW) Lower end occupied by steelhead but not far up; Need more information on fish distributions and habitat.</p>

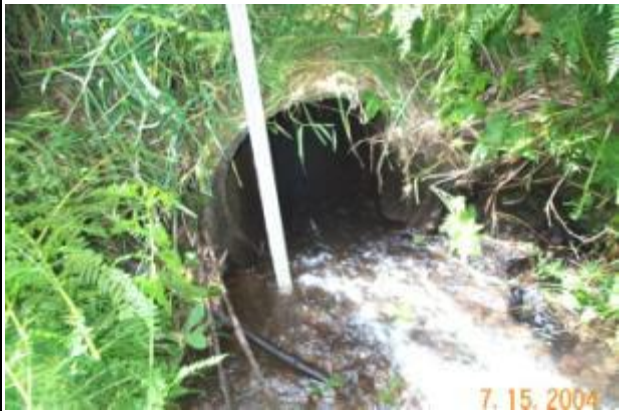
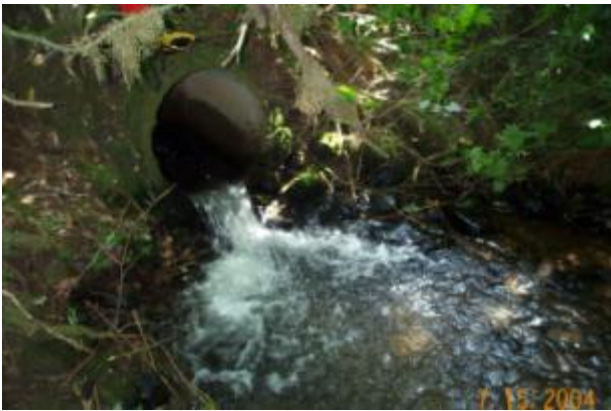
Culvert ID #	1110	Priority Ranking	Med
Location Information			
Watershed	Willamina	Township-Range-Section-1/4	4S 7W 27 NW of SE
Stream Name	Gilbert Creek	UTM Easting/Northing	458052 / 5004468
Road Name	Gilbert Creek Road	Owner Type	Private
Culvert Information			
Barrel Shape	Circular	Length (ft)	50.00
Culvert Material	Concrete	Horizontal Width (in)	36.00
Slope (%)	3.00	Vertical Height (in)	36.00
Overall Culvert Condition	Poor	Outlet Drop(ft)	0.60
Channel Information			
Inlet Gradient (%)	24.00	Upstream Bankfull Width (ft)	14.00
Upstream Channel Gradient (%)	2.00	Downstream Bankfull Width (ft)	14.00
Bankfull Ratio	0.21		
Prioritization Analysis			
Habitat Length (miles)	2.56	(1) Habitat Length Points	3
Habitat Quality	1.08 - Med	(2) Habitat Quality Points	2
Fish Presence	Yes	(3) Fish Presence Points	2
Barrier Severity	Red	Total Prioritization Points	7
Comments			
<p>Survey Date: 7/15/2004; Survey Comments: Culvert sections pulling apart, breaks in slope, undersized; November 29 2012 TAC Meeting: (ODFW) Above anadromous use; Waterfall downstream; Resident Cutthroat above and possibly lamprey to consider.</p>

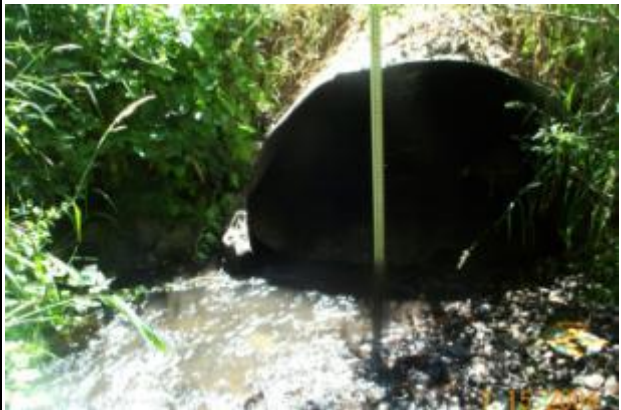
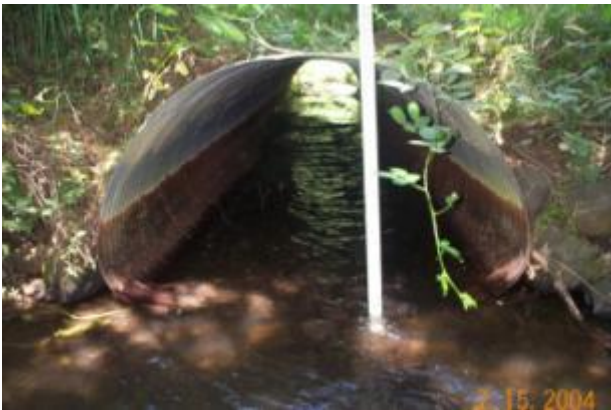
Culvert ID #	10016	Priority Ranking	Med
Location Information			
Watershed	Willamina	Township-Range-Section-1/4	5S 7W 3 NE of NW
Stream Name	Gilbert Creek	UTM Easting/Northing	457963 / 5002006
Road Name	Gilbert Creek Road	Owner Type	Private
Culvert Information			
Barrel Shape	Pipe-Arch	Length (ft)	50.00
Culvert Material	Annular CMP	Horizontal Width (in)	84.00
Slope (%)	2.00	Vertical Height (in)	54.00
Overall Culvert Condition	Good	Outlet Drop(ft)	- 0.67
Channel Information			
Inlet Gradient (%)	16.00	Upstream Bankfull Width (ft)	15.00
Upstream Channel Gradient (%)	3.00	Downstream Bankfull Width (ft)	17.00
Bankfull Ratio	0.47		
Prioritization Analysis			
Habitat Length (miles)	2.02	(1) Habitat Length Points	3
Habitat Quality	1.27 - Med	(2) Habitat Quality Points	2
Fish Presence	Yes	(3) Fish Presence Points	2
Barrier Severity	Red	Total Prioritization Points	7
Comments			
<p>Survey Date: 7/15/2004 ; Survey Comments: Fish presence verified; November 29 2012 TAC Meeting: (ODFW) Above anadromous use; Isolated cutthroat and lamprey potential; Lower mile of Gilbert Creek - steelhead are on the map, but there is a waterfall about 300' upstream of the mainstem of Coast Fork; would be good to fix for trout.</p>

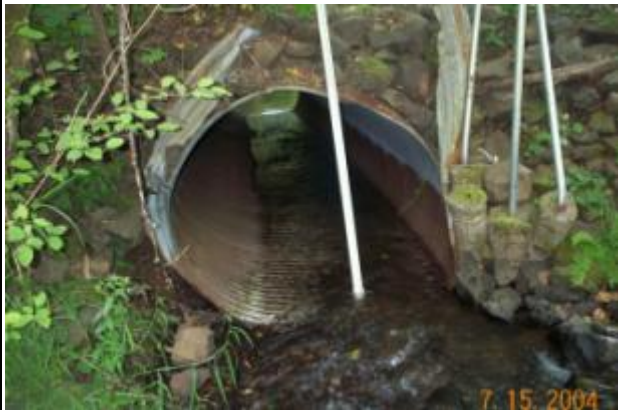
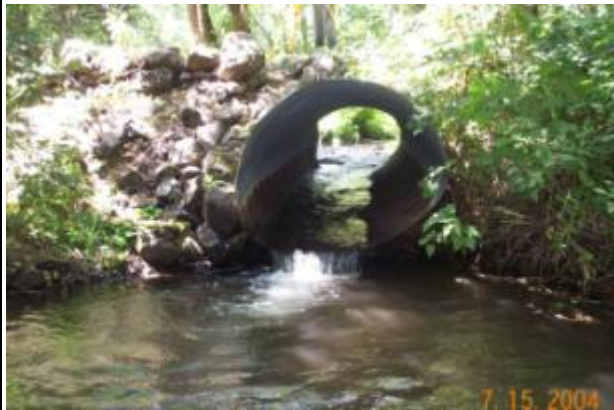
Culvert ID #	10017	Priority Ranking	Med
Location Information			
Watershed	Willamina	Township-Range-Section-1/4	5S 7W 3 NE of NW
Stream Name	Gilbert Creek	UTM Easting/Northing	457926 / 5002062
Road Name	Gilbert Creek Road	Owner Type	Private
Culvert Information			
Barrel Shape	Pipe-Arch	Length (ft)	29.00
Culvert Material	Spiral CMP	Horizontal Width (in)	72.00
Slope (%)	1.00	Vertical Height (in)	60.00
Overall Culvert Condition	Fair	Outlet Drop(ft)	0.60
Channel Information			
Inlet Gradient (%)	10.00	Upstream Bankfull Width (ft)	16.00
Upstream Channel Gradient (%)	2.00	Downstream Bankfull Width (ft)	15.00
Bankfull Ratio	0.38		
Prioritization Analysis			
Habitat Length (miles)	2.02	(1) Habitat Length Points	3
Habitat Quality	1.27 - Med	(2) Habitat Quality Points	2
Fish Presence	Yes	(3) Fish Presence Points	2
Barrier Severity	Red	Total Prioritization Points	7
Comments			
<p>Survey Date: 07/15/2004; Survey Comments: Fish presence verified; Top of culvert slightly collapsing; Bent inlet; November 29 2012 TAC Meeting: (ODFW) Above anadromy; Isolated cutthroat and lamprey potential; Lower mile of Gilbert Creek - steelhead are on the map, but there is a waterfall about 300' upstream of the mainstem Coast Fork; Would be good to fix for trout.</p>

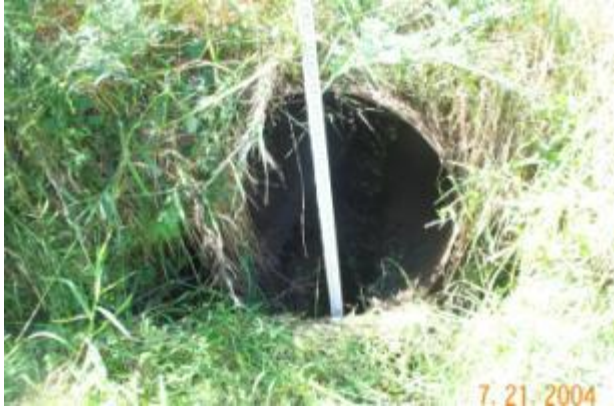
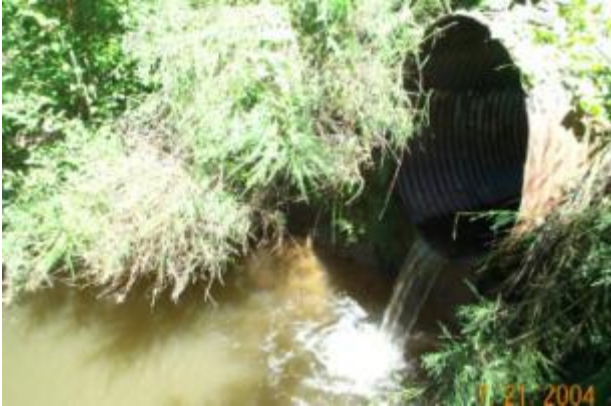
Culvert ID #	1116	Priority Ranking	Med
Location Information			
Watershed	Willamina	Township-Range-Section-1/4	4S 6W 29 NW of SW
Stream Name	La Tautena Mary Cr	UTM Easting/Northing	463912 / 5004442
Road Name	N/A	Owner Type	USDI-BLM
Culvert Information			
Barrel Shape	Circular	Length (ft)	33.00
Culvert Material	Annular CMP	Horizontal Width (in)	54.00
Slope (%)	2.00	Vertical Height (in)	54.00
Overall Culvert Condition	Poor	Outlet Drop(ft)	2.50
Channel Information			
Inlet Gradient (%)	21.00	Upstream Bankfull Width (ft)	13.00
Upstream Channel Gradient (%)	1.00	Downstream Bankfull Width (ft)	12.00
Bankfull Ratio	0.35		
Prioritization Analysis			
Habitat Length (miles)	2.02	(1) Habitat Length Points	3
Habitat Quality	0.64 - Low	(2) Habitat Quality Points	1
Fish Presence	Yes	(3) Fish Presence Points	2
Barrier Severity	Red	Total Prioritization Points	6
Comments			
Survey Date: 7/21/2004; Survey Comments: Undersized; Rusting through; Adjacent to Culvert ID # 10018; November 29 2012 TAC Meeting: N/A

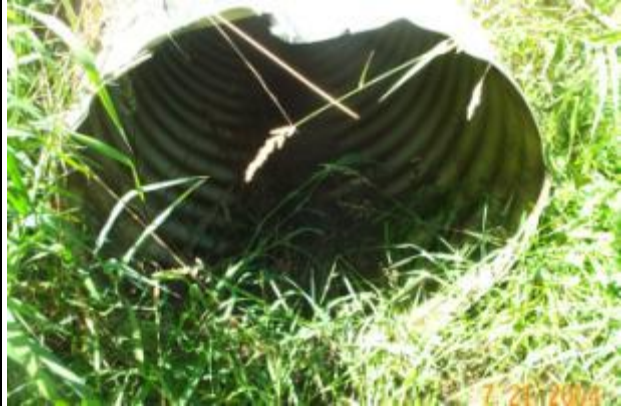
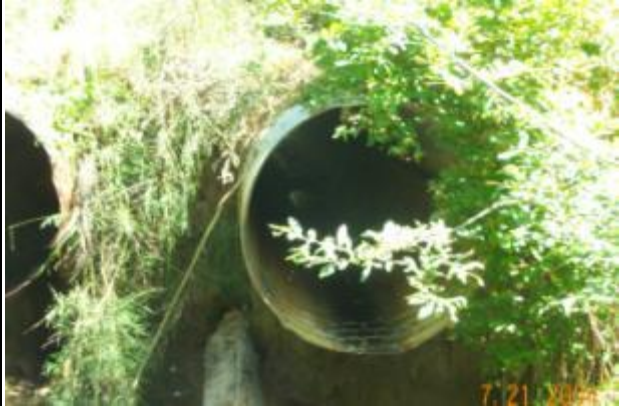
Culvert ID #	10018	Priority Ranking	Med
Location Information			
Watershed	Willamina	Township-Range-Section-1/4	4S 6W 29 NW of SW
Stream Name	La Tautena Mary Cr	UTM Easting/Northing	463912 / 5004442
Road Name	N/A	Owner Type	USDI-BLM
Culvert Information			
Barrel Shape	Circular	Length (ft)	47.00
Culvert Material	Annular CMP	Horizontal Width (in)	48.00
Slope (%)	4.00	Vertical Height (in)	48.00
Overall Culvert Condition	Fair	Outlet Drop(ft)	2.90
Channel Information			
Inlet Gradient (%)	21.00	Upstream Bankfull Width (ft)	13.00
Upstream Channel Gradient (%)	1.00	Downstream Bankfull Width (ft)	12.00
Bankfull Ratio	0.35		
Prioritization Analysis			
Habitat Length (miles)	2.02	(1) Habitat Length Points	3
Habitat Quality	0.64 - Low	(2) Habitat Quality Points	1
Fish Presence	Yes	(3) Fish Presence Points	2
Barrier Severity	Red	Total Prioritization Points	6
Comments			
Survey Date: 7/21/2004; Survey Comments: No water flowing through, Cracked inlet; Adjacent to Culvert ID # 1116; November 29 2012 TAC Meeting: N/A
