# NORTH YAMHILL RIVER SUBWATERSHED

## WATER QUALITY MONITORING FINAL REPORT

March 2007

Prepared By:  
L. Denise Schmit  
Water Quality Monitoring Technician  
Yamhill Basin Council  
McMinnville, Oregon  
[www.co.yamhill.or.us/ycb](http://www.co.yamhill.or.us/ycb)

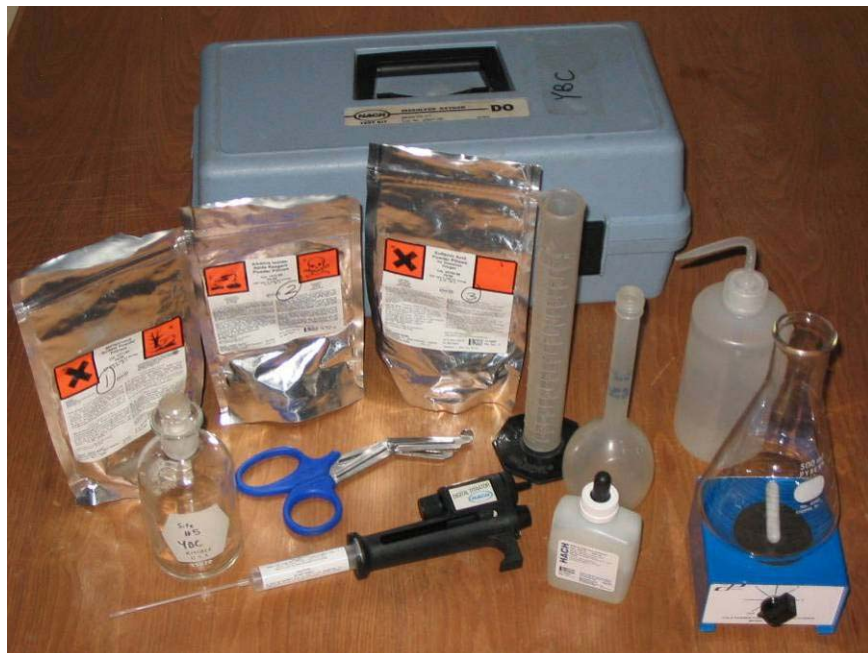
Photo 2.1 Hach Dissolved Oxygen Kit

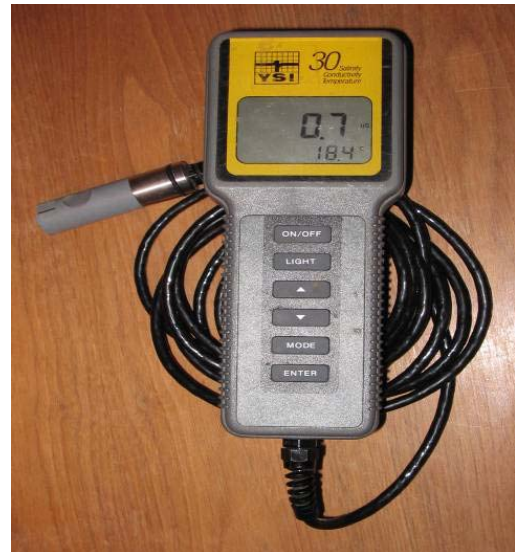
Photo2.2 YSI Model 30  
Conductivity/Temperature Meter

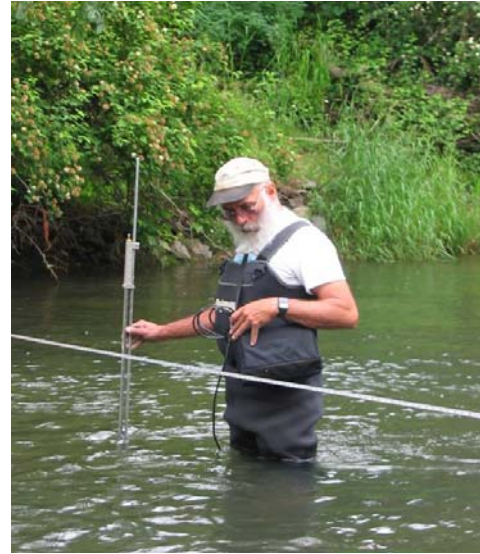
Flow, or stream discharge, was measured in cubic feet per second (cfs) using a Marsh-McBirney Flow-Mate™ digital flow meter and a top-setting wading rod. Discharge was calculated using the standard velocity-area method. For a detailed description of flow measurement methods, see Appendix E.

Photo 2.3 Stream Flow Measurement

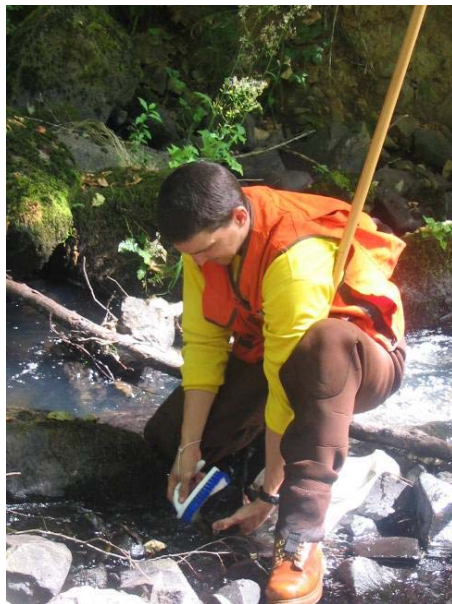
Benthic macroinvertebrates were collected using Oregon DEQ protocols. A D-frame kick net with 500 micron netting was used to capture macroinvertebrates in 8, 1ft squares in 1-8 (depending upon the number of riffles within the stretch being measured) riffles at each of 9 sites in 2005 and 7 sites in 2006. Moving downstream to upstream, so as not to disturb subsequent samples, rocks were scrubbed and substrate was disturbed for a depth of several centimeters within the 1ft squares upstream from the net with the hands and feet. Samples were preserved in 91% isopropyl alcohol (immediately on site) in labeled plastic containers.

Photo 2.4 Macroinvertebrate Collection

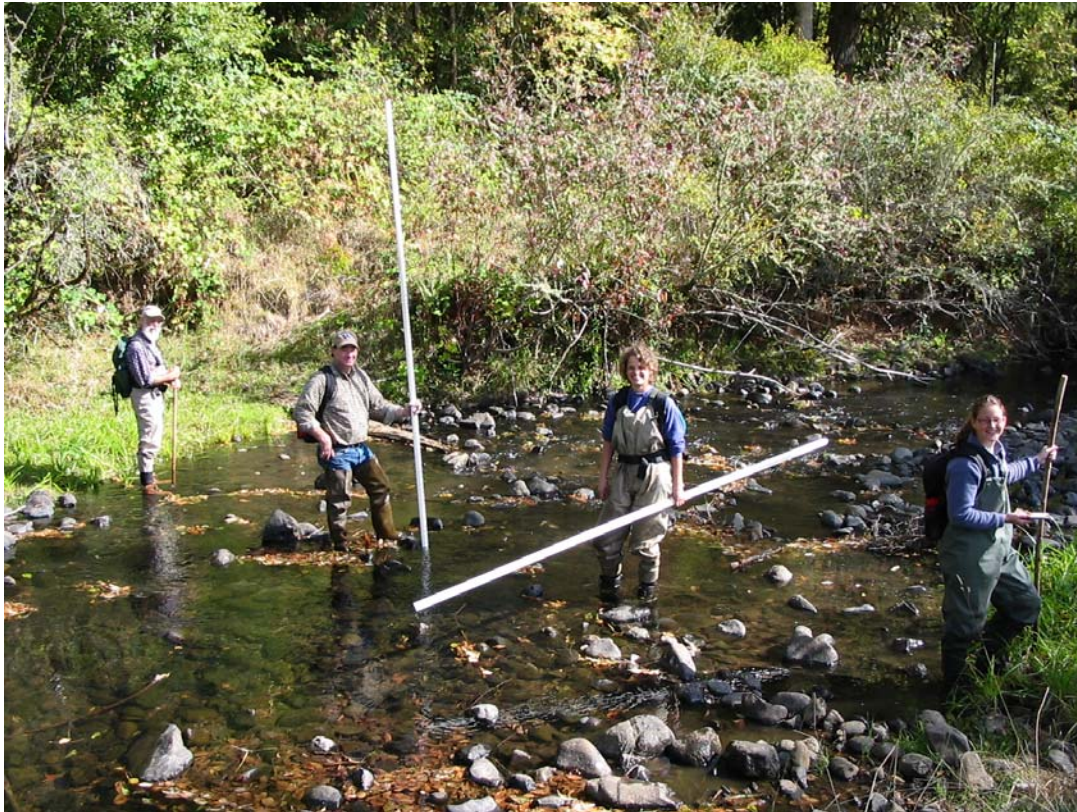
measured at each of the 11 transects. Gradient was measured between each transect if visibility allowed using a clinometer and measuring rods. Canopy cover data was collected at each of the 11 transects at the left bank, center upstream, center left, center downstream, center right and right bank with a clinometer. Thalweg depth (deepest flow point in the stream) was measured every 100<sup>th</sup> of the total reach distance or at 9 points between each transect as well as each transect (a total of 101 thalweg measurements). Large woody debris (LWD) was tallied along the reach and categorized based on large-end diameter.

Photo 2.5 Habitat Data Collection

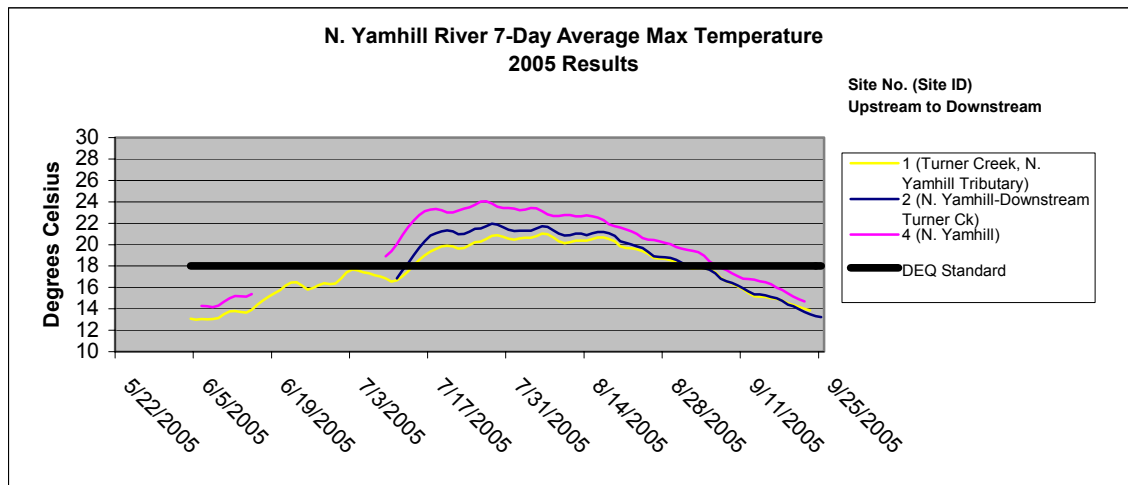
For 2005, as shown in Figure 3.1a, the sites monitored on the North Yamhill River exceeded the DEQ temperature standard from approximately Mid-July through the end of August, during the hotter summer months. At site No. 4 (N. Yamhill River downstream of Yamhill Creek), the temperature logger had been removed accidentally during the second week of June and was redeployed during the second week of July, accounting for the missing temperature data between mid June to mid July. The loggers at site Nos. 3 & 6 on the N. Yamhill River were lost. A logger was not deployed No. 5 (Yamhill Creek), due to safety concerns.

**Figure 3.1a** 2005 North Yamhill River 7-Day Average Max Temperature

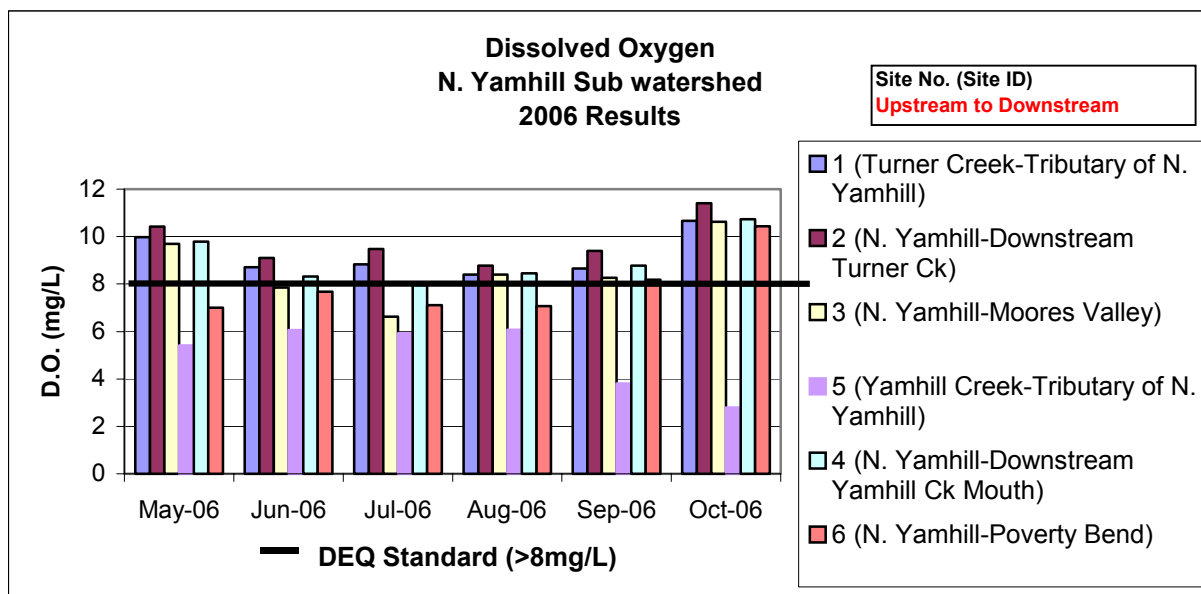
In 2006, most sites met or exceeded the standard through the sampling season as shown in Figure 3.4b. The Yamhill Creek site (No. 5), again consistently fell below DO standards in 2006. Site No. 6 on the N. Yamhill fell below standards in May-August of 2006.

**Figure 3.4b** 2006 Dissolved Oxygen North Yamhill River Subwatershed

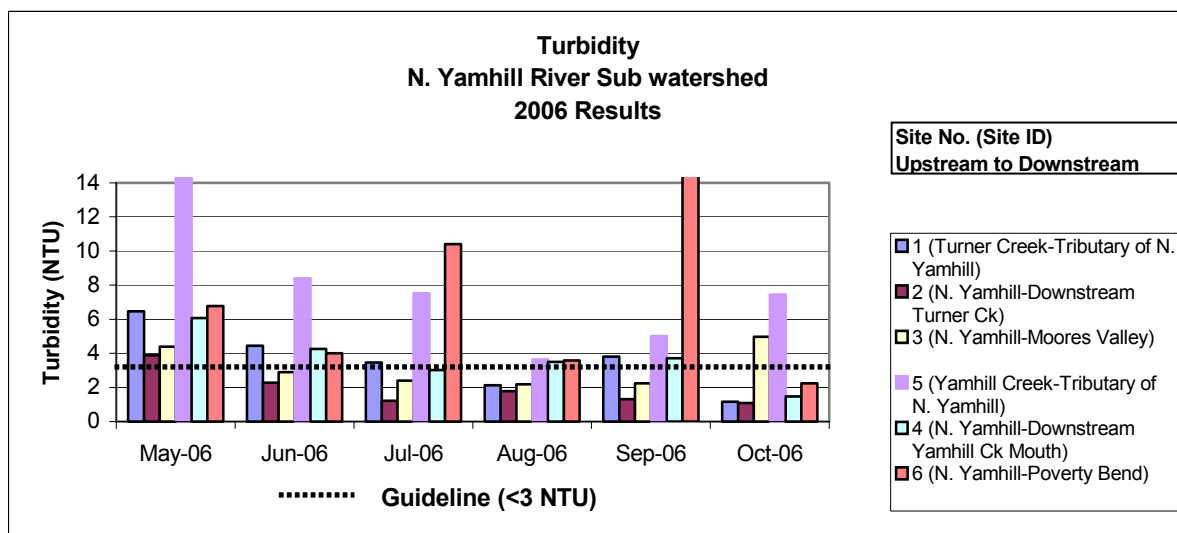
During 2006, as shown in figure 3.7b, on the N. Yamhill River and the tributaries (Turner Creek and Yamhill Creek), no one site met or fell below the turbidity guideline, although site No. 2 (N. Yamhill) only exceeded the guideline once in May 2006. All other sites exceeded at least 2 or more times during the 2006 sampling season. Again in 2006, Yamhill Creek (site No. 5) exceeded the guideline for the entire sampling season.

Figure 3.7b 2006 Turbidity North Yamhill River

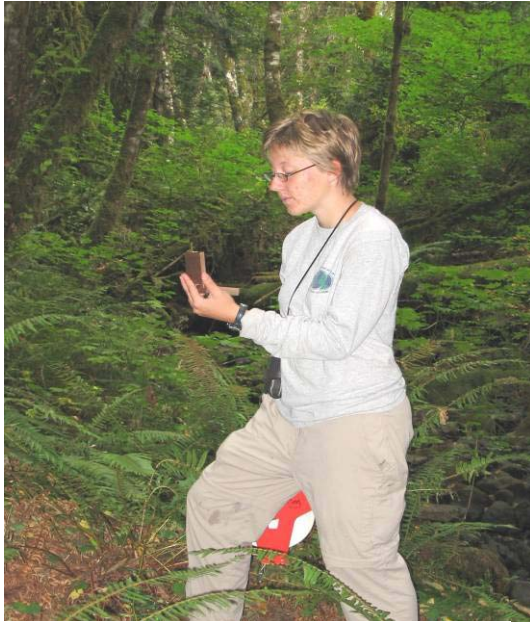
Photo 5.1 Riparian Shade Measurement

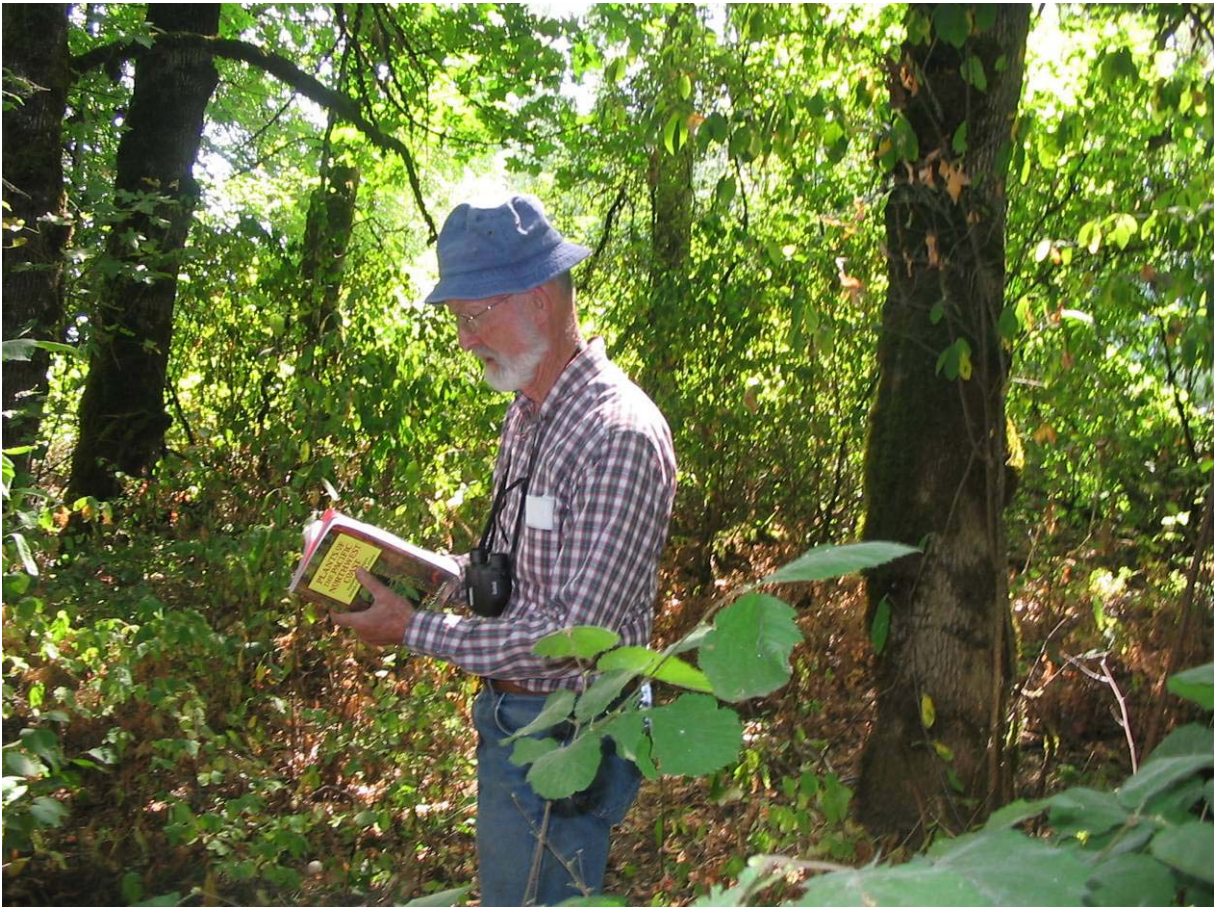
Photo 5.2 Riparian Plant Identification

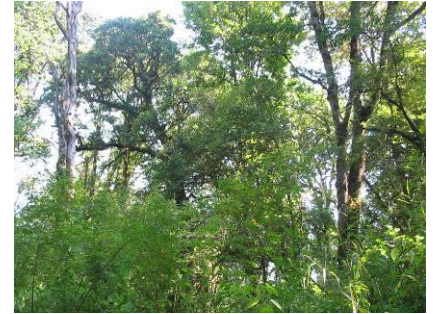
Photo 5.3 McPhillips Creek

1) McPhillips Creek AVG.	VEG COVER				
	Conifer	Deciduous	Shrub	Grass/ herb	Bare ground
% Total Cover	<b>0%</b>	<b>68%</b>	<b>73%</b>	<b>31%</b>	<b>23%</b>
Dominant Species	<b>NA</b>	<b>Ash/Oak</b>	<b>Snowberry</b>	<b>Sedge/Nettle</b>	
Veg Ht.(ft)*	Canopy Height	Densimeter	% shade	Bankful Width	Left/Right Bank
	<b>66</b>	<b>2.72</b>	<b>84%</b>	<b>20 ft</b>	<b>5/1</b>

*Notes: McPhillips Creeks is a small tributary to the South Yamhill River, southwest of McMinnville. The vegetation community was mostly native vegetation, with predominantly Oregon Ash in closest proximity to the banks. Oregon White Oak was also very present within the floodplain. The site typically experiences widespread inundation during the wetter winter season and my run dry in late summer. The shrub layer was dense, diverse and patchy. The topography was generally flat below the bench.*

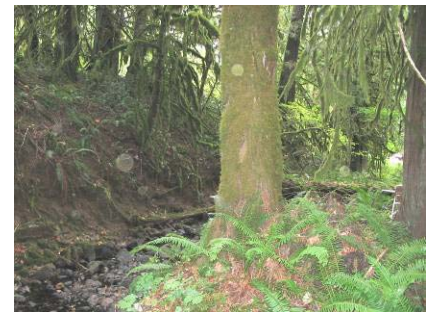
Photo 5.6 Baker Creek tributary

2) Baker Ck Trib AVG.	VEG COVER				
	Conifer	Deciduous	Shrub	Grass/ herb	Bare ground
% Total Cover	<b>54%</b>	<b>23%</b>	<b>8%</b>	<b>57%</b>	<b>38%</b>
Dominant Species	<b>Western Red Cedar</b>	<b>Big Leaf Maple</b>	<b>Vine Maple</b>	<b>Sword Fern</b>	
Veg Ht.(ft)*	Canopy Height	Densimeter	% shade	Bankful Width	Left/Right Bank
	<b>100</b>	<b>0.8</b>	<b>95%</b>	<b>16 ft</b>	<b>0/5</b>

*This tributary to Baker Creek is the highest elevation site and is dominated by conifer species. Western Red Cedar was the dominant canopy, with some mixing of Big Leaf Maple. Hemlock seedlings were observed. The topography is steep and canyon-like and the site is very shaded.*

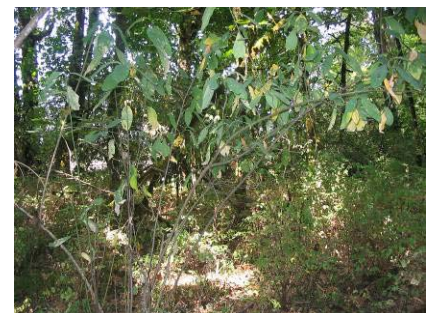
Photo 5.5 North Yamhill River

3) N. Yamhill AVG.	VEG COVER				
	Conifer	Deciduous	Shrub	Grass/ herb	Bare ground
% Total Cover	<b>2%</b>	<b>76%</b>	<b>47%</b>	<b>16%</b>	<b>40%</b>
Dominant Species	<b>Douglas Fir</b>	<b>Big Leaf Maple</b>	<b>Snowberry</b>	<b>Sedge</b>	
Veg Ht.(ft)*	Canopy Height	Densimeter	% shade	Bankful Width	Left/Right Bank
	<b>84</b>	<b>1.39</b>	<b>92%</b>	<b>35 ft</b>	<b>0/5</b>

*The site was located along the North Yamhill River south of Carlton. The river banks were typical of the area with deep incision and steep banks. The canopy was comprised of mixed deciduous mature trees: maple, oak and ash. The shrub layer was dominated by snowberry but had other species, such as ninebark, present. There was a significant presence of bare ground, which may result from frequent flooding.*
