Yamhill Watershed Culvert Prioritization and Action Plan for Fish Passage

**GREATER YAMHILL
WATERSHED COUNCIL**

**Luke Westphal
Executive Director
Greater Yamhill Watershed Council**

December 2012

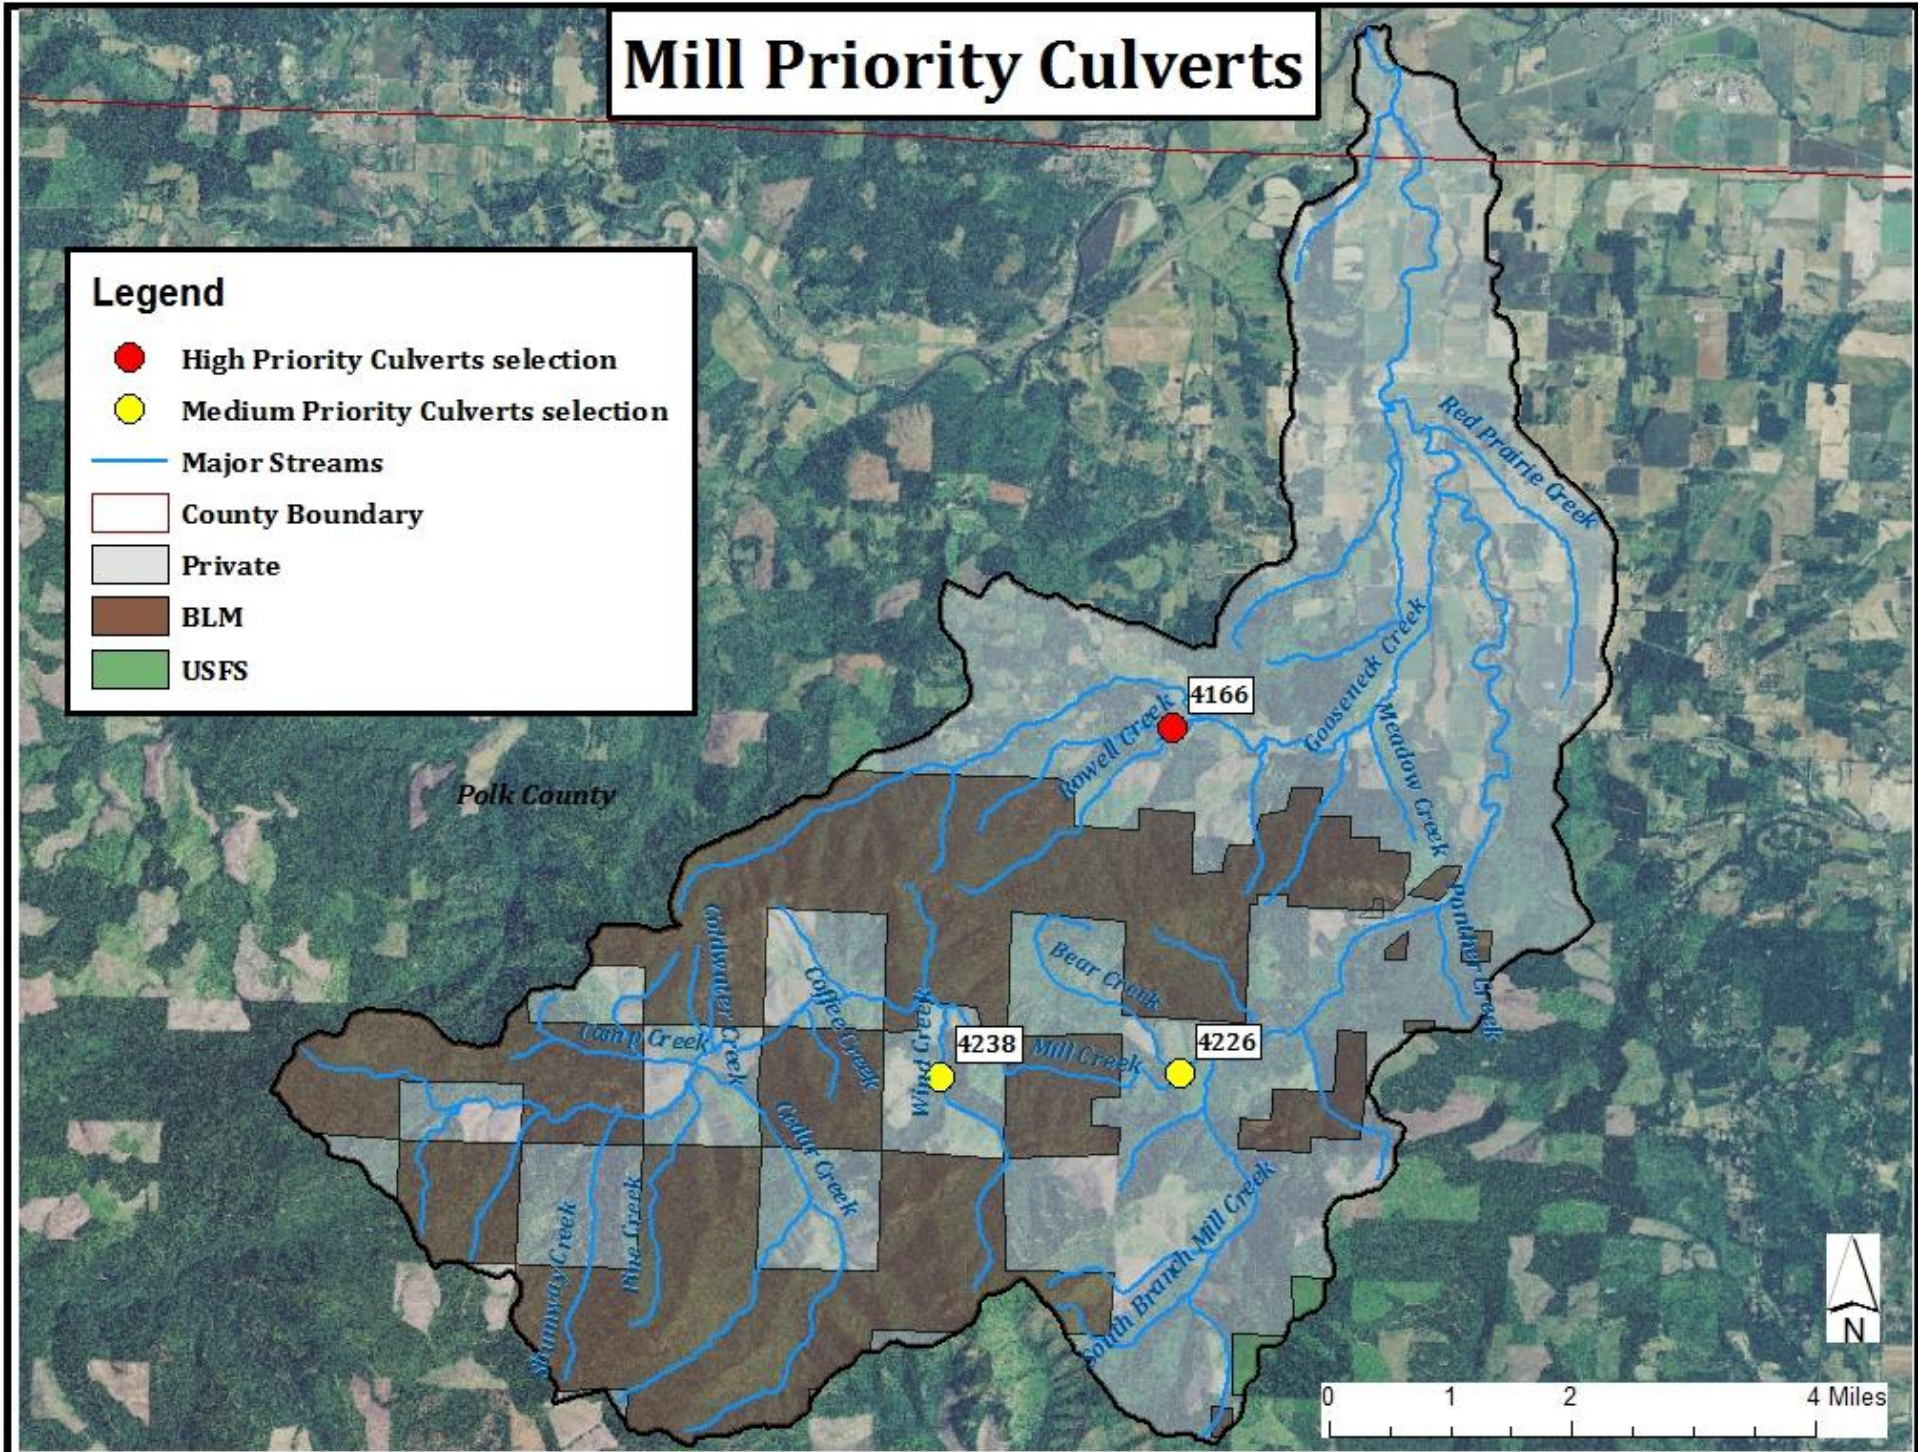
Culvert ID #	4166	Priority Ranking	High
Location Information			
Watershed	Mill Creek	Township-Range-Section-1/4	6S 6W 31 NE of SW
Stream Name	Gooseneck Creek	UTM Easting/Northing	NA
Road Name	Gooseneck Creek Rd	Owner Type	Private
Culvert Information			
Barrel Shape	Circular	Length (ft)	55.50
Culvert Material	Annular CMP	Horizontal Width (in)	72.00
Slope (%)	1.00	Vertical Height (in)	68.00
Overall Culvert Condition	Good	Outlet Drop(ft)	1.70
Channel Information			
Inlet Gradient (%)	5.00	Upstream Bankfull Width (ft)	10.30
Upstream Channel Gradient (%)	2.00	Downstream Bankfull Width (ft)	18.40
Bankfull Ratio	0.42		
Prioritization Analysis			
Habitat Length (miles)	2.22	(1) Habitat Length Points	3
Habitat Quality	0.90	(2) Habitat Quality Points	2
Fish Presence	Yes	(3) Fish Presence Points	2
Barrier Severity	Red	Total Prioritization Points	7
Comments			
<p>Survey Date: 7/21/2010; Survey Comments: Culvert perched; November 29 2012 TAC Meeting: (ODFW): Actually a County-owned pipe; Very High Priority; High quality habitat upstream. (BLM): BLM replaced a pipe upstream six years ago; GIS stream layer is wrong - tributary is actually upstream, thus more habitat upstream.</p>

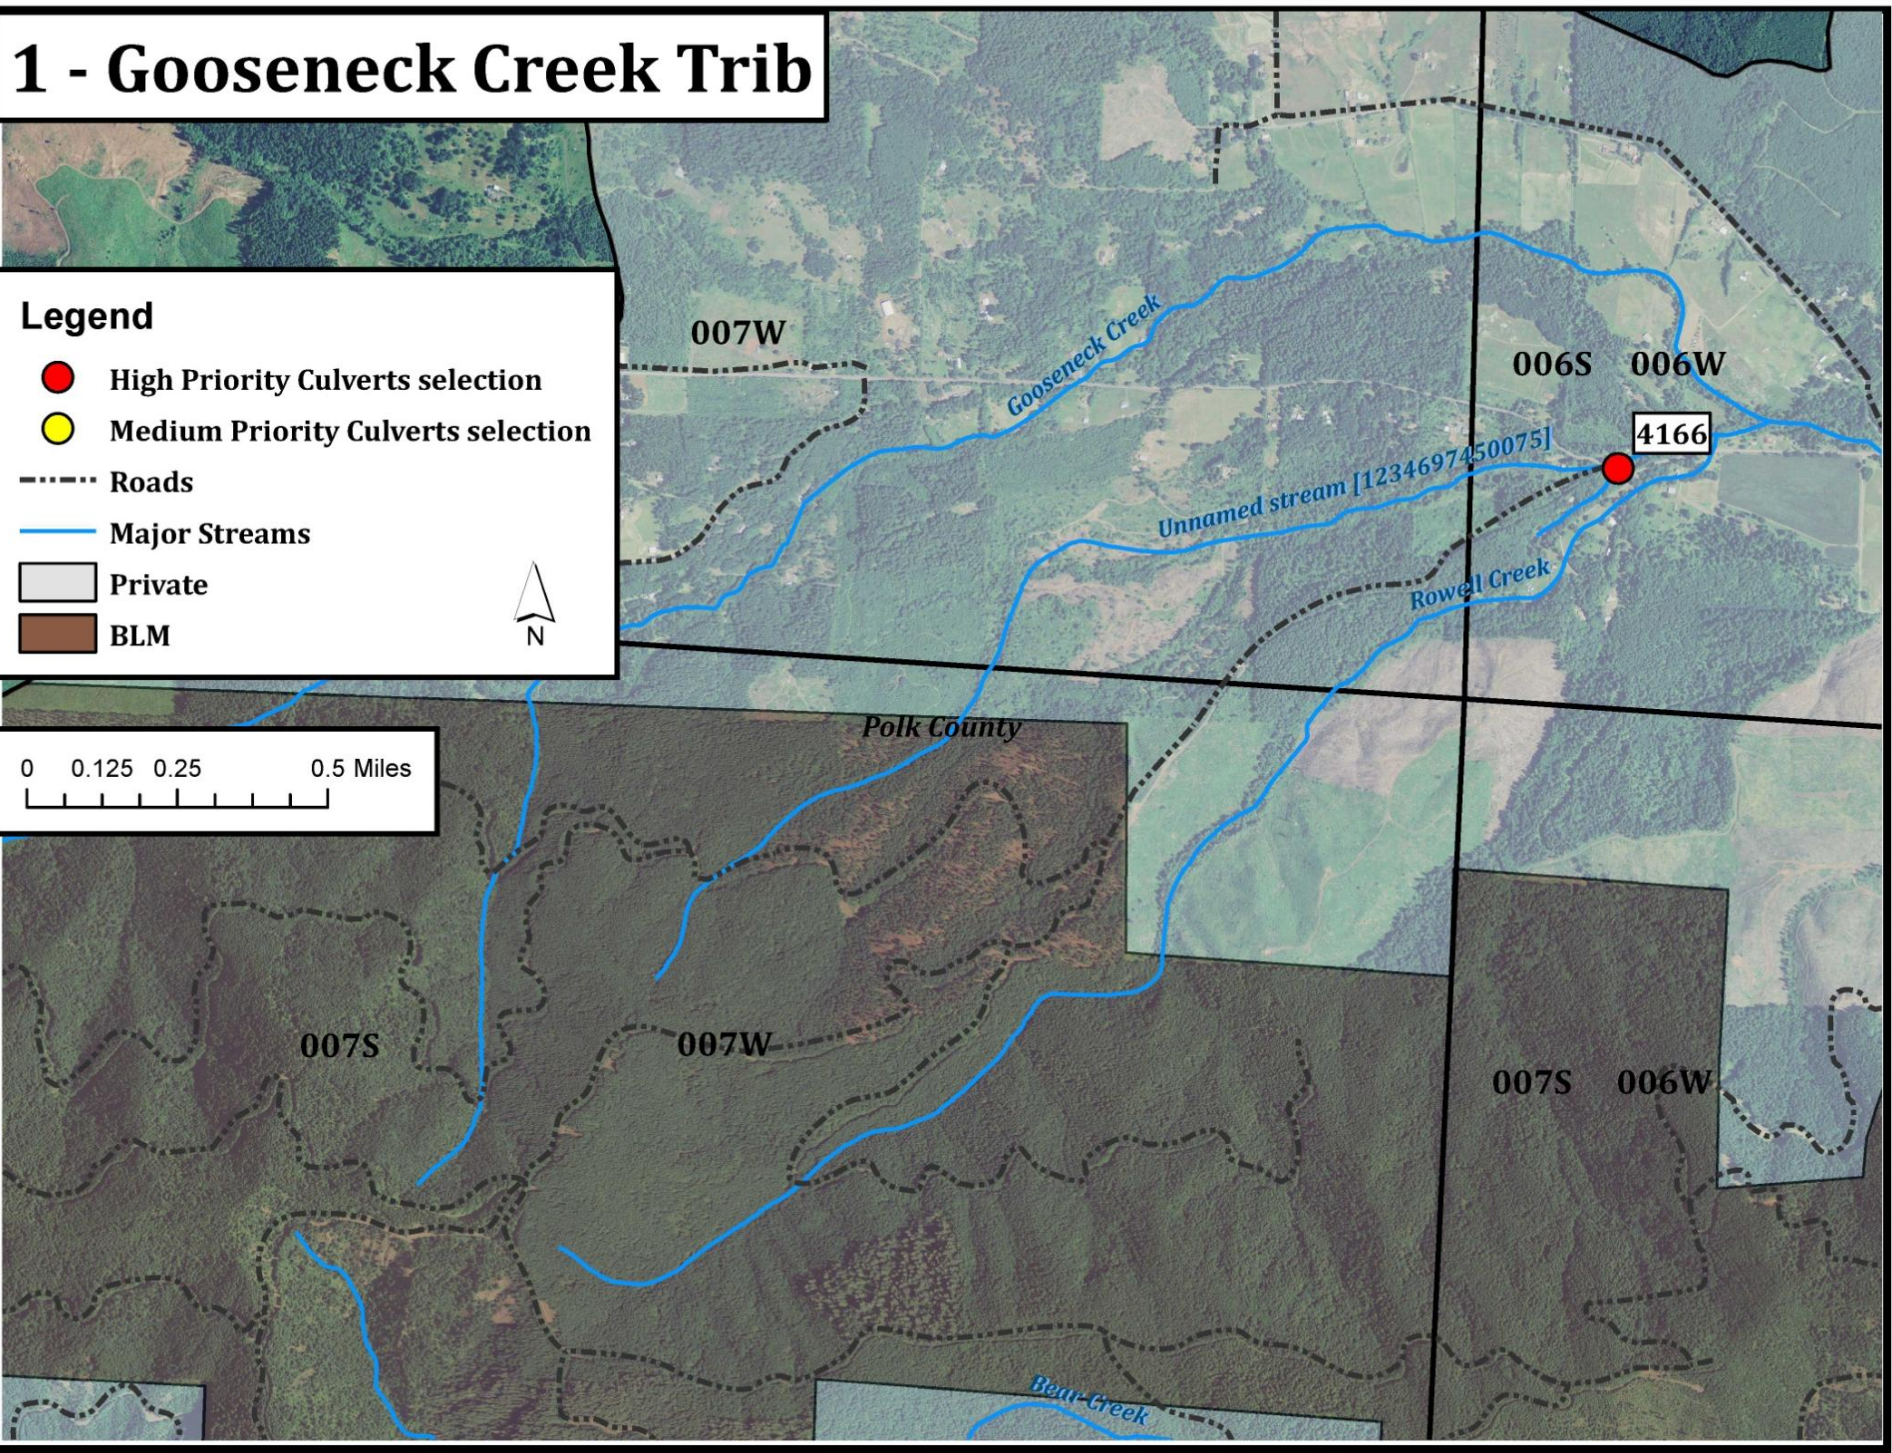
Culvert ID #	4238	Priority Ranking	Med
Location Information			
Watershed	Mill Creek	Township-Range-Section-1/4	7S 7W 14 SE of NW
Stream Name	Wind Creek	UTM Easting/Northing	NA
Road Name	Wind Creek Road	Owner Type	Private Industrial
Culvert Information			
Barrel Shape	Pipe-Arch	Length (ft)	48.42
Culvert Material	Annular CMP	Horizontal Width (in)	86.00
Slope (%)	0.20	Vertical Height (in)	66.00
Overall Culvert Condition	Good	Outlet Drop(ft)	1.75
Channel Information			
Inlet Gradient (%)	11.00	Upstream Bankfull Width (ft)	12.28
Upstream Channel Gradient (%)	12.00	Downstream Bankfull Width (ft)	19.80
Bankfull Ratio	0.48		
Prioritization Analysis			
Habitat Length (miles)	3.94	(1) Habitat Length Points	4
Habitat Quality	1.55	(2) Habitat Quality Points	2
Fish Presence	Yes	(3) Fish Presence Points	2
Barrier Severity	Red	Total Prioritization Points	8
Comments			
<p>Survey Date: 9/1/2010; Survey Comments: Bent inlet and sections folded apart; November 29 2012 TAC Meeting: (BLM): Culvert almost washed out this year - debris jams; WYCO mainline. (ODFW): Downstream barriers (slots) to steelhead access; Need more information on fish distributions and habitat.</p>

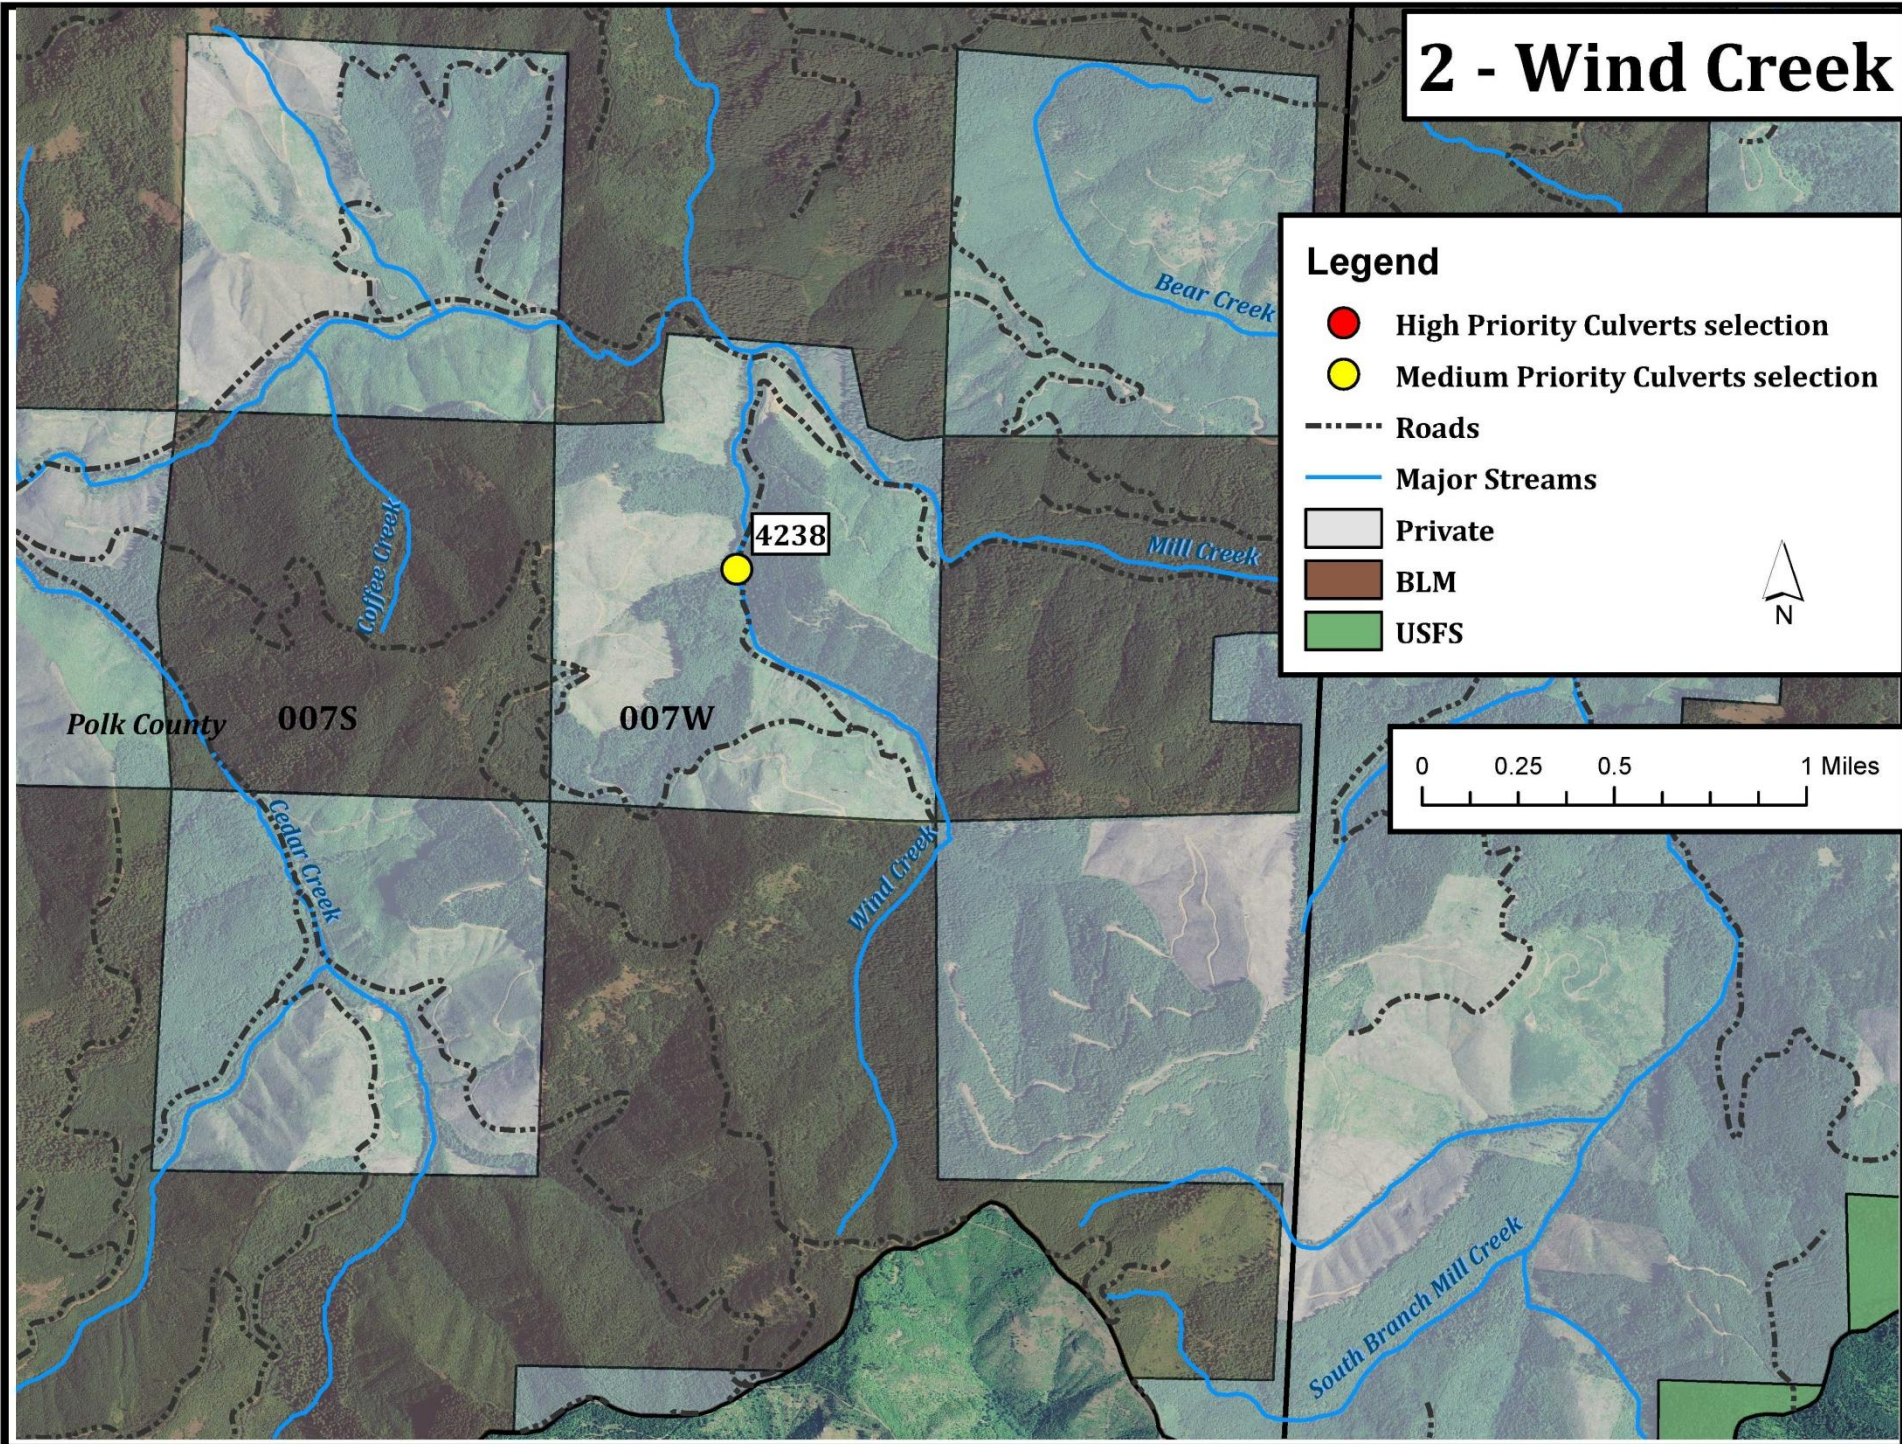
Culvert ID #	4226	Priority Ranking	Med
Location Information			
Watershed	Mill Creek	Township-Range-Section-1/4	7S 6W 18 SE of NW
Stream Name	Bear Creek	UTM Easting/Northing	NA
Road Name	Bear Creek Road	Owner Type	Private Industrial
Culvert Information			
Barrel Shape	Circular	Length (ft)	40.6
Culvert Material	Annular CMP	Horizontal Width (in)	72.00
Slope (%)	3.00	Vertical Height (in)	72.00
Overall Culvert Condition	Good	Outlet Drop(ft)	5.30
Channel Information			
Inlet Gradient (%)	13.00	Upstream Bankfull Width (ft)	11.93
Upstream Channel Gradient (%)	6.00	Downstream Bankfull Width (ft)	11.13
Bankfull Ratio	0.52		
Prioritization Analysis			
Habitat Length (miles)	2.20	(1) Habitat Length Points	3
Habitat Quality	1.13 - Med	(2) Habitat Quality Points	2
Fish Presence	Yes	(3) Fish Presence Points	2
Barrier Severity	Red	Total Prioritization Points	7
Comments			
Survey Date: 8/31/2010; Survey Comments: NA; November 29 2012 TAC Meeting: (ODFW): Does not have anadromy; Cutthroat trout present in streams.

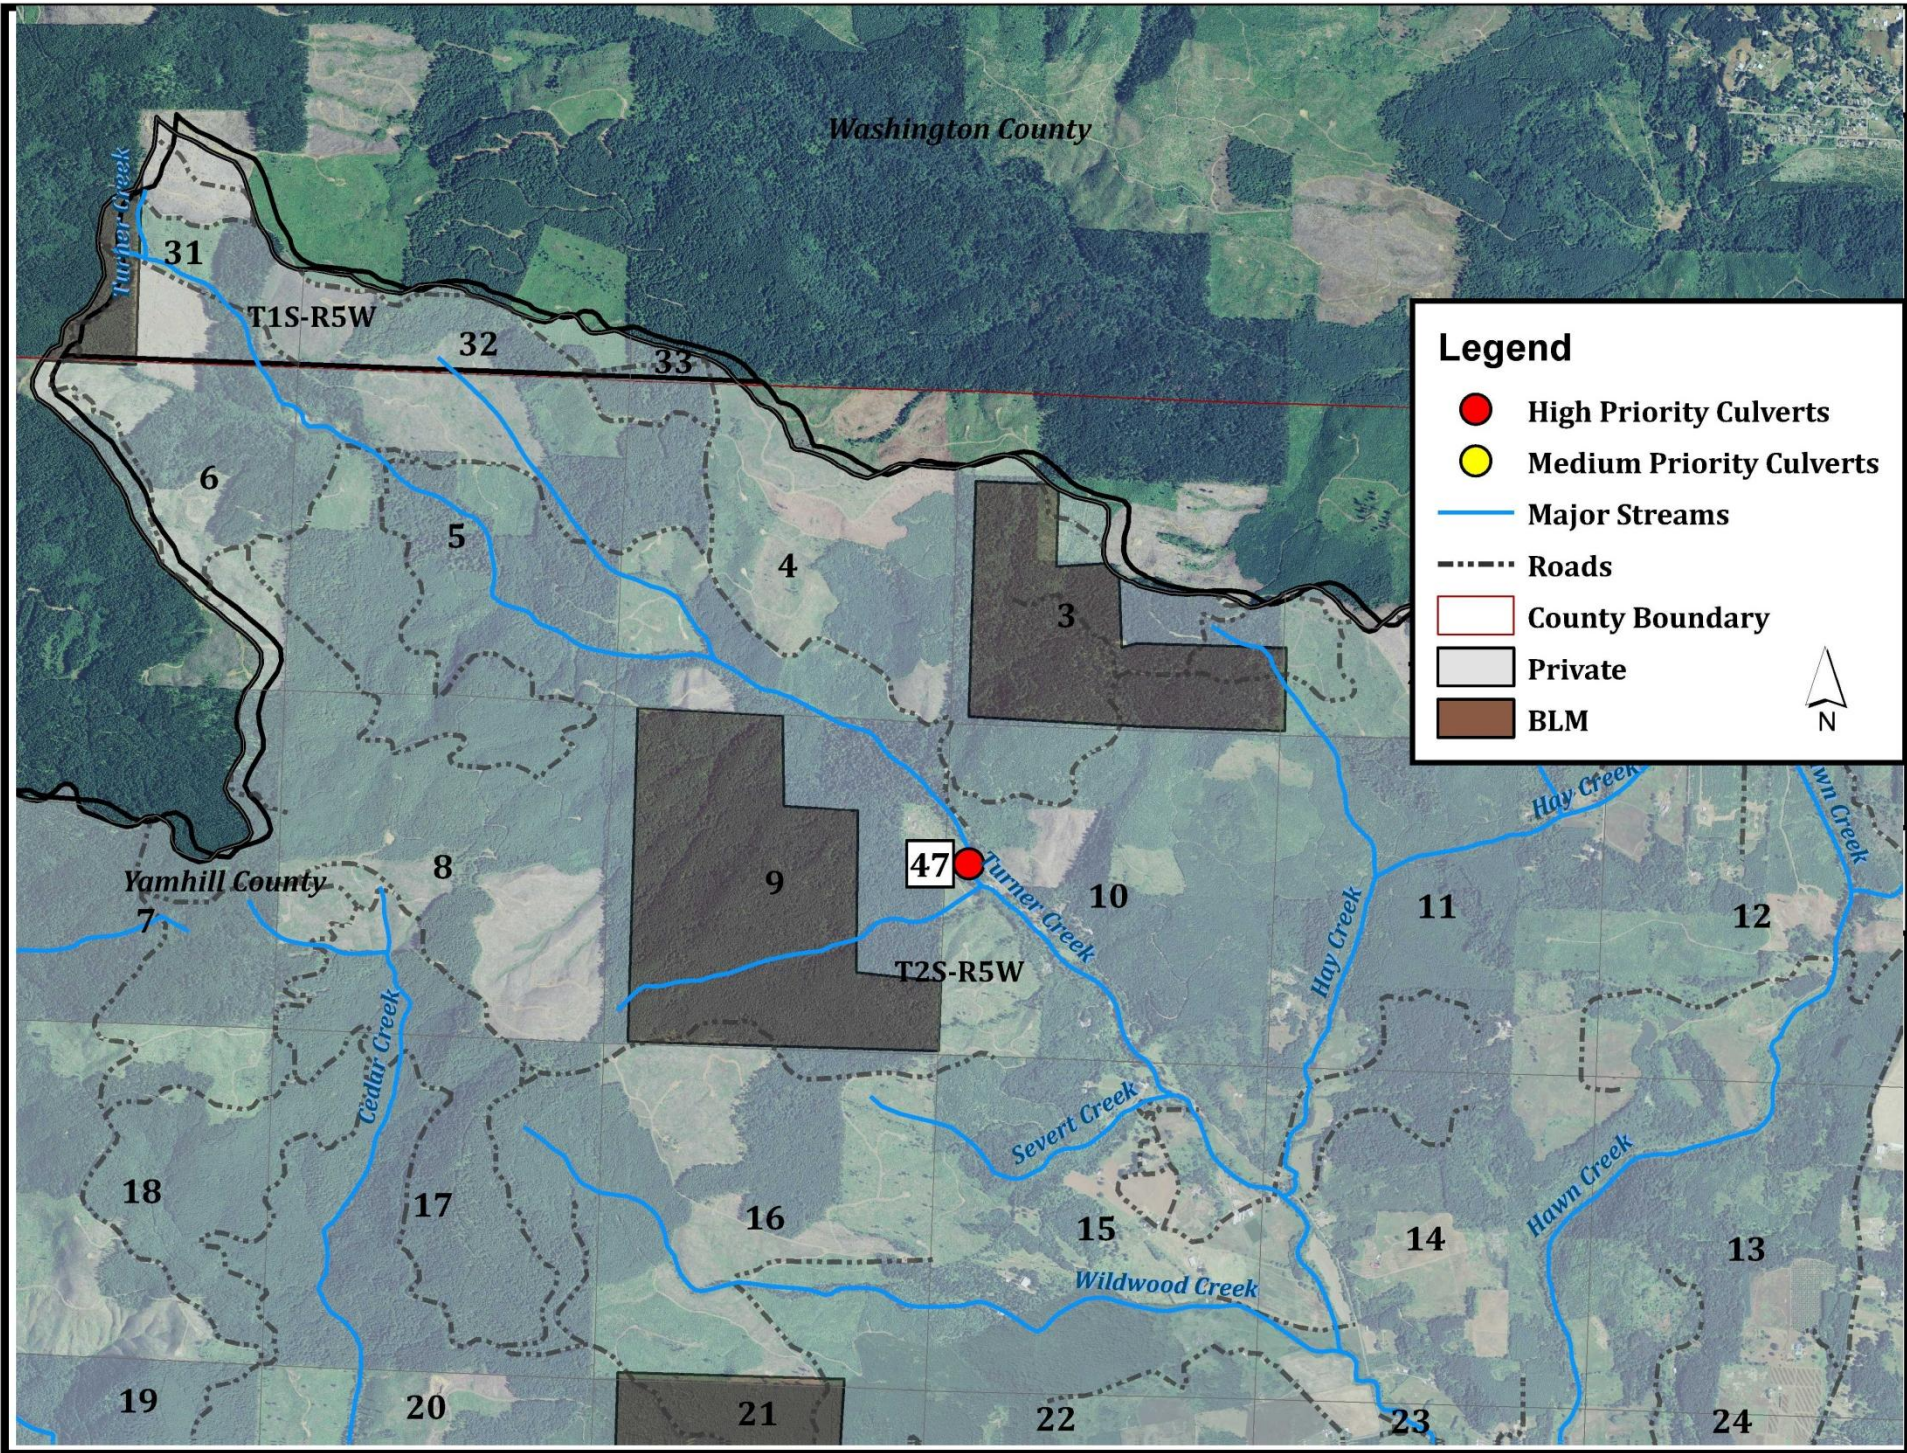
Culvert ID #	262	Priority Ranking	High
Location Information			
Watershed	North Yamhill	Township-Range-Section-1/4	2S 5W 28 SW of SW
Stream Name	Cedar Creek	UTM Easting/Northing	NA
Road Name	Old RailRd Grade Rd	Owner Type	County
Culvert Information			
Barrel Shape	Circular	Length (ft)	75.00
Culvert Material	Annular CMP	Horizontal Width (in)	102.00
Slope (%)	1.00	Vertical Height (in)	120.00
Overall Culvert Condition	Good	Outlet Drop(ft)	1.00
Channel Information			
Inlet Gradient (%)	13.00	Upstream Bankfull Width (ft)	24.00
Upstream Channel Gradient (%)	3.00	Downstream Bankfull Width (ft)	16.00
Bankfull Ratio	0.50		
Prioritization Analysis			
Habitat Length (miles)	6.74	(1) Habitat Length Points	5
Habitat Quality	3.48 - High	(2) Habitat Quality Points	3
Fish Presence	Yes	(3) Fish Presence Points	2
Barrier Severity	Red	Total Prioritization Points	10
Comments			
<p>Survey Date: 10/29/2007; Survey Comments: Will be good habitat. Restoration zone. Outlet drop but nice deep pool; November 29 2012 TAC Meeting: (BLM): Velocity barrier; probable bridge; BLM has done evaluation of the channel downstream - found Clams; Steelhead verified; Good habitat but needs wood. One culvert way upstream.</p>

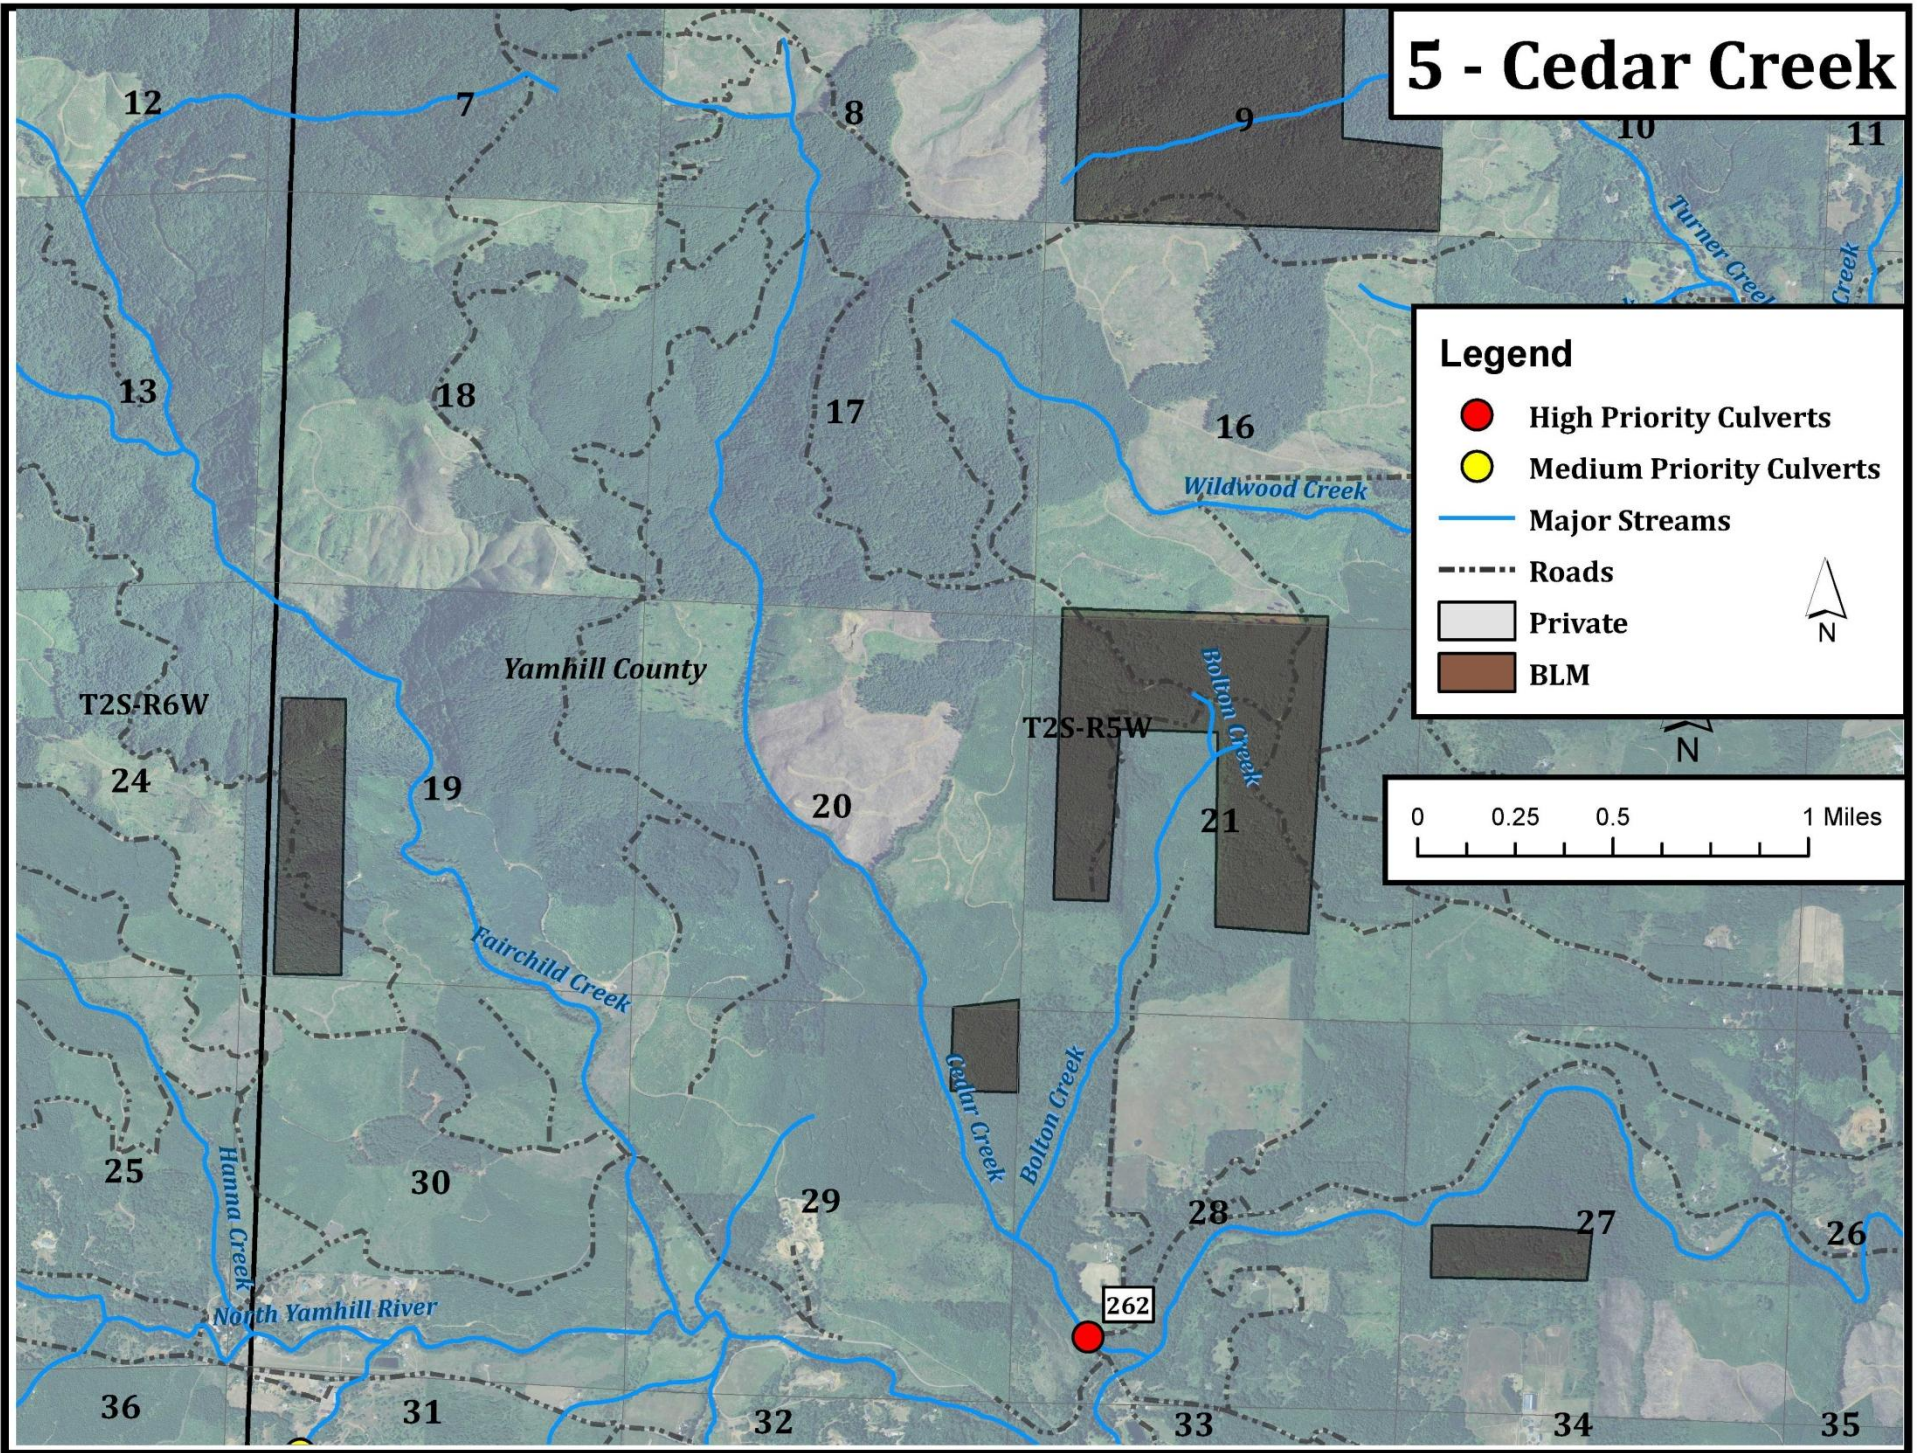
Culvert ID #	3327	Priority Ranking	High
Location Information			
Watershed	North Yamhill	Township-Range-Section-1/4	3S 4W 6 SE of SE
Stream Name	Unnamed Trib of North Yamhill River	UTM Easting/Northing	NA
Road Name	Old RailRd Grade Rd	Owner Type	County
Culvert Information			
Barrel Shape	Circular	Length (ft)	45.00
Culvert Material	Annular CMP	Horizontal Width (in)	120.00
Slope (%)	2.00	Vertical Height (in)	72.00
Overall Culvert Condition	Fair	Outlet Drop(ft)	0.00
Channel Information			
Inlet Gradient (%)	13.00	Upstream Bankfull Width (ft)	35.00
Upstream Channel Gradient (%)	1.00	Downstream Bankfull Width (ft)	10.00
Bankfull Ratio	2.85		
Prioritization Analysis			
Habitat Length (miles)	5.33	(1) Habitat Length Points	5
Habitat Quality	2.39 - High	(2) Habitat Quality Points	3
Fish Presence	Yes	(3) Fish Presence Points	2
Barrier Severity	Red	Total Prioritization Points	10
Comments			
<p>Survey Date: 10/30/2007; Survey Comments: Not good habitat, no real channel; Backwater; Channelized upstream; Oily film/murky; November 29 2012 TAC Meeting: (ODFW) Surrounded by fields; need more information on fish distributions. Upstream 35' BFW; downstream 10' (incised?).</p>

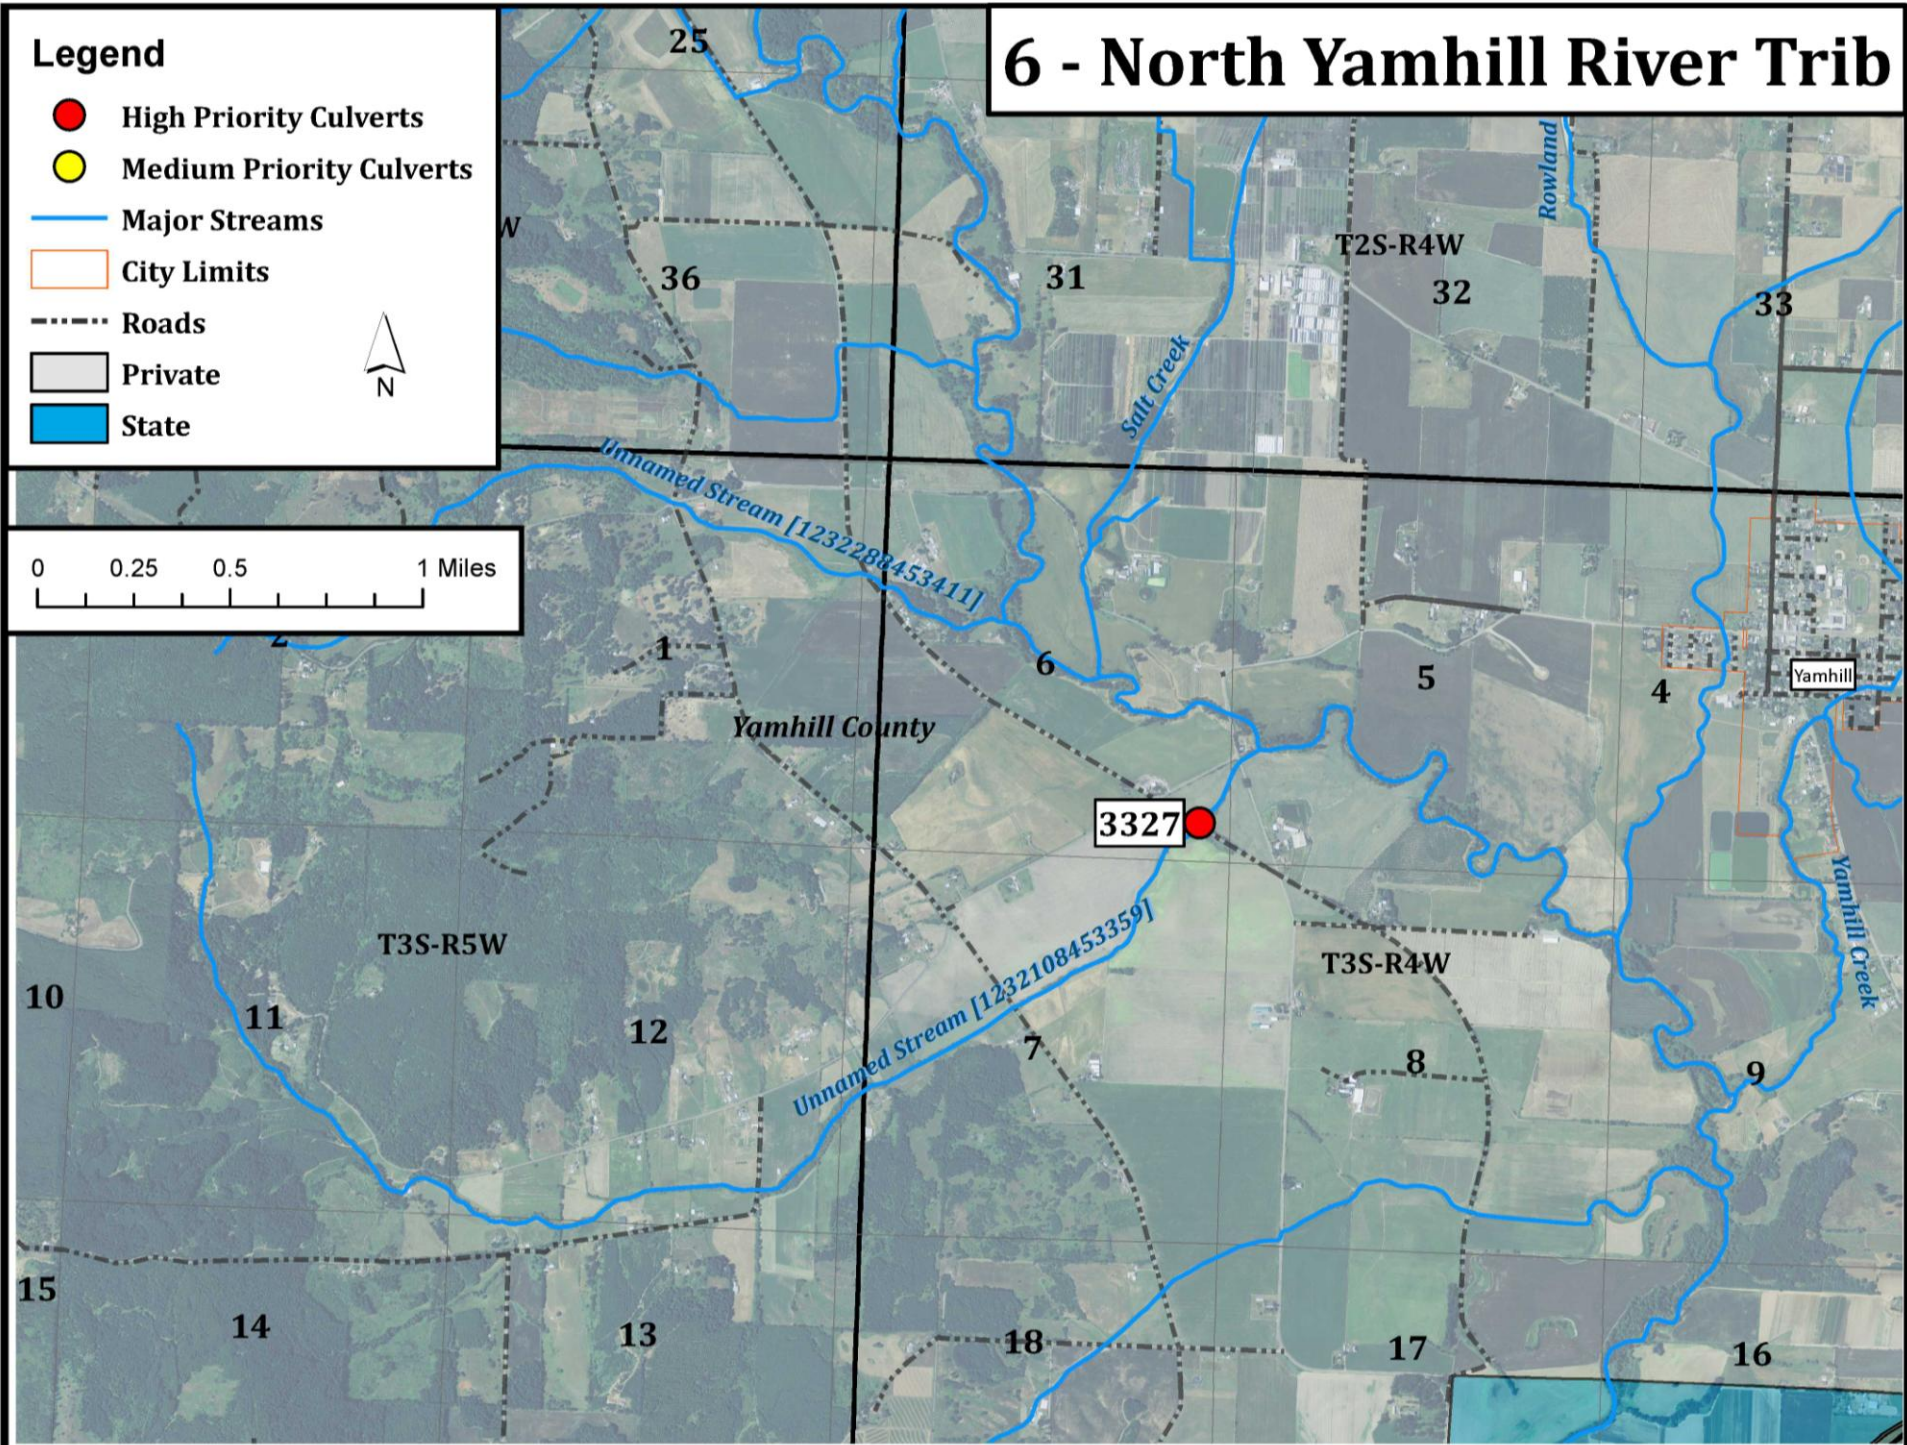
Culvert ID #	3093	Priority Ranking	High
Location Information			
Watershed	North Yamhill	Township-Range-Section-1/4	2S 5W 24
Stream Name	Unnamed Trib of North Yamhill River	UTM Easting/Northing	481222 / 5025030
Road Name	Tanager Lane	Owner Type	Private
Culvert Information			
Barrel Shape	Circular	Length (ft)	16.00
Culvert Material	Spiral CMP	Horizontal Width (in)	72.00
Slope (%)	- 1.00	Vertical Height (in)	72.00
Overall Culvert Condition	Poor	Outlet Drop(ft)	1.48
Channel Information			
Inlet Gradient (%)	4.00	Upstream Bankfull Width (ft)	50.00
Upstream Channel Gradient (%)	3.00	Downstream Bankfull Width (ft)	80.00
Bankfull Ratio	NA		
Prioritization Analysis			
Habitat Length (miles)	3.20	(1) Habitat Length Points	4
Habitat Quality	1.46 - Med	(2) Habitat Quality Points	2
Fish Presence	Yes	(3) Fish Presence Points	2
Barrier Severity	Red	Total Prioritization Points	8
Comments			
<p>Survey Date: 5/16/2011; Survey Comments: Located on Lazy River Vineyard. Owners willing to participate in any restoration needed. Heavy Bank Erosion, perched, water flows over and around culvert in high flows, Debris Plugging Inlet; Bottom Worn Thru; November 29 2012 TAC Meeting: (ODFW) Downstream Culvert #10037 being replaced soon; Habitat to 3093 should be next on the list.</p>

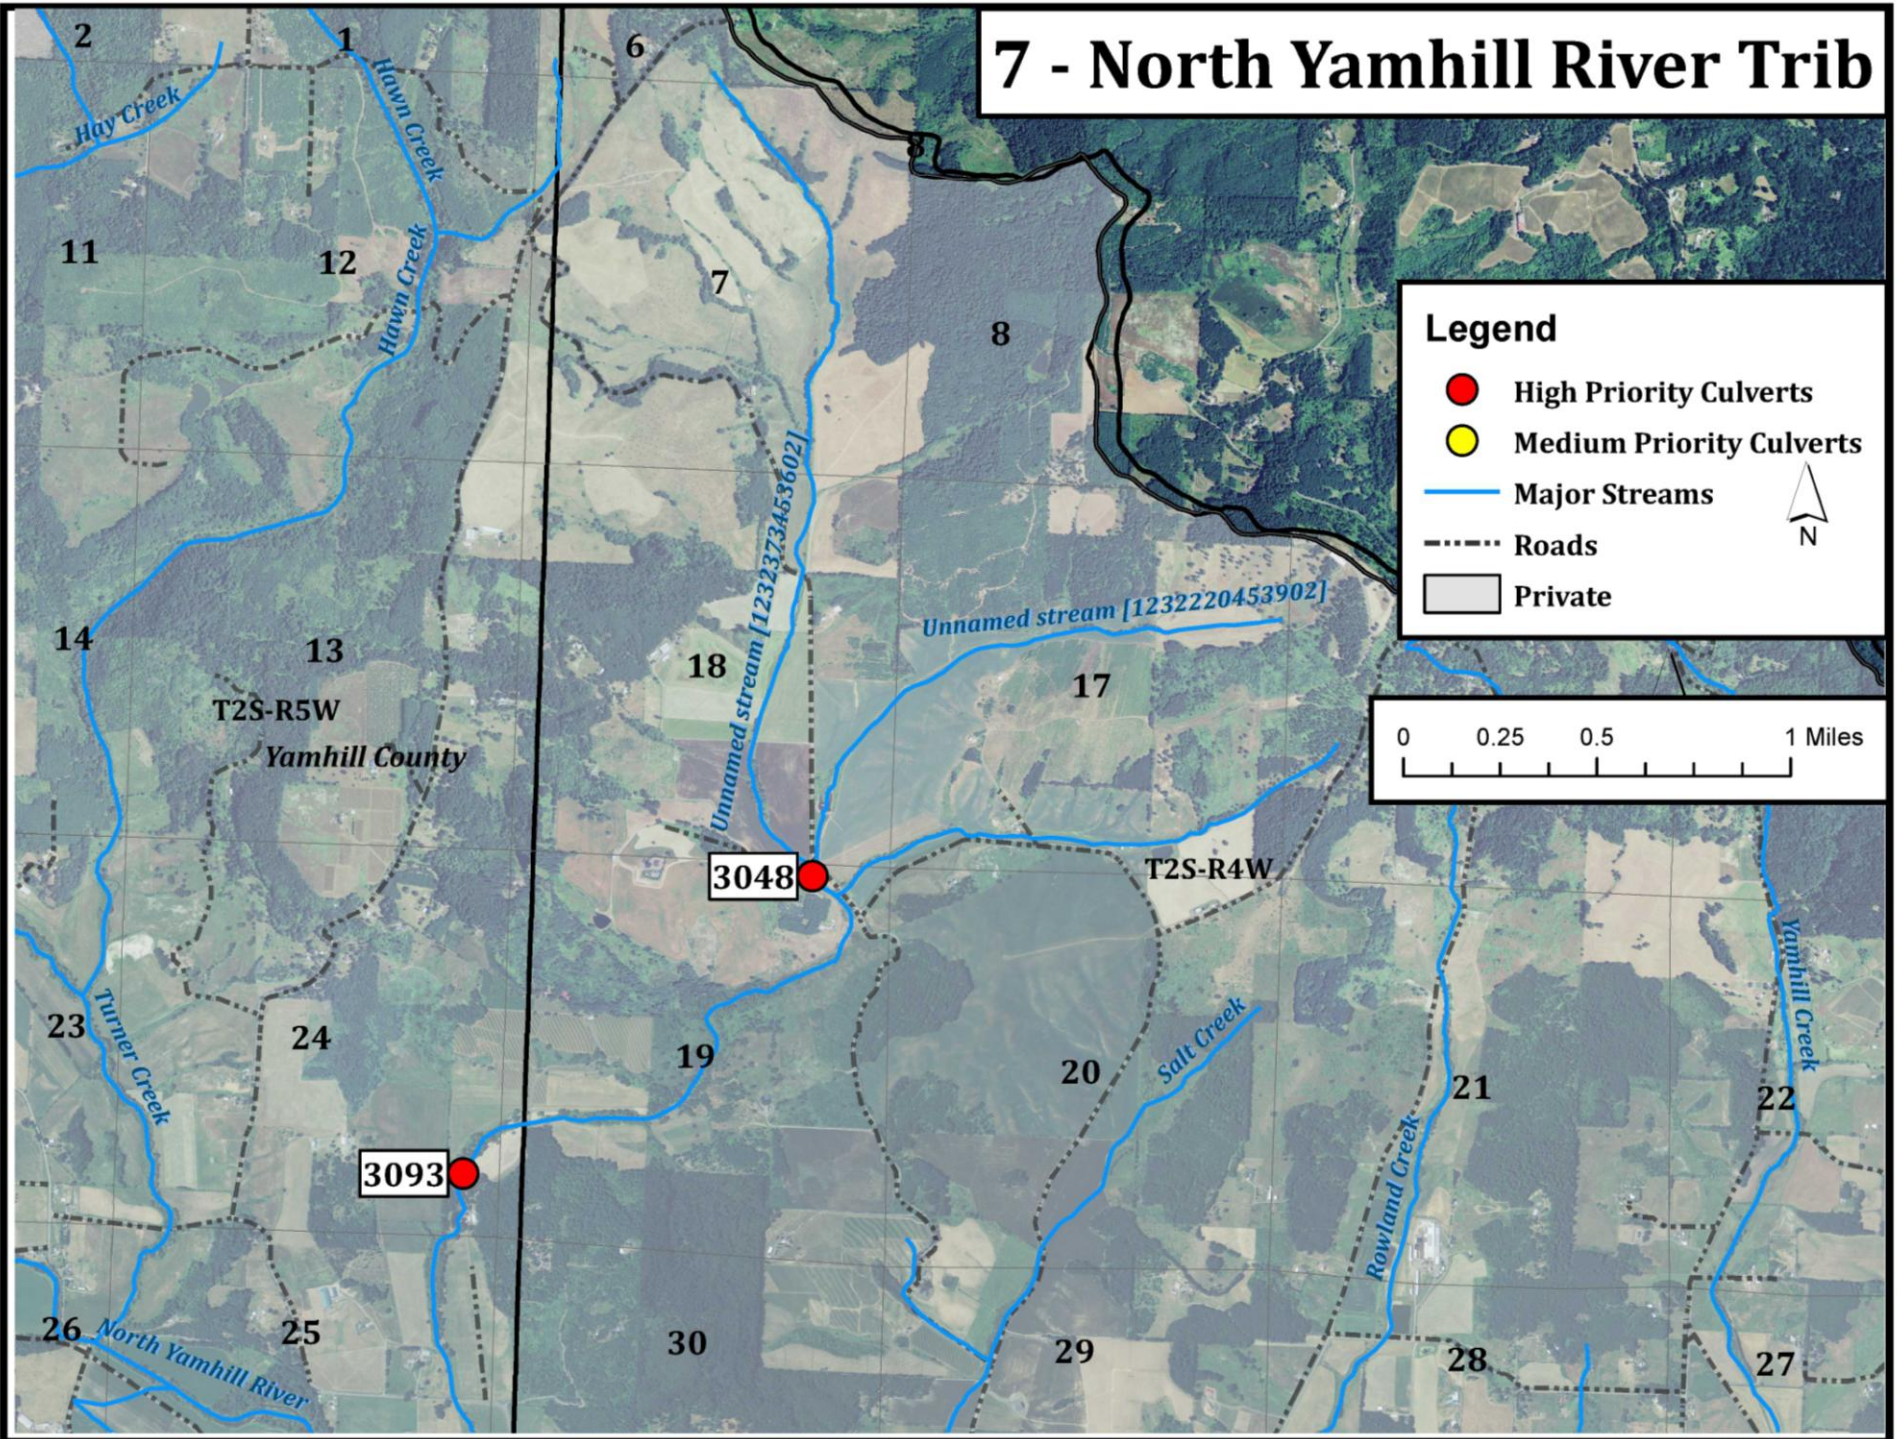
Culvert ID #	3444	Priority Ranking	Med
Location Information			
Watershed	North Yamhill	Township-Range-Section-1/4	3S 5W 23 NE of SW
Stream Name	Beaver Creek	UTM Easting/Northing	NA
Road Name	Panther Creek Road	Owner Type	County
Culvert Information			
Barrel Shape	Circular	Length (ft)	61.00
Culvert Material	Concrete	Horizontal Width (in)	70.00
Slope (%)	2.00	Vertical Height (in)	70.00
Overall Culvert Condition	Good	Outlet Drop(ft)	1.16
Channel Information			
Inlet Gradient (%)	4.00	Upstream Bankfull Width (ft)	NA
Upstream Channel Gradient (%)	NA	Downstream Bankfull Width (ft)	14.00
Bankfull Ratio	NA		
Prioritization Analysis			
Habitat Length (miles)	1.80	(1) Habitat Length Points	2
Habitat Quality	0.72 Med	(2) Habitat Quality Points	2
Fish Presence	Yes	(3) Fish Presence Points	2
Barrier Severity	Red	Total Prioritization Points	6
Comments			
<p>Survey Date: 11/01/2007; Survey Comments: Railroad ties underneath culvert; dip in culvert near outlet; downstream old car upside down in creek; beaver activity upstream; November 29 2012 TAC Meeting: N/A</p>
