Yamhill Watershed Culvert Prioritization and Action Plan for Fish Passage

**GREATER YAMHILL
WATERSHED COUNCIL**

**Luke Westphal
Executive Director
Greater Yamhill Watershed Council**

December 2012

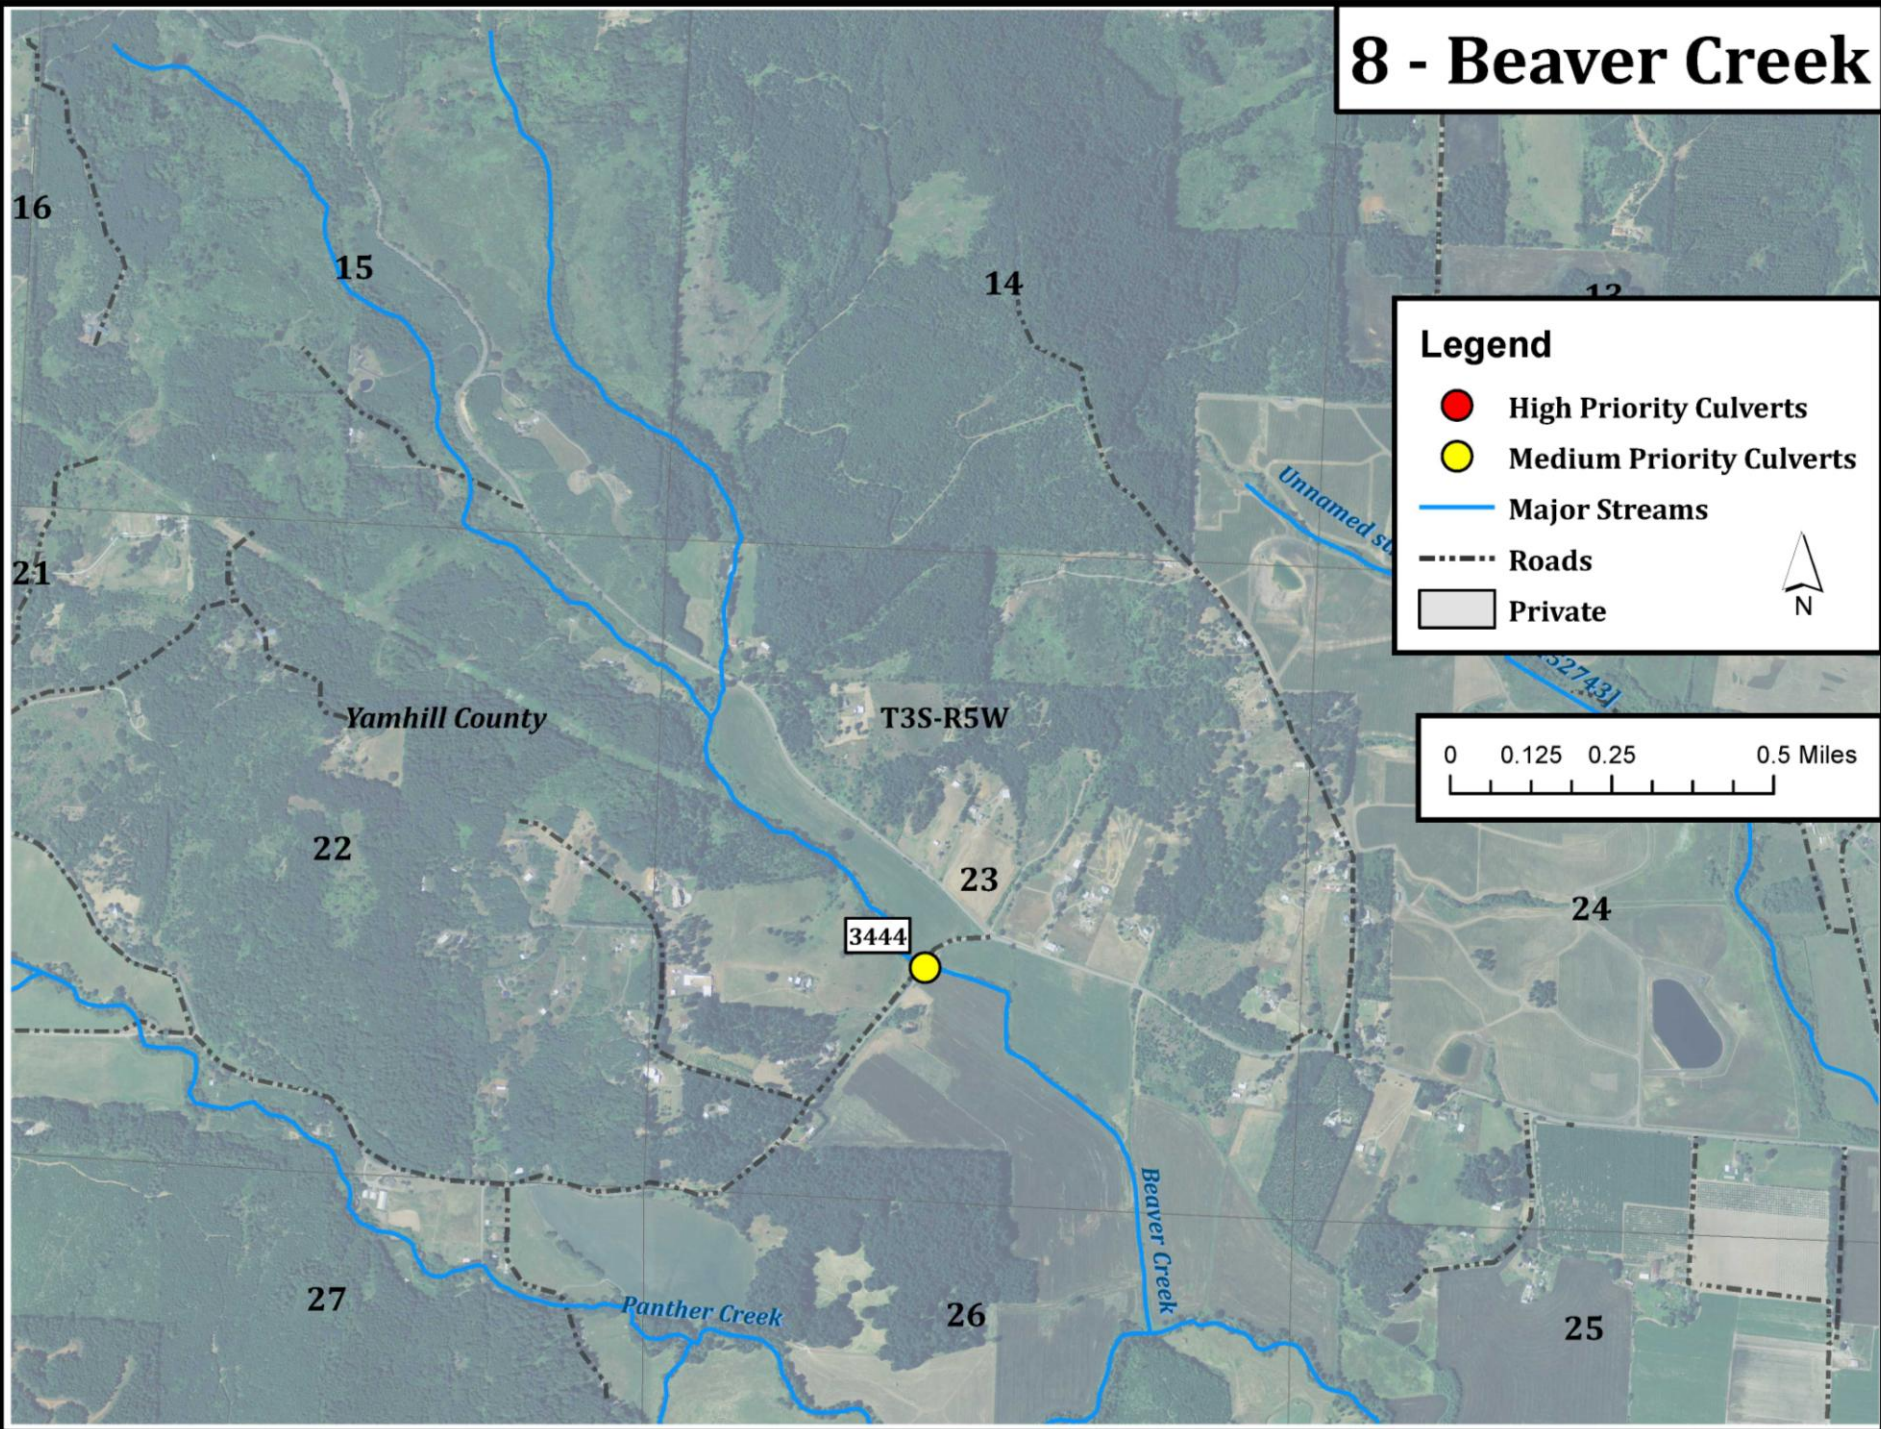
Culvert ID #	3475	Priority Ranking	Med
Location Information			
Watershed	North Yamhill	Township-Range-Section-1/4	3S 5W 28 SE of NE
Stream Name	Kane Creek	UTM Easting/Northing	NA
Road Name	Panther Creek Road	Owner Type	Private
Culvert Information			
Barrel Shape	Circular	Length (ft)	49.00
Culvert Material	Spiral CMP	Horizontal Width (in)	69.00
Slope (%)	3.00	Vertical Height (in)	71.00
Overall Culvert Condition	Poor	Outlet Drop(ft)	0.70
Channel Information			
Inlet Gradient (%)	10.00	Upstream Bankfull Width (ft)	12.00
Upstream Channel Gradient (%)	7.00	Downstream Bankfull Width (ft)	14.00
Bankfull Ratio	0.48		
Prioritization Analysis			
Habitat Length (miles)	2.43	(1) Habitat Length Points	3
Habitat Quality	0.48 - Low	(2) Habitat Quality Points	1
Fish Presence	Yes	(3) Fish Presence Points	2
Barrier Severity	Red	Total Prioritization Points	6
Comments			
Survey Date: 10/5/2007; Survey Comments: Hydro power "station" connected at outlet from holes in the bottom of the pipe. Good habitat; November 29 2012 TAC Meeting: N/A

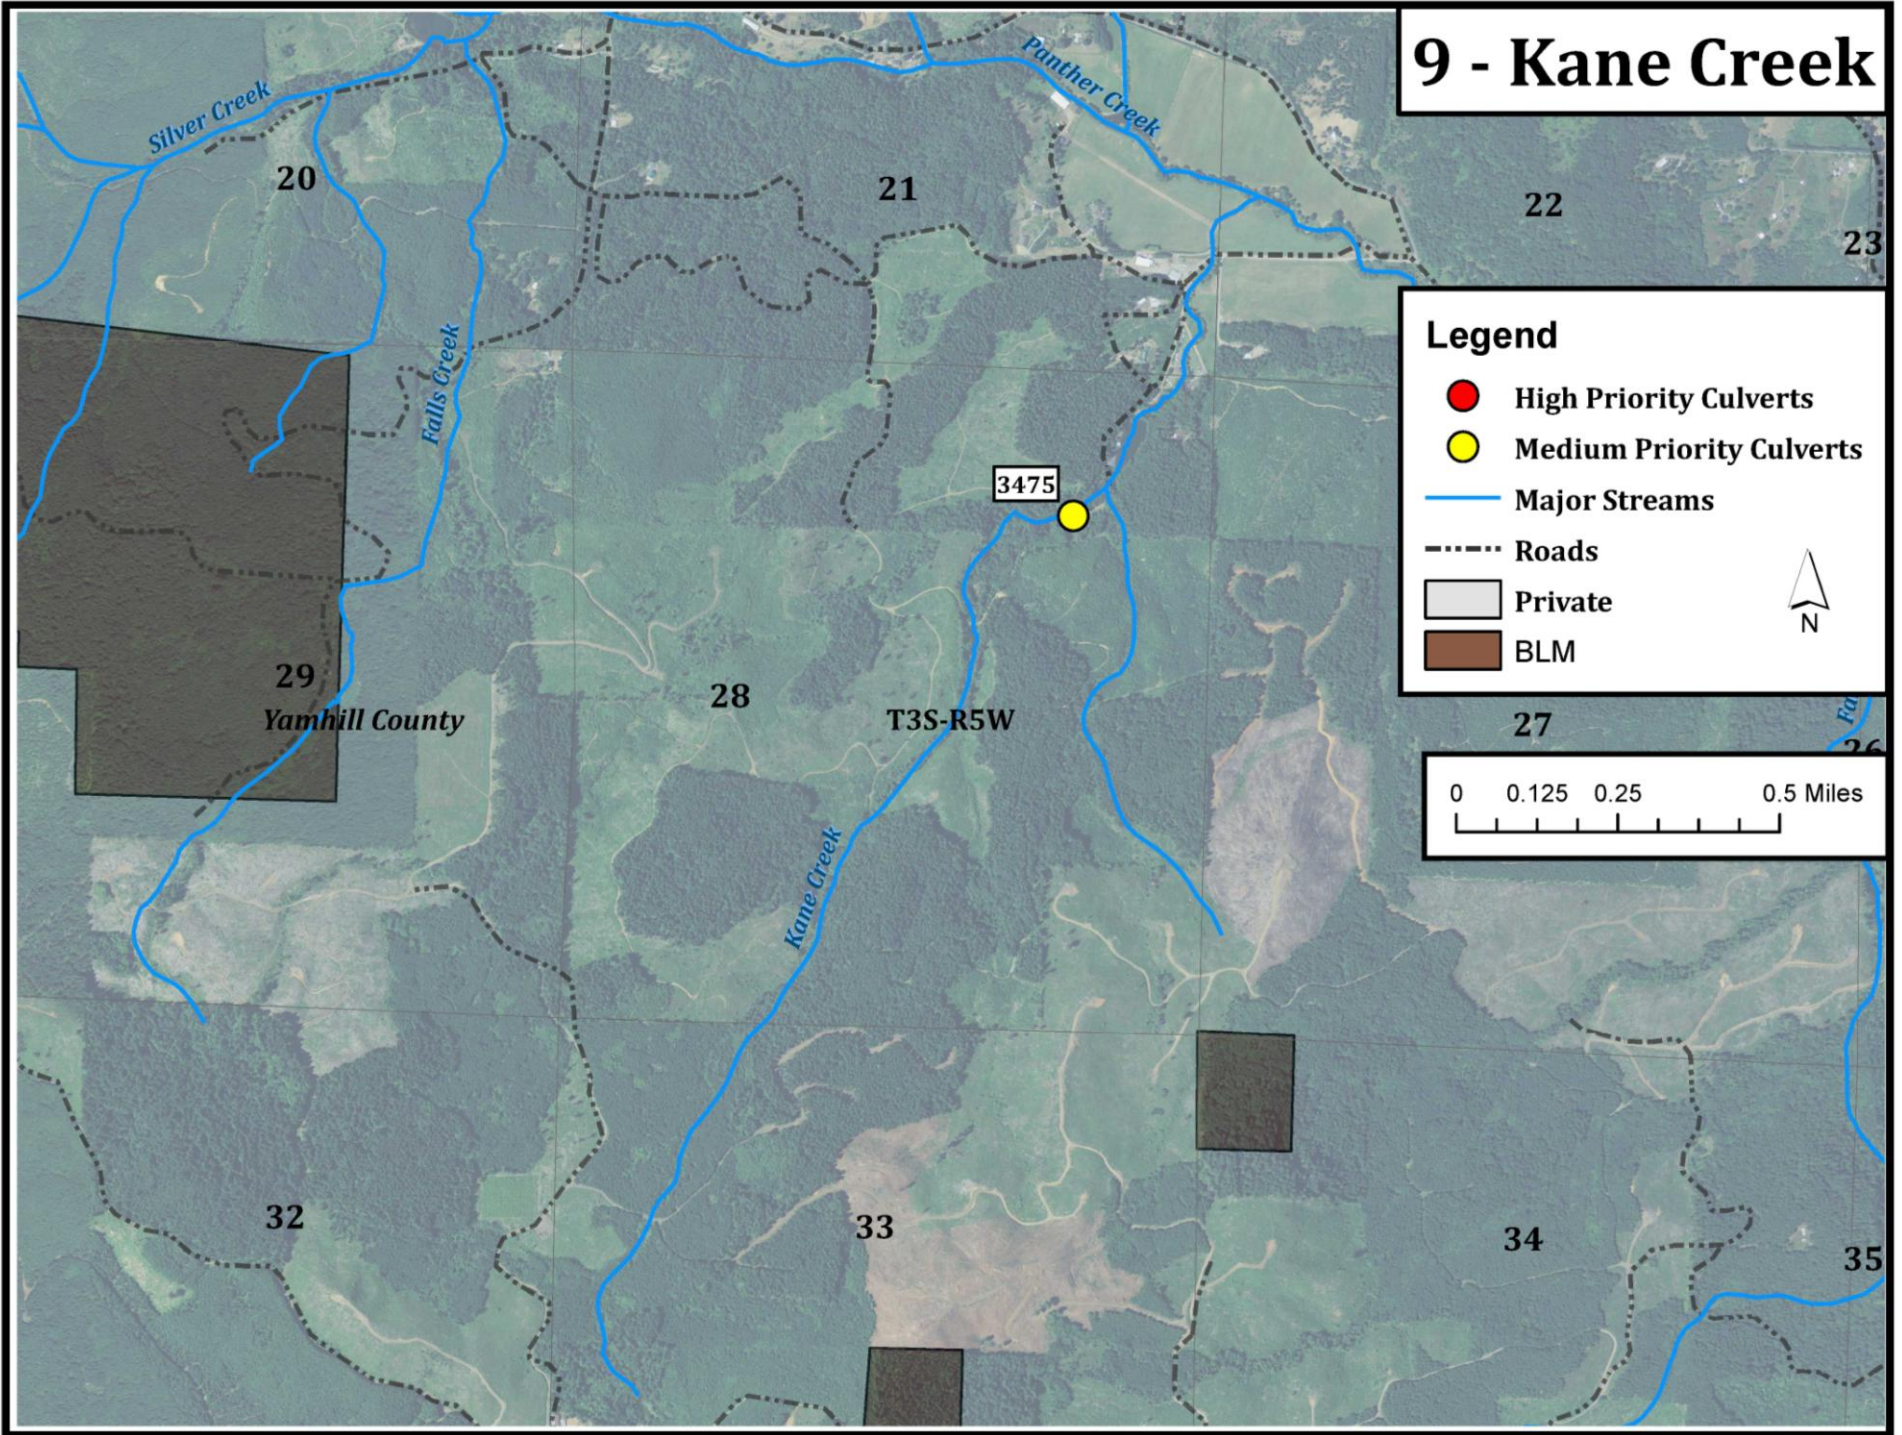
Culvert ID #	10040	Priority Ranking	Med
Location Information			
Watershed	North Yamhill	Township-Range-Section-1/4	NA
Stream Name	Petch Creek	UTM Easting/Northing	NA
Road Name	Flying M Road	Owner Type	Private
Culvert Information			
Barrel Shape	Circular	Length (ft)	24.00
Culvert Material	Concrete	Horizontal Width (in)	84.00
Slope (%)	6.00	Vertical Height (in)	84.00
Overall Culvert Condition	Good	Outlet Drop(ft)	1.13
Channel Information			
Inlet Gradient (%)	NA	Upstream Bankfull Width (ft)	60.00
Upstream Channel Gradient (%)	3.00	Downstream Bankfull Width (ft)	30.00
Bankfull Ratio	NA		
Prioritization Analysis			
Habitat Length (miles)	1.95	(1) Habitat Length Points	2
Habitat Quality	1.15 - Med	(2) Habitat Quality Points	2
Fish Presence	Yes	(3) Fish Presence Points	2
Barrier Severity	Red	Total Prioritization Points	6
Comments			
Survey Date: 6/6/2011; Survey Comments: Well known by landowners as having a salmon run ; November 29 2012 TAC Meeting: N/A

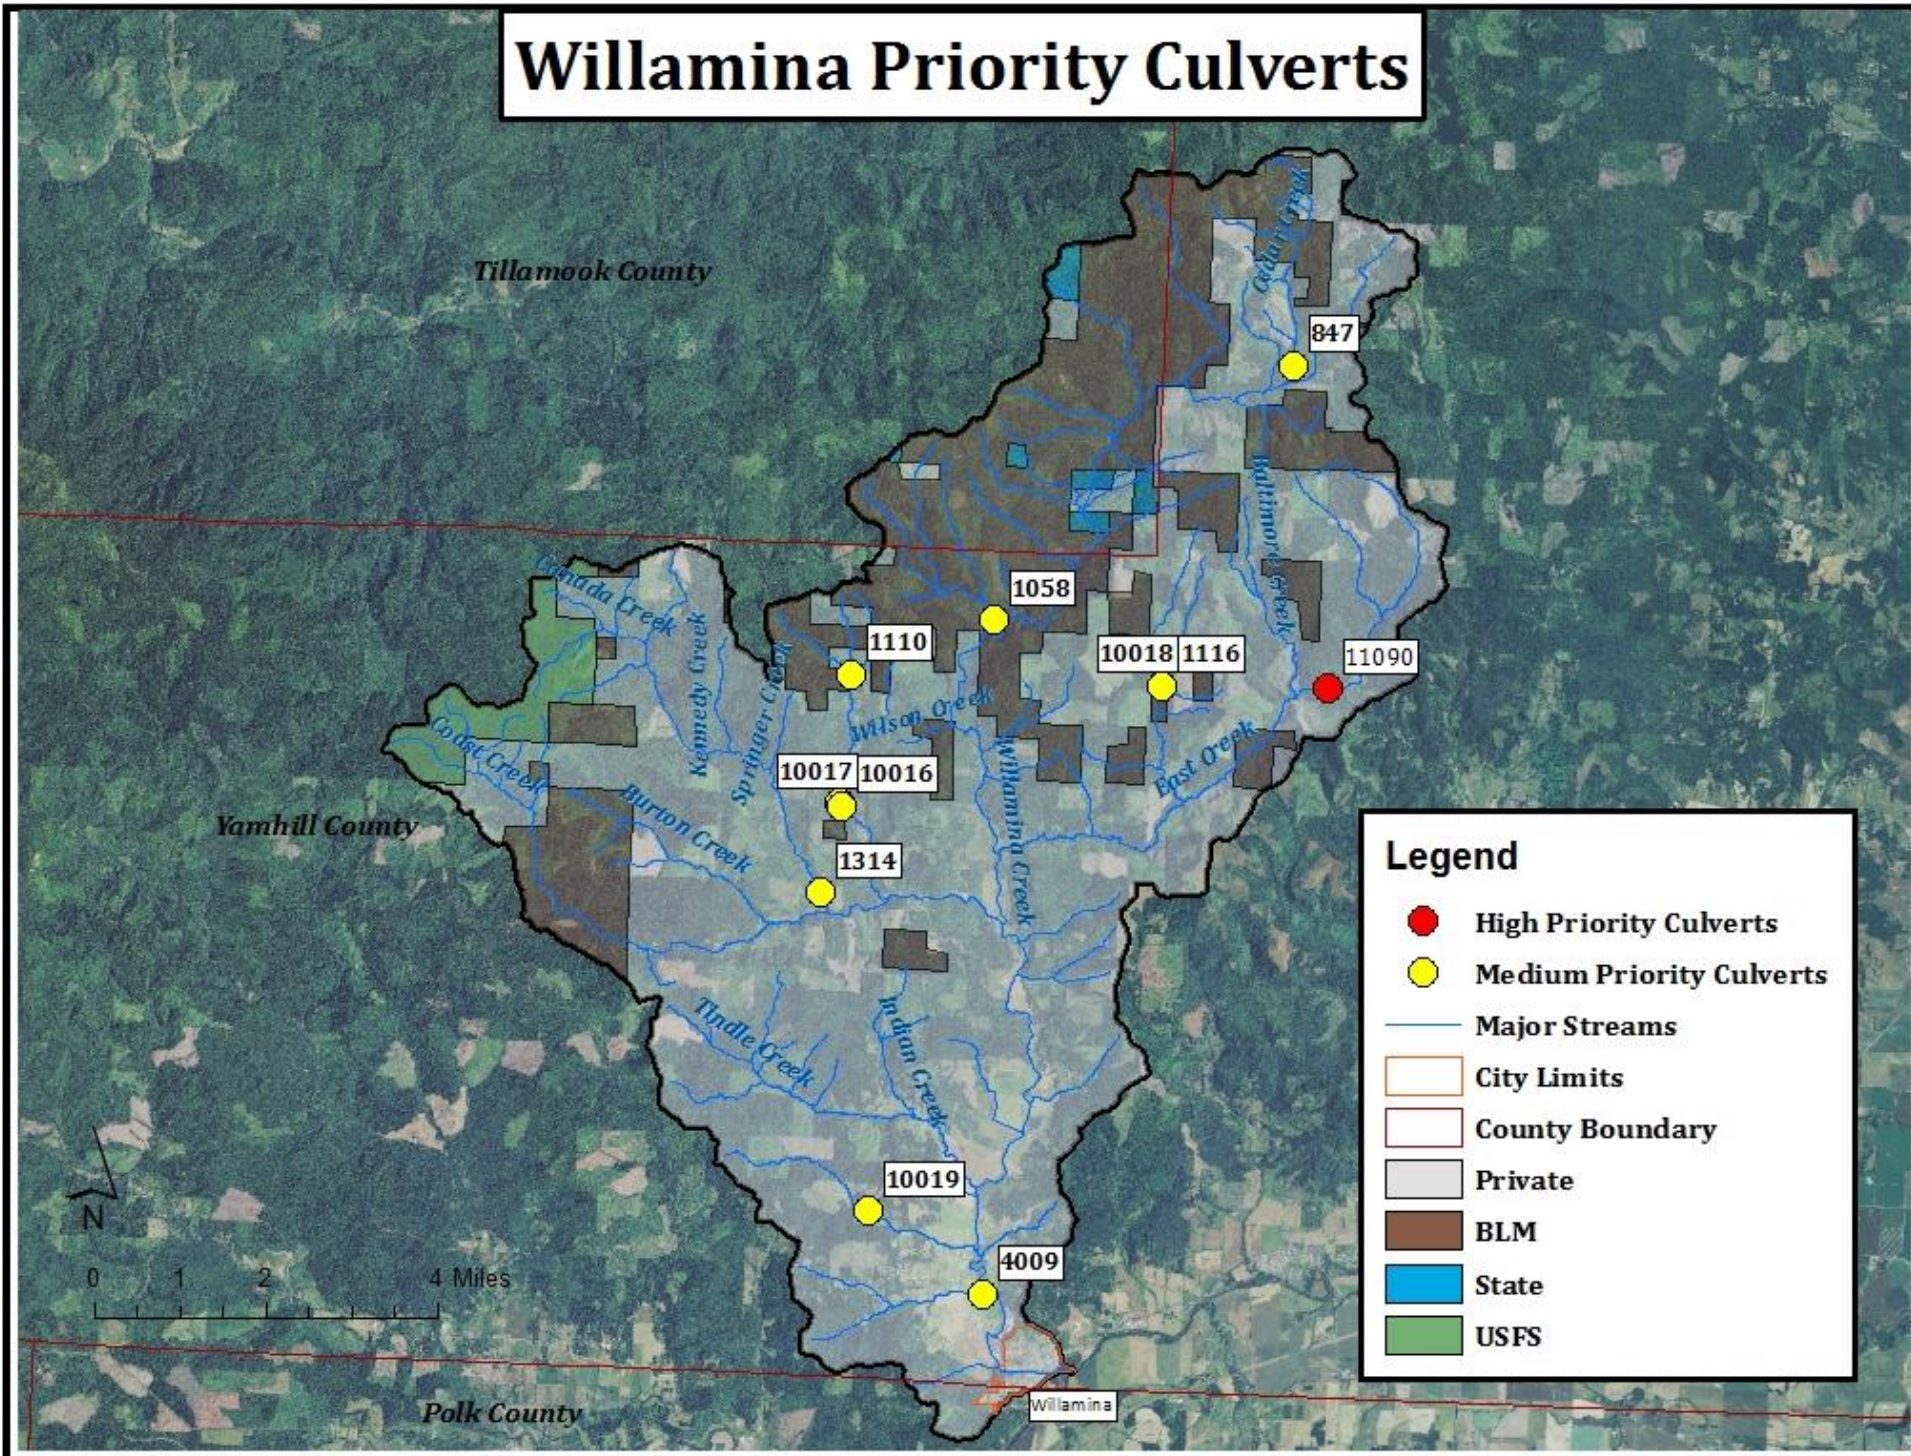
Culvert ID #	11090	Priority Ranking	High
Location Information			
Watershed	Willamina	Township-Range-Section-1/4	4S 6W 27 SW of NW
Stream Name	Baltimore Creek	UTM Easting/Northing	NA
Road Name	Baltimore Creek Rd	Owner Type	Private
Culvert Information			
Barrel Shape	Circular	Length (ft)	20.25
Culvert Material	Spiral CMP	Horizontal Width (in)	70.8
Slope (%)	3.00	Vertical Height (in)	61.2
Overall Culvert Condition	Poor	Outlet Drop(ft)	- 0.68
Channel Information			
Inlet Gradient (%)	22.00	Upstream Bankfull Width (ft)	12.00
Upstream Channel Gradient (%)	0.50	Downstream Bankfull Width (ft)	12.00
Bankfull Ratio	0.49		
Prioritization Analysis			
Habitat Length (miles)	8.52	(1) Habitat Length Points	5
Habitat Quality	3.33 - High	(2) Habitat Quality Points	3
Fish Presence	Yes	(3) Fish Presence Points	2
Barrier Severity	Red	Total Prioritization Points	10
Comments			
<p>Survey Date: 7/5/2007; Survey Comments: 2 culverts, both dammed by beaver; Debris plugging inlet; November 29 2012 TAC Meeting: (ODFW)Coho uses system; probable steelhead; Good habitat upstream; City has water rights upstream; Need more information on fish distributions.</p>

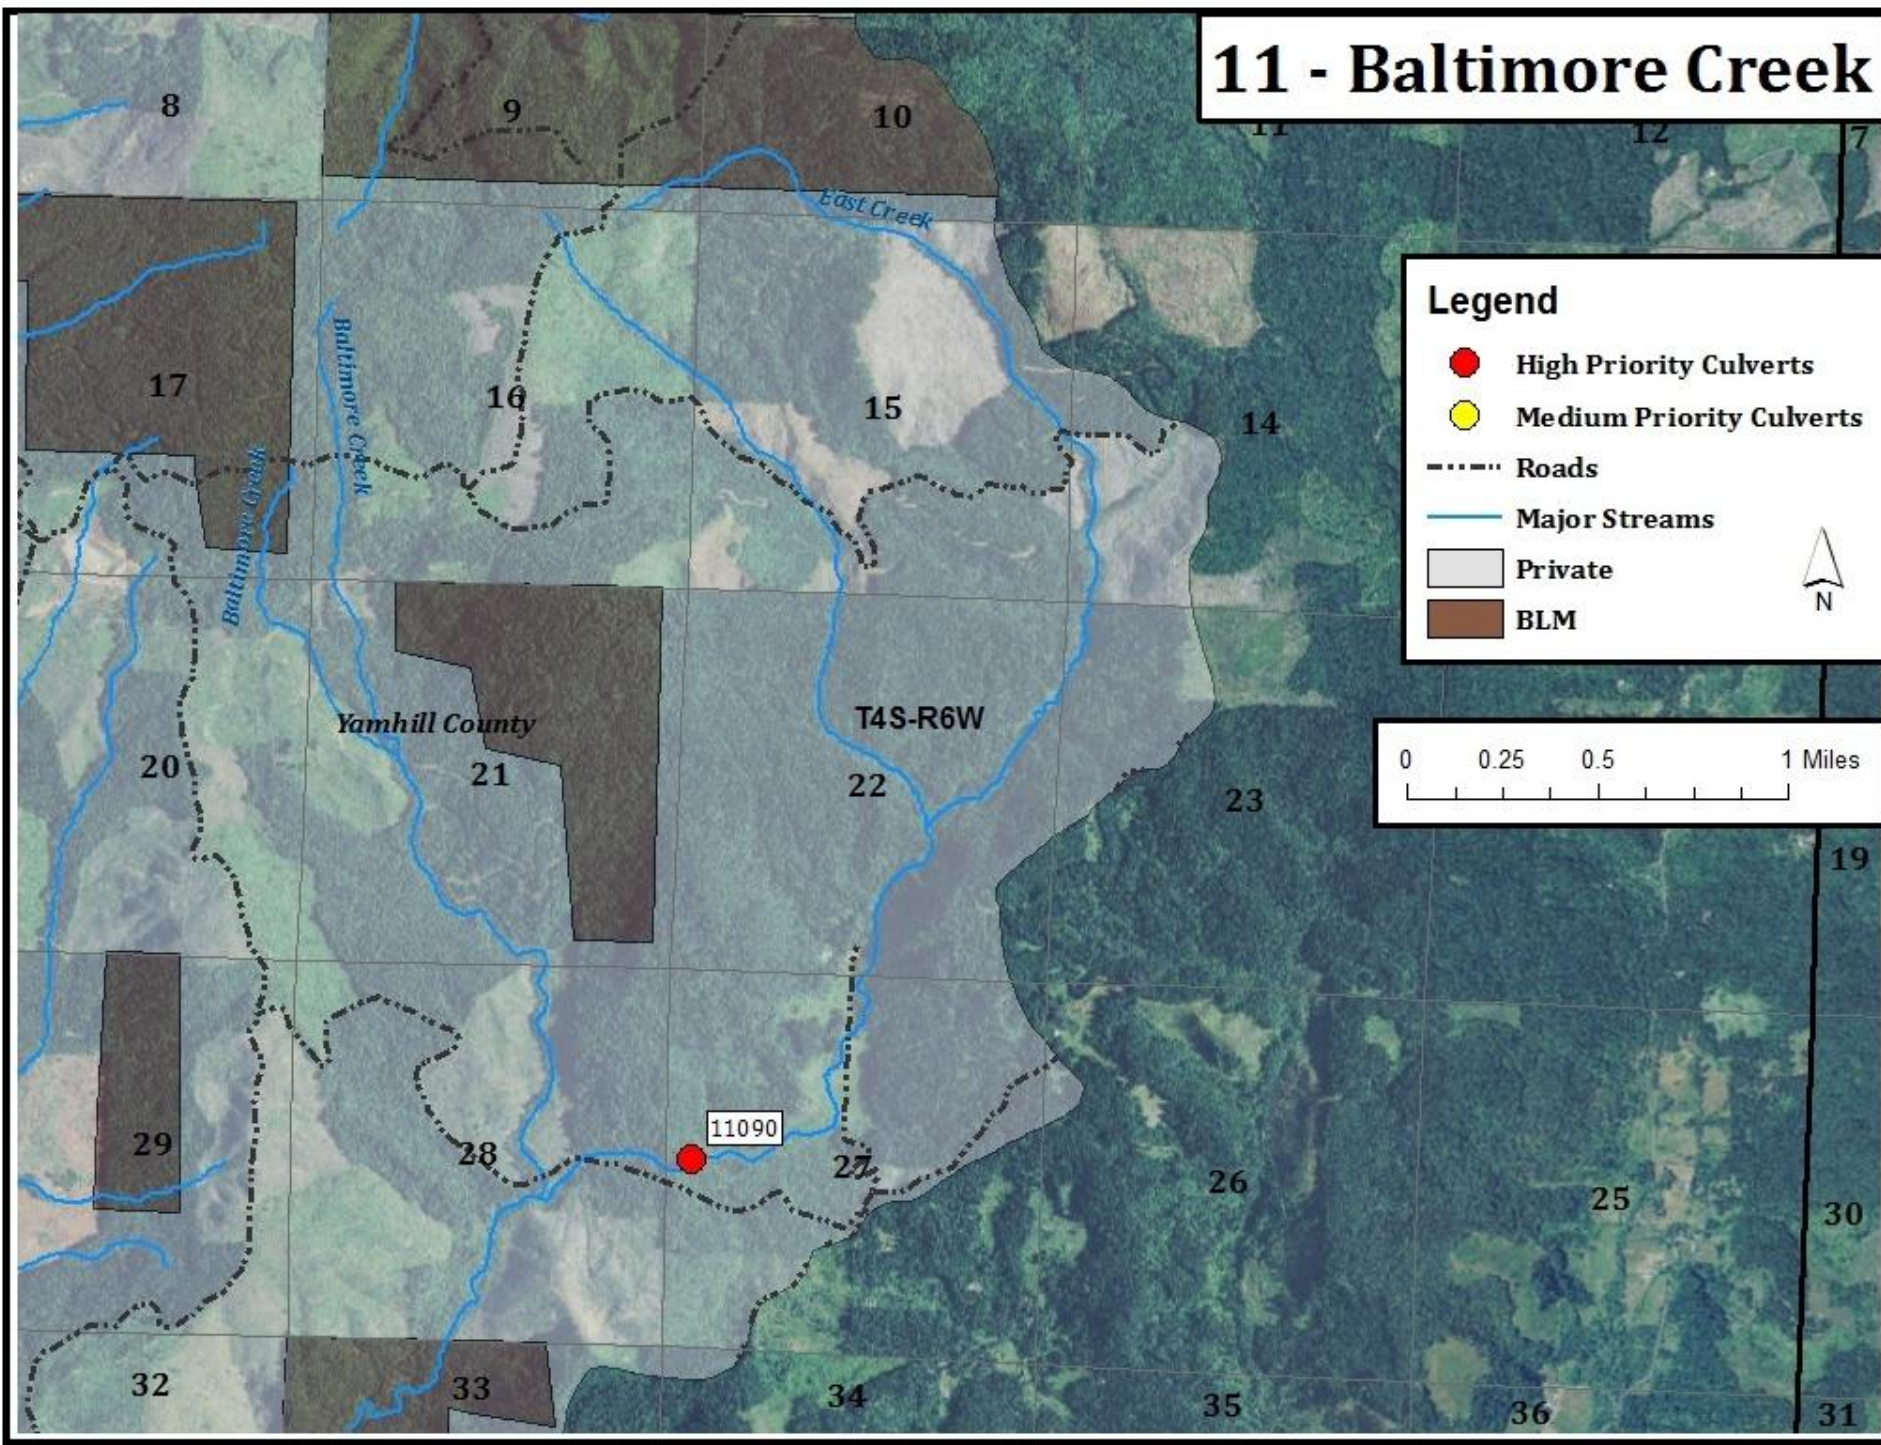
Culvert ID #	1314	Priority Ranking	Med
Location Information			
Watershed	Willamina	Township-Range-Section-1/4	5S 7W 10 NW of NW
Stream Name	Canada Creek	UTM Easting/Northing	457530 / 5000415
Road Name	Canada Creek Road	Owner Type	Private Industrial
Culvert Information			
Barrel Shape	Open Bottom Arch	Length (ft)	48.00
Culvert Material	SSP (Steel)	Horizontal Width (in)	168.00
Slope (%)	1.00	Vertical Height (in)	120.00
Overall Culvert Condition	Good	Outlet Drop(ft)	- 1.20
Channel Information			
Inlet Gradient (%)	10.00	Upstream Bankfull Width (ft)	27.00
Upstream Channel Gradient (%)	2.00	Downstream Bankfull Width (ft)	24.00
Bankfull Ratio	0.52		
Prioritization Analysis			
Habitat Length (miles)	5.70	(1) Habitat Length Points	5
Habitat Quality	4.02 - High	(2) Habitat Quality Points	3
Fish Presence	Yes	(3) Fish Presence Points	2
Barrier Severity	Red	Total Prioritization Points	10
Comments			
<p>Survey Date: 7/6/2004; Survey Comments: Backwater pool; Culvert sits on a 2ft concrete footwall; Fill eroding; November 29 2012 TAC Meeting: (BLM): Undersized culvert; May have washed out; Not scheduled to be replaced; Possibly still used as access road - low water ford.</p>

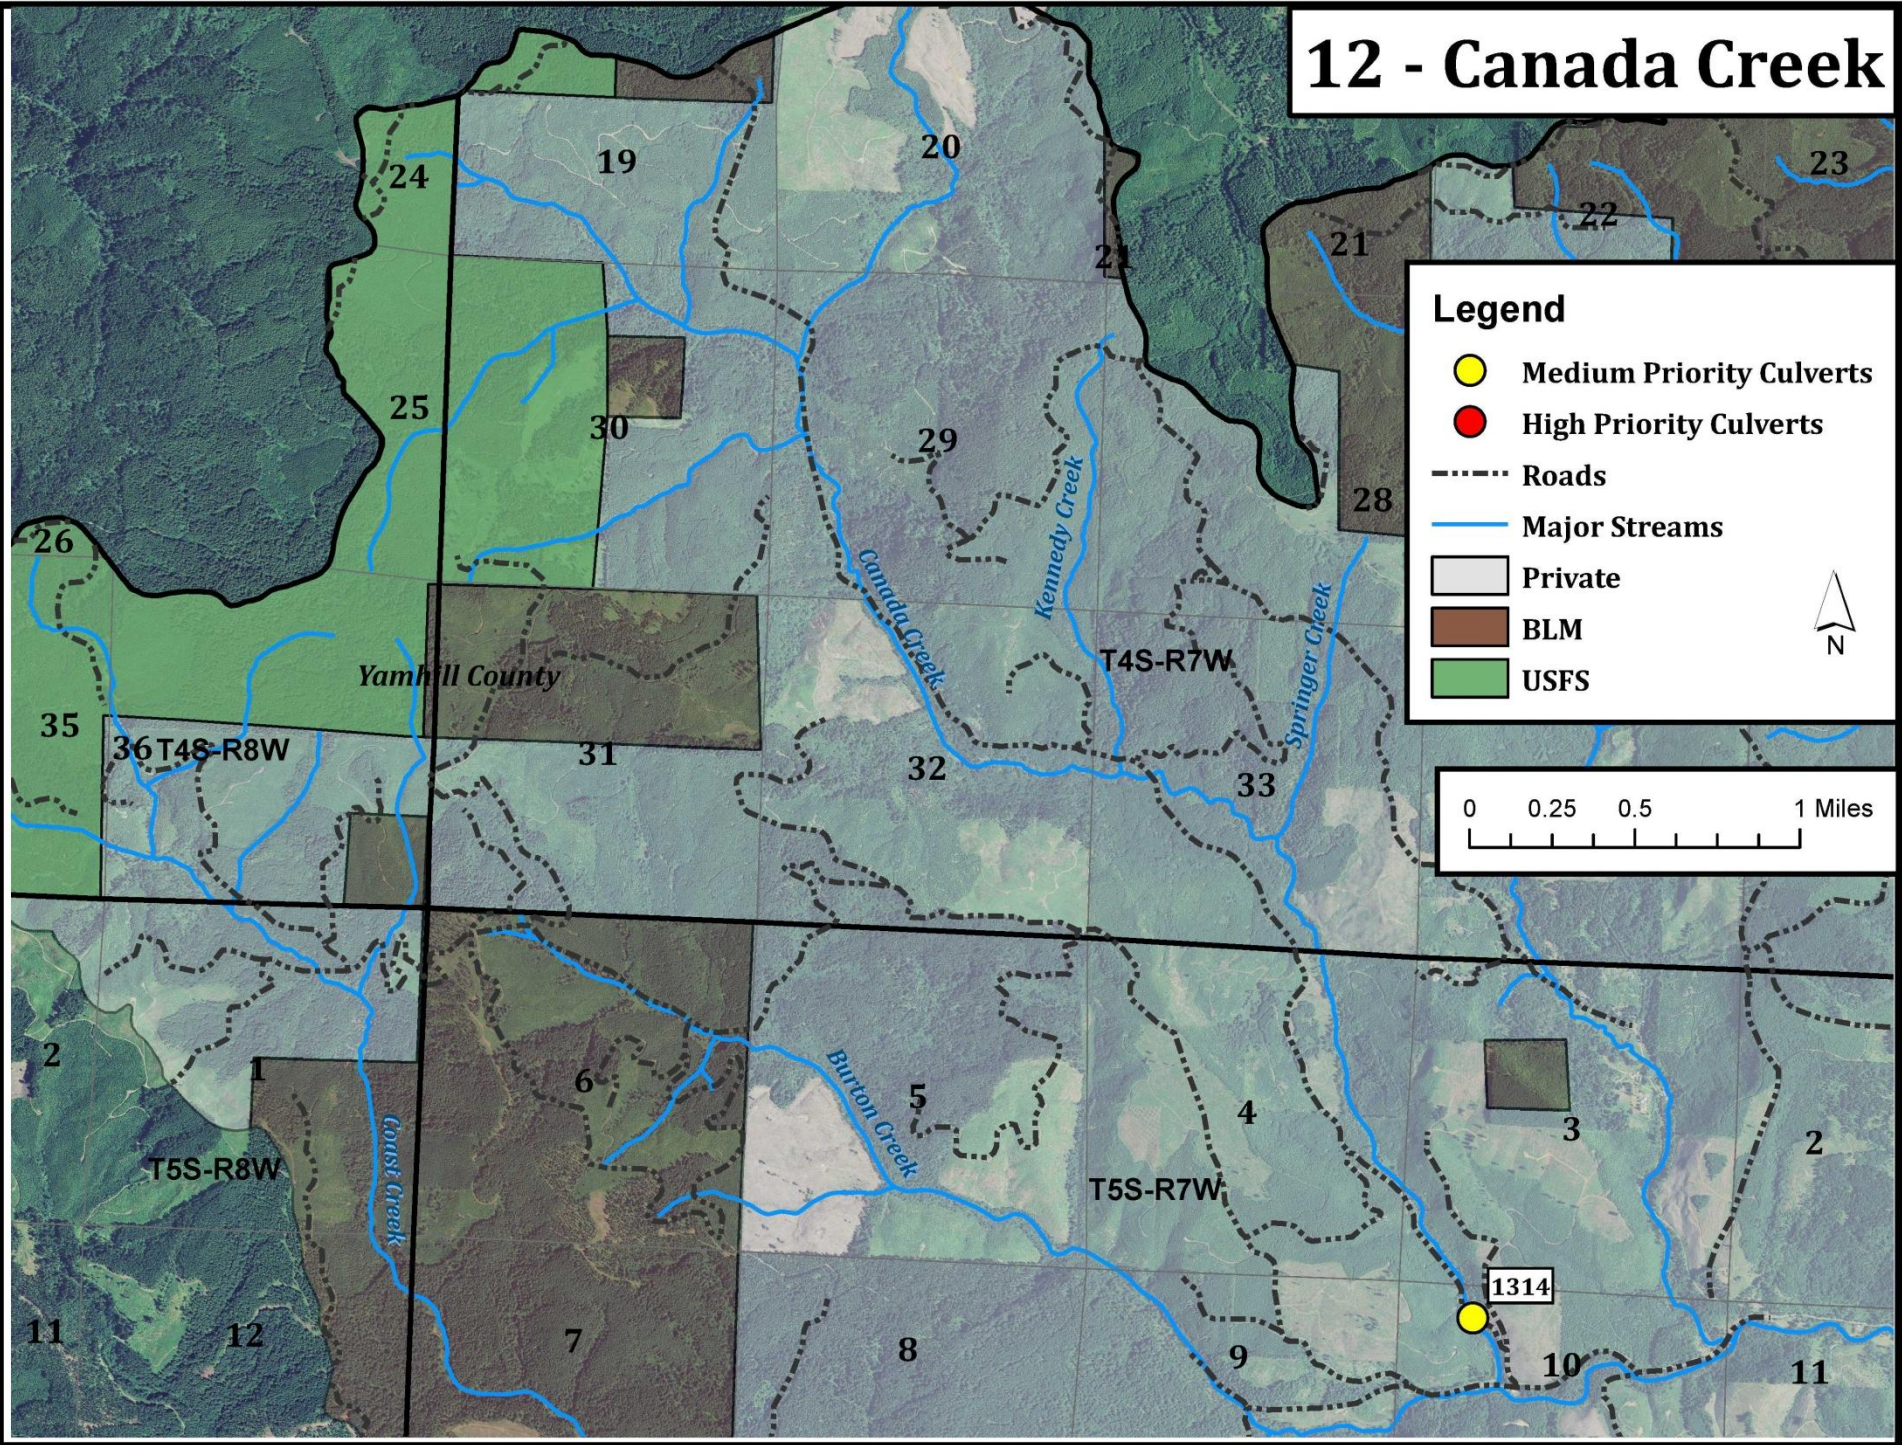
Culvert ID #	847	Priority Ranking	Med
Location Information			
Watershed	Willamina	Township-Range-Section-1/4	4S 6W 4 NW of SE
Stream Name	Cedar Creek	UTM Easting/Northing	466145 / 5010553
Road Name	Peavine Road	Owner Type	Private Industrial
Culvert Information			
Barrel Shape	Pipe-Arch	Length (ft)	41.00
Culvert Material	Annular CMP	Horizontal Width (in)	72.00
Slope (%)	1.00	Vertical Height (in)	42.00
Overall Culvert Condition	Fair	Outlet Drop(ft)	0.20
Channel Information			
Inlet Gradient (%)	2.00	Upstream Bankfull Width (ft)	16.50
Upstream Channel Gradient (%)	1.00	Downstream Bankfull Width (ft)	16.50
Bankfull Ratio	0.36		
Prioritization Analysis			
Habitat Length (miles)	4.08	(1) Habitat Length Points	5
Habitat Quality	2.38 - High	(2) Habitat Quality Points	3
Fish Presence	Yes	(3) Fish Presence Points	2
Barrier Severity	Red	Total Prioritization Points	10
Comments			
Survey Date: 6/28/2004; Survey Comments: Fish presence verified; November 29 2012 TAC Meeting: (ODFW): Above anadromous use; 50' waterfall downstream.

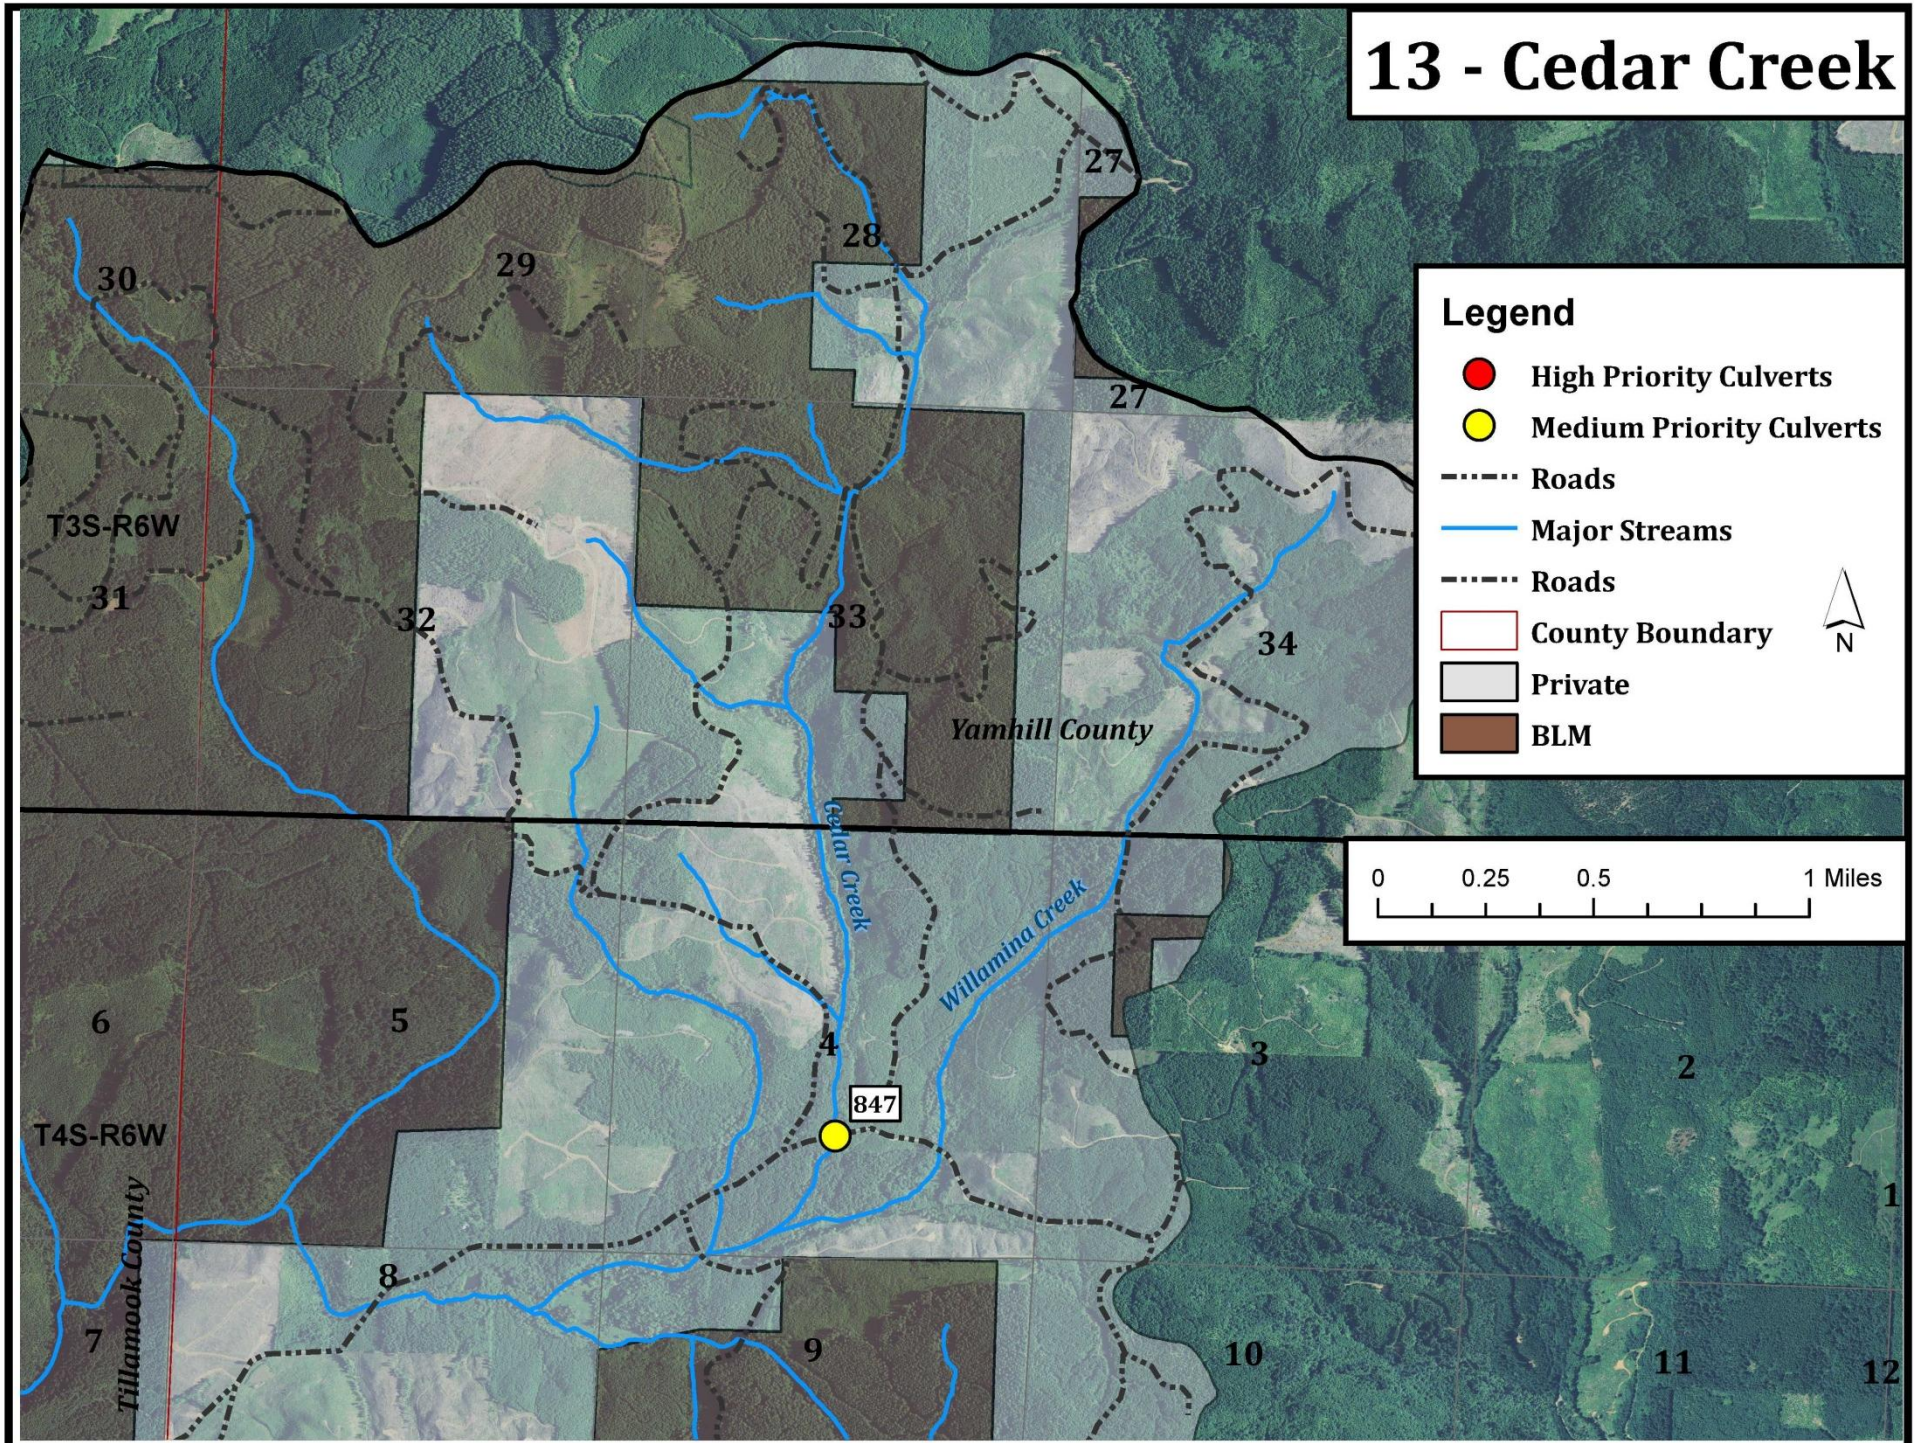
Culvert ID #	1058	Priority Ranking	Med
Location Information			
Watershed	Willamina	Township-Range-Section-1/4	4S 7W 24 SW of SW
Stream Name	Trib to Willamina Creek	UTM Easting/Northing	460697 / 5005596
Road Name	Willamina Creek Road	Owner Type	USDI-BLM
Culvert Information			
Barrel Shape	Circular	Length (ft)	114.00
Culvert Material	Annular CMP	Horizontal Width (in)	78.00
Slope (%)	5.00	Vertical Height (in)	78.00
Overall Culvert Condition	Fair	Outlet Drop(ft)	2.84
Channel Information			
Inlet Gradient (%)	25.00	Upstream Bankfull Width (ft)	27.00
Upstream Channel Gradient (%)	10.00	Downstream Bankfull Width (ft)	NA
Bankfull Ratio	0.24		
Prioritization Analysis			
Habitat Length (miles)	4.08	(1) Habitat Length Points	5
Habitat Quality	1.75 - Med	(2) Habitat Quality Points	2
Fish Presence	Yes	(3) Fish Presence Points	2
Barrier Severity	Red	Total Prioritization Points	9
Comments			
<p>Survey Date: 9/30/2003; Survey Comments: Culvert outlet influenced by another stream; no channel downstream; November 29 2012 TAC Meeting: (ODFW): Most stream crossings in this area have waterfalls upstream. (BLM): May not be fish upstream; Need more information on fish distribution; BLM recently cleaned debris from the culvert; Willamina Creek is downstream and backwaters; BLM does not rank highly – Low Priority for BLM.</p>

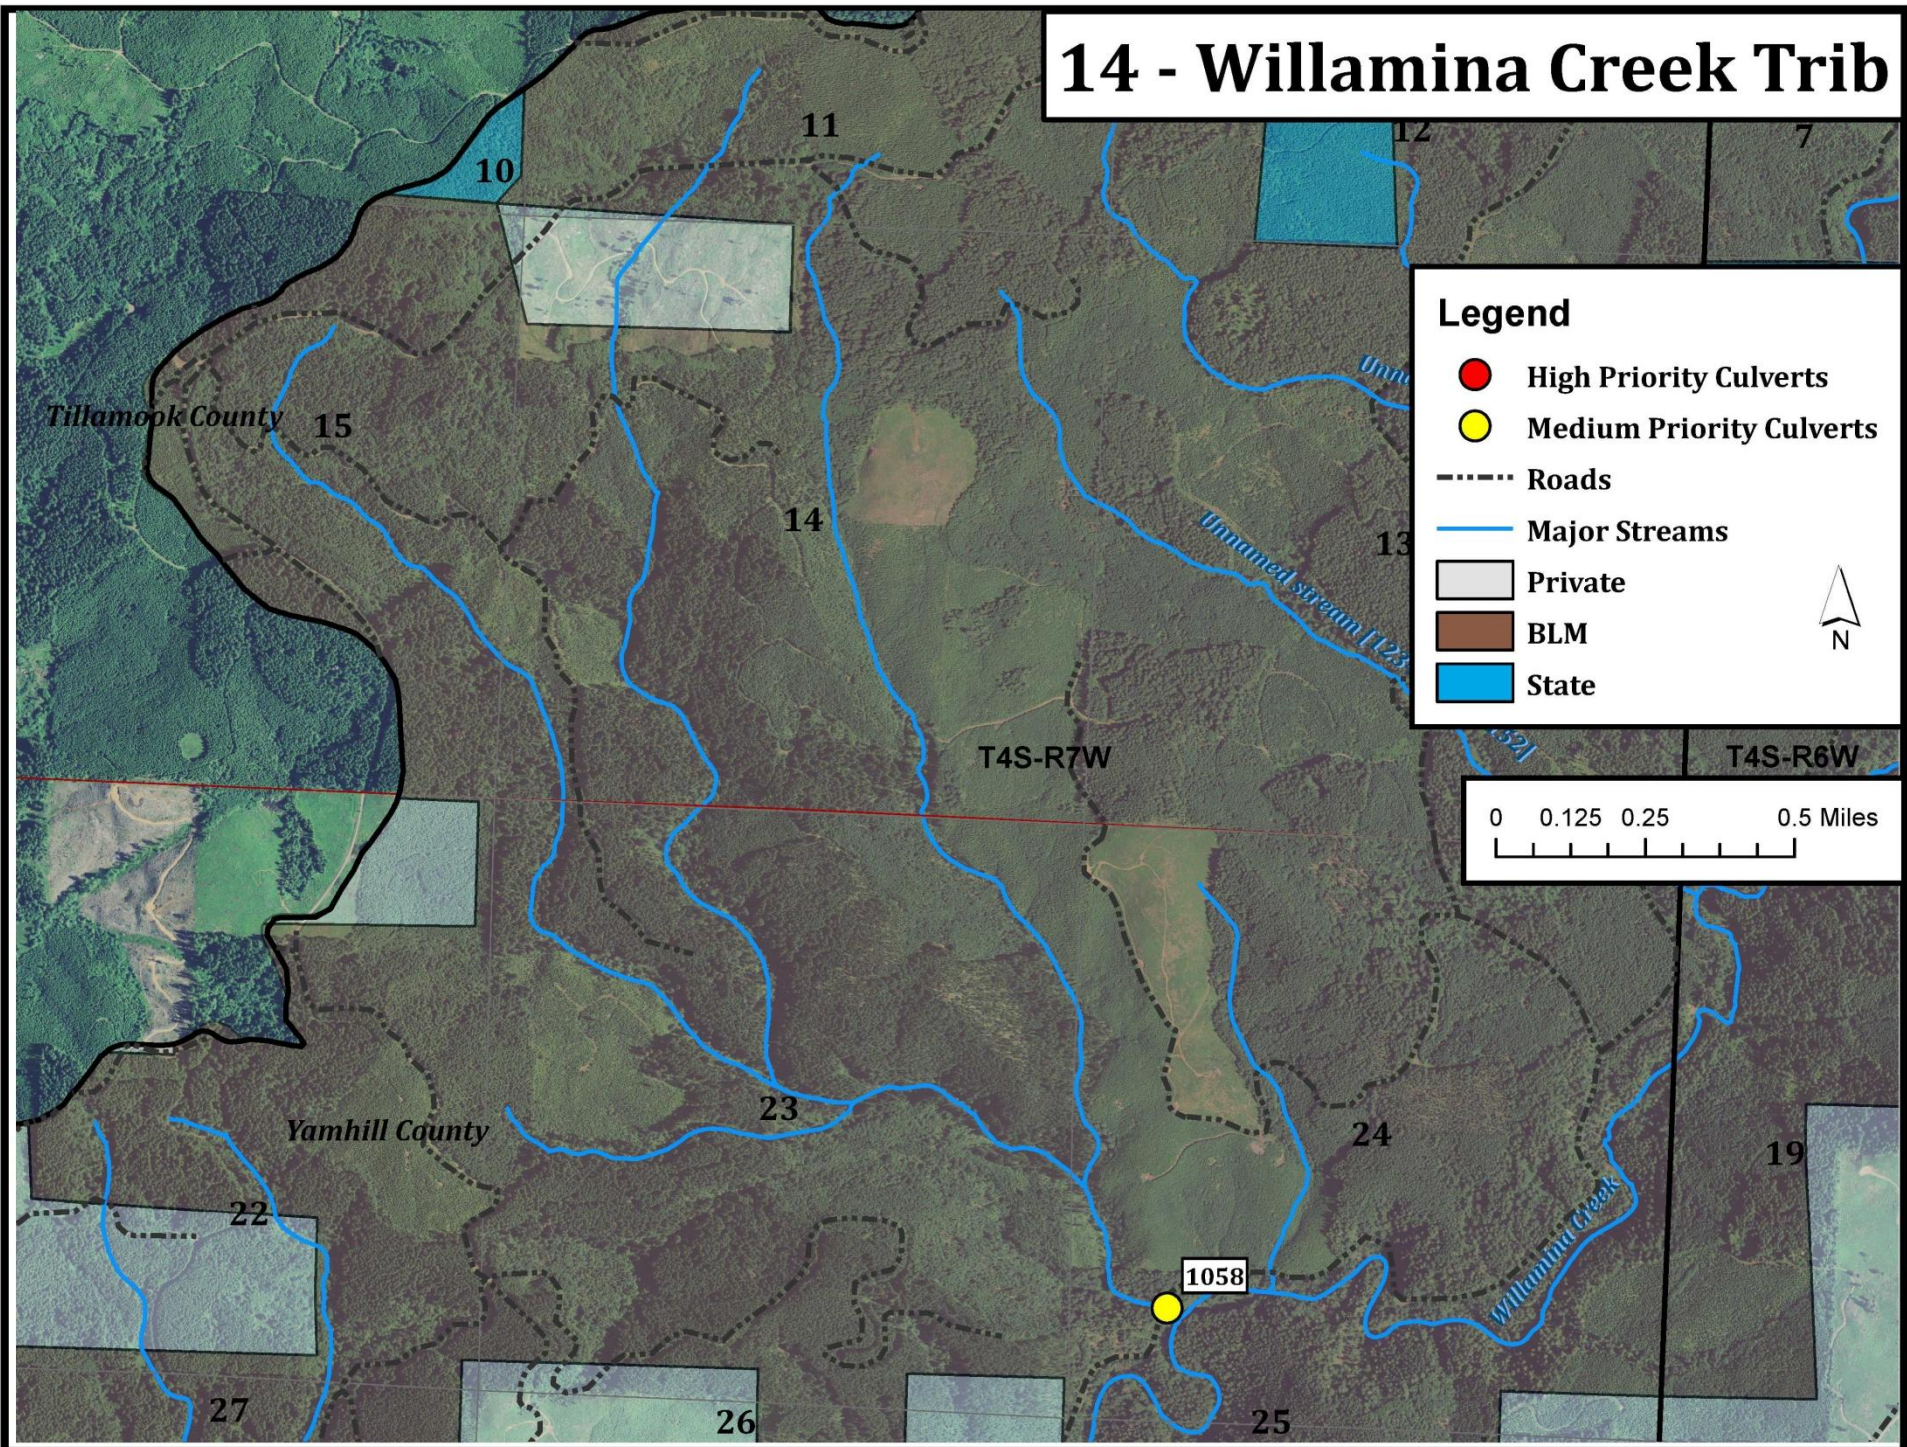
Culvert ID #	4009	Priority Ranking	Med
Location Information			
Watershed	Willamina	Township-Range-Section-1/4	5S 7W 36 NE of SW
Stream Name	Trib to Willamina Creek	UTM Easting/Northing	NA
Road Name	Fort Hill Road	Owner Type	Private
Culvert Information			
Barrel Shape	Circular	Length (ft)	16.00
Culvert Material	Spiral CMP	Horizontal Width (in)	60.00
Slope (%)	5.00	Vertical Height (in)	60.00
Overall Culvert Condition	Poor	Outlet Drop(ft)	1.48
Channel Information			
Inlet Gradient (%)	15.00	Upstream Bankfull Width (ft)	7.00
Upstream Channel Gradient (%)	3.00	Downstream Bankfull Width (ft)	6.00
Bankfull Ratio	0.76		
Prioritization Analysis			
Habitat Length (miles)	2.21	(1) Habitat Length Points	3
Habitat Quality	1.13 - Med	(2) Habitat Quality Points	2
Fish Presence	Yes	(3) Fish Presence Points	2
Barrier Severity	Red	Total Prioritization Points	7
Comments			
Survey Date: 7/24/2007; Survey Comments: Outlet 7' to Willamina Creek; Culvert bottom worn through; November 29 2012 TAC Meeting: N/A
