Yamhill Watershed Culvert Prioritization and Action Plan for Fish Passage

**GREATER YAMHILL
WATERSHED COUNCIL**

**Luke Westphal
Executive Director
Greater Yamhill Watershed Council**

December 2012

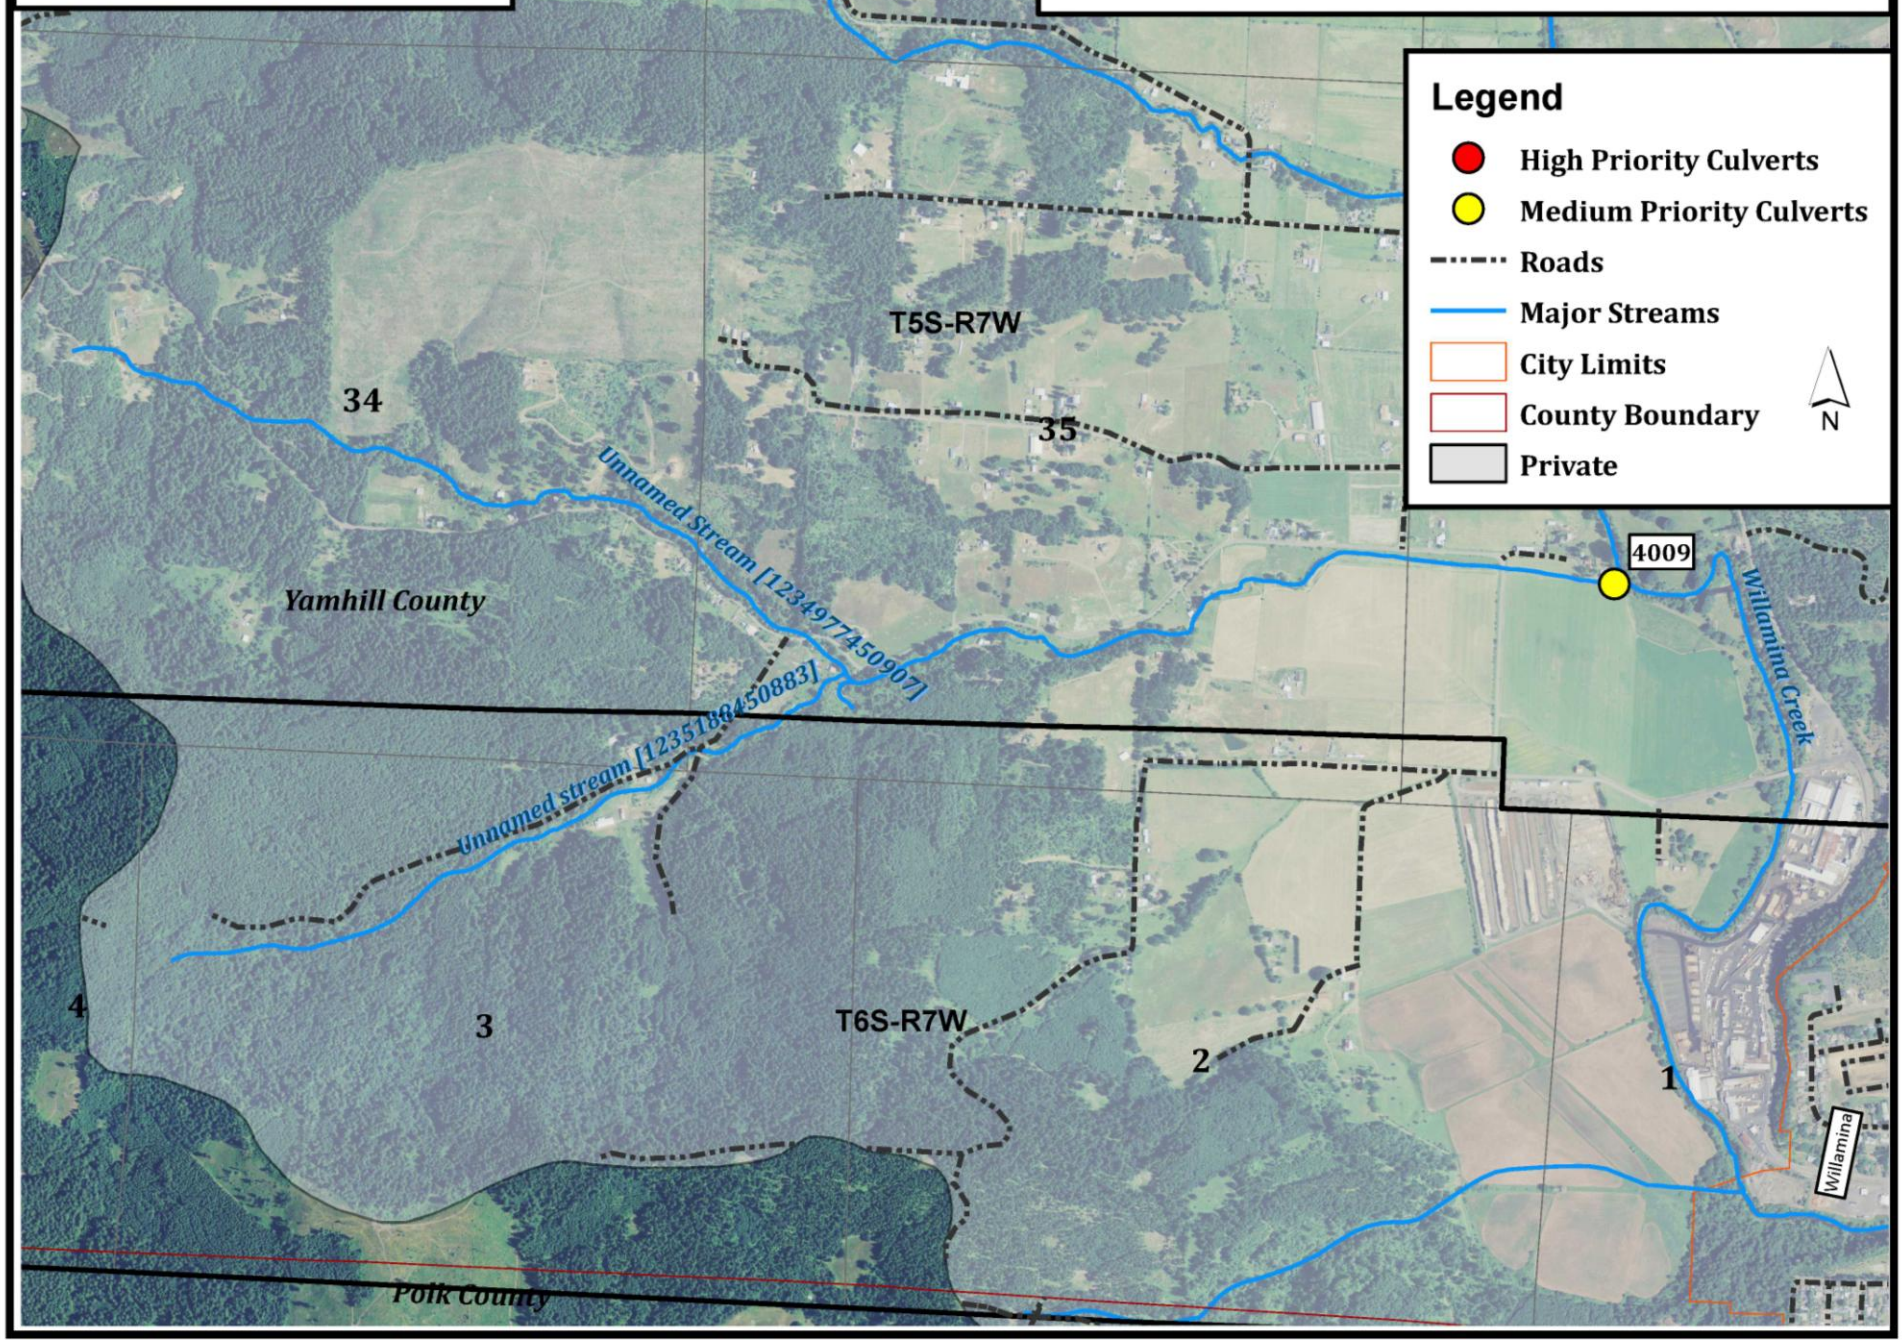
Culvert ID #	10019	Priority Ranking	Med
Location Information			
Watershed	Willamina	Township-Range-Section-1/4	5S 7W 27 NE OF SE
Stream Name	Trib to Willamina	UTM Easting/Northing	NA
Road Name	Allen Road	Owner Type	Private
Culvert Information			
Barrel Shape	Circular	Length (ft)	55.00
Culvert Material	Annular CMP	Horizontal Width (in)	76.80
Slope (%)	3.00	Vertical Height (in)	91.20
Overall Culvert Condition	Fair	Outlet Drop(ft)	1.45
Channel Information			
Inlet Gradient (%)	0.00	Upstream Bankfull Width (ft)	11.50
Upstream Channel Gradient (%)	1.00	Downstream Bankfull Width (ft)	11.00
Bankfull Ratio	0.56		
Prioritization Analysis			
Habitat Length (miles)	2.51	(1) Habitat Length Points	3
Habitat Quality	1.24 - Med	(2) Habitat Quality Points	2
Fish Presence	Yes	(3) Fish Presence Points	2
Barrier Severity	Red	Total Prioritization Points	7
Comments			
<p>Survey Date: 6/19/2007; Survey Comments: Beaver pools upstream; Culvert bottom rusting through; November 29 2012 TAC Meeting: (ODFW) Lower end occupied by steelhead but not far up; Need more information on fish distributions and habitat.</p>

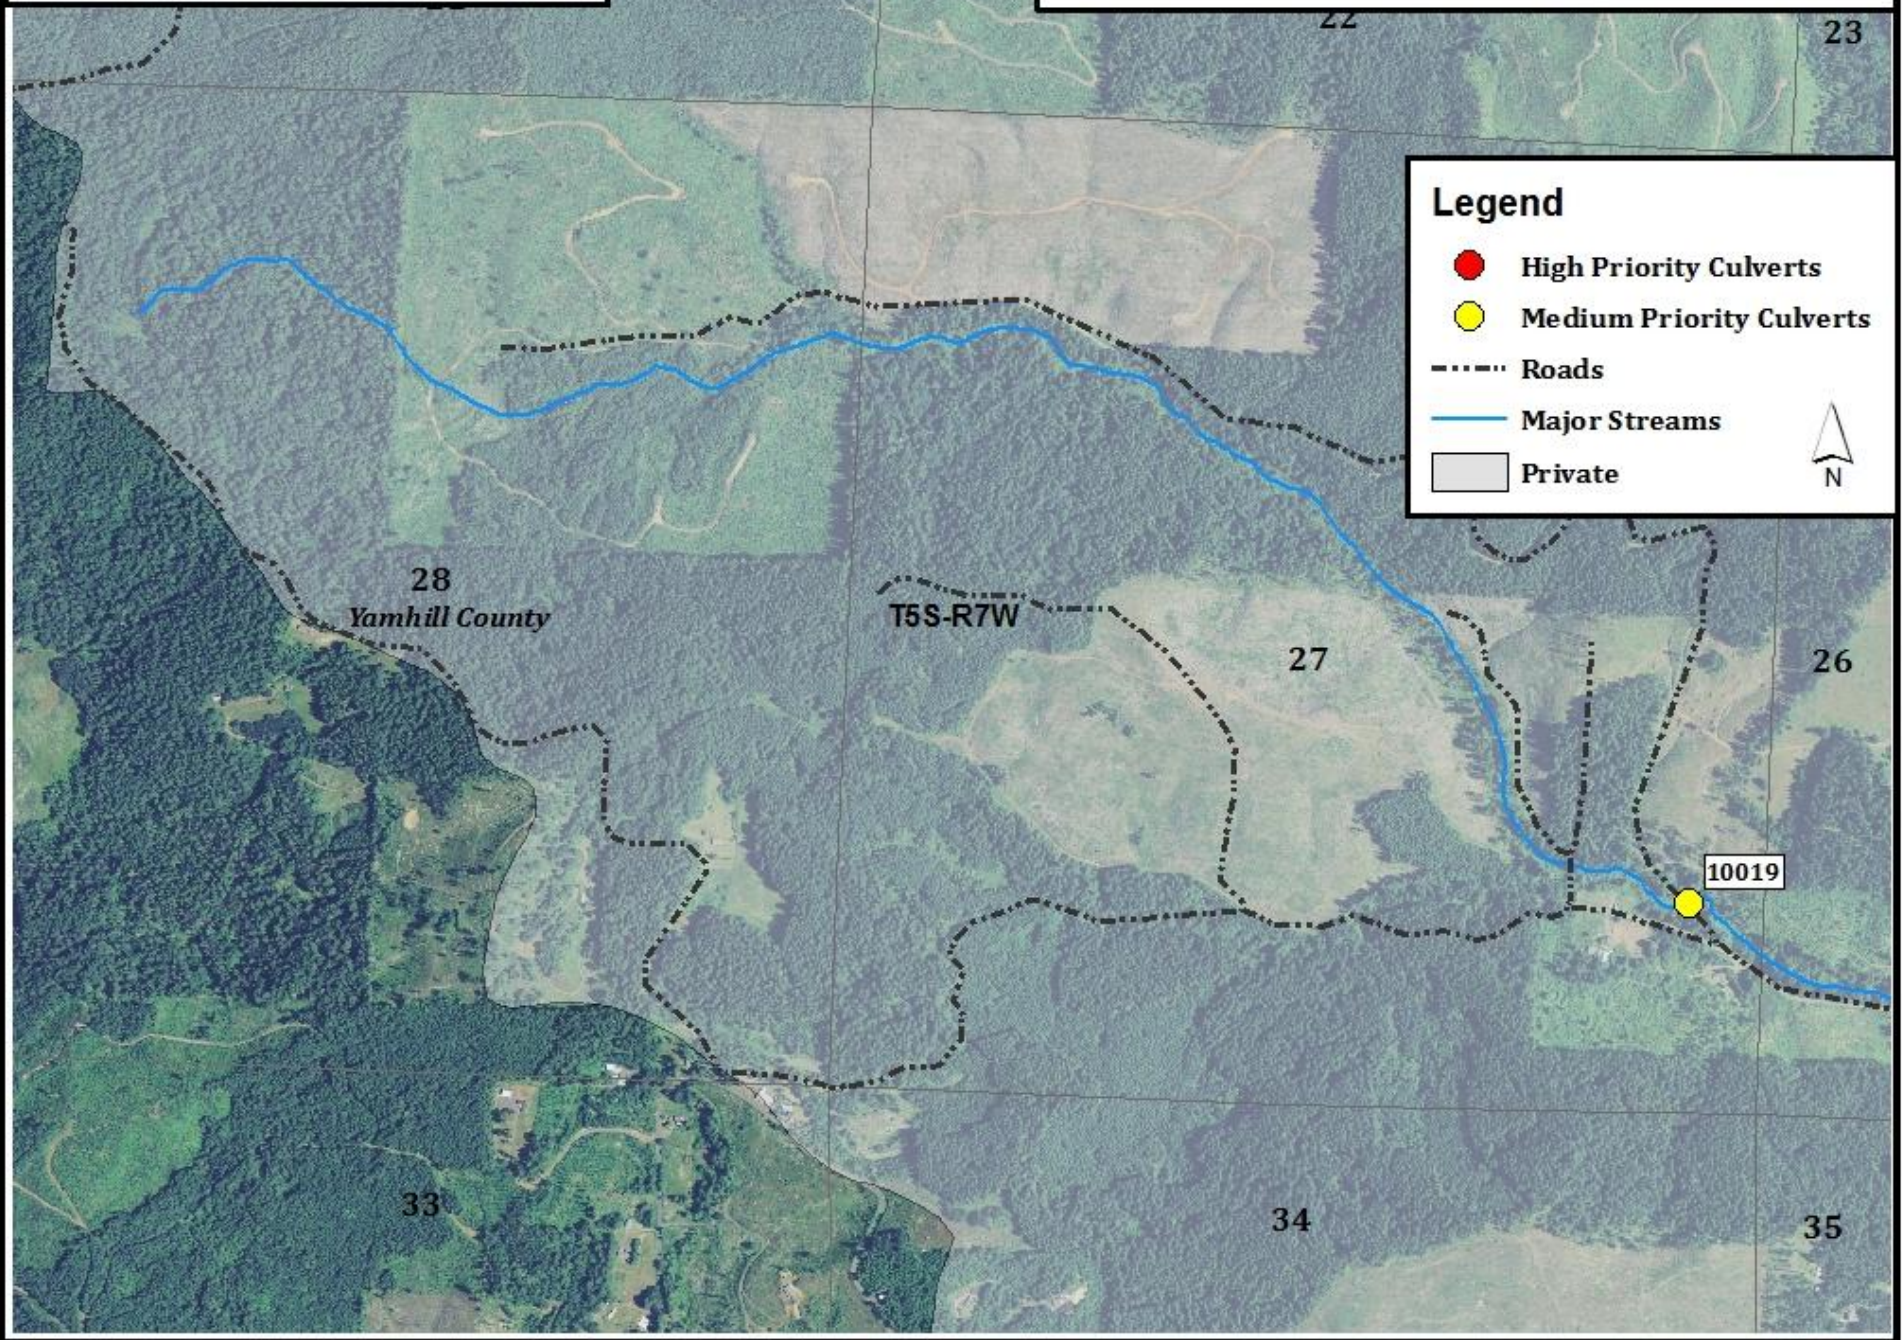
Culvert ID #	1110	Priority Ranking	Med
Location Information			
Watershed	Willamina	Township-Range-Section-1/4	4S 7W 27 NW of SE
Stream Name	Gilbert Creek	UTM Easting/Northing	458052 / 5004468
Road Name	Gilbert Creek Road	Owner Type	Private
Culvert Information			
Barrel Shape	Circular	Length (ft)	50.00
Culvert Material	Concrete	Horizontal Width (in)	36.00
Slope (%)	3.00	Vertical Height (in)	36.00
Overall Culvert Condition	Poor	Outlet Drop(ft)	0.60
Channel Information			
Inlet Gradient (%)	24.00	Upstream Bankfull Width (ft)	14.00
Upstream Channel Gradient (%)	2.00	Downstream Bankfull Width (ft)	14.00
Bankfull Ratio	0.21		
Prioritization Analysis			
Habitat Length (miles)	2.56	(1) Habitat Length Points	3
Habitat Quality	1.08 - Med	(2) Habitat Quality Points	2
Fish Presence	Yes	(3) Fish Presence Points	2
Barrier Severity	Red	Total Prioritization Points	7
Comments			
<p>Survey Date: 7/15/2004; Survey Comments: Culvert sections pulling apart, breaks in slope, undersized; November 29 2012 TAC Meeting: (ODFW) Above anadromous use; Waterfall downstream; Resident Cutthroat above and possibly lamprey to consider.</p>

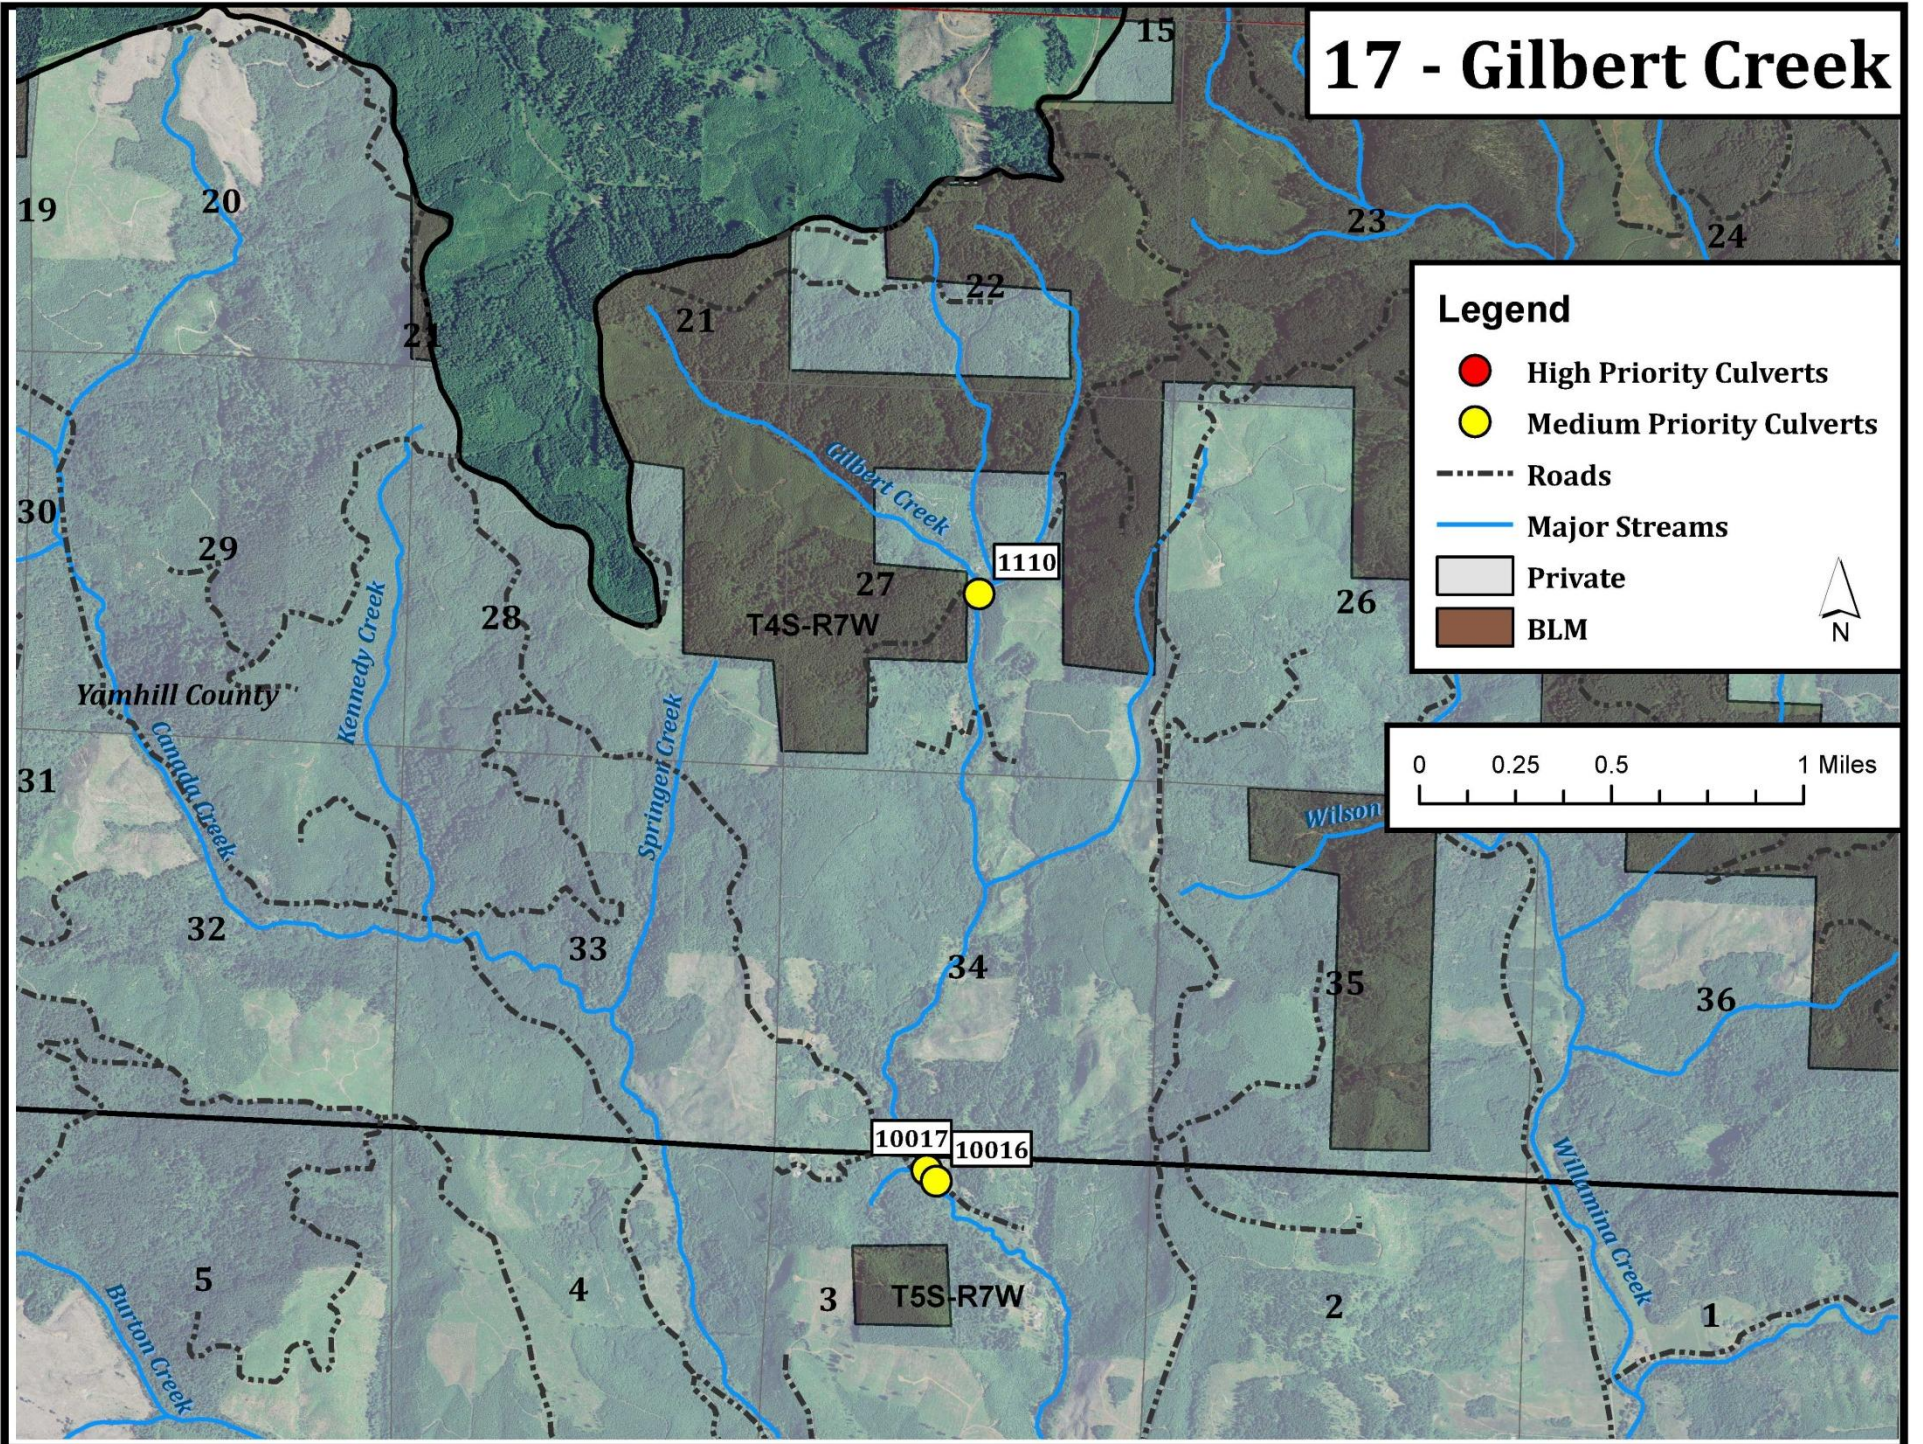
Culvert ID #	1116	Priority Ranking	Med
Location Information			
Watershed	Willamina	Township-Range-Section-1/4	4S 6W 29 NW of SW
Stream Name	La Tautena Mary Cr	UTM Easting/Northing	463912 / 5004442
Road Name	N/A	Owner Type	USDI-BLM
Culvert Information			
Barrel Shape	Circular	Length (ft)	33.00
Culvert Material	Annular CMP	Horizontal Width (in)	54.00
Slope (%)	2.00	Vertical Height (in)	54.00
Overall Culvert Condition	Poor	Outlet Drop(ft)	2.50
Channel Information			
Inlet Gradient (%)	21.00	Upstream Bankfull Width (ft)	13.00
Upstream Channel Gradient (%)	1.00	Downstream Bankfull Width (ft)	12.00
Bankfull Ratio	0.35		
Prioritization Analysis			
Habitat Length (miles)	2.02	(1) Habitat Length Points	3
Habitat Quality	0.64 - Low	(2) Habitat Quality Points	1
Fish Presence	Yes	(3) Fish Presence Points	2
Barrier Severity	Red	Total Prioritization Points	6
Comments			
Survey Date: 7/21/2004; Survey Comments: Undersized; Rusting through; Adjacent to Culvert ID # 10018; November 29 2012 TAC Meeting: N/A
